City of St. Augustine, Florida

**Archaeological Investigations Along the Seaward Side
of St. Augustine's Historic 19th-Century Sea Wall**

Carl D. Halbirt
City Archaeologist

January 20, 2004

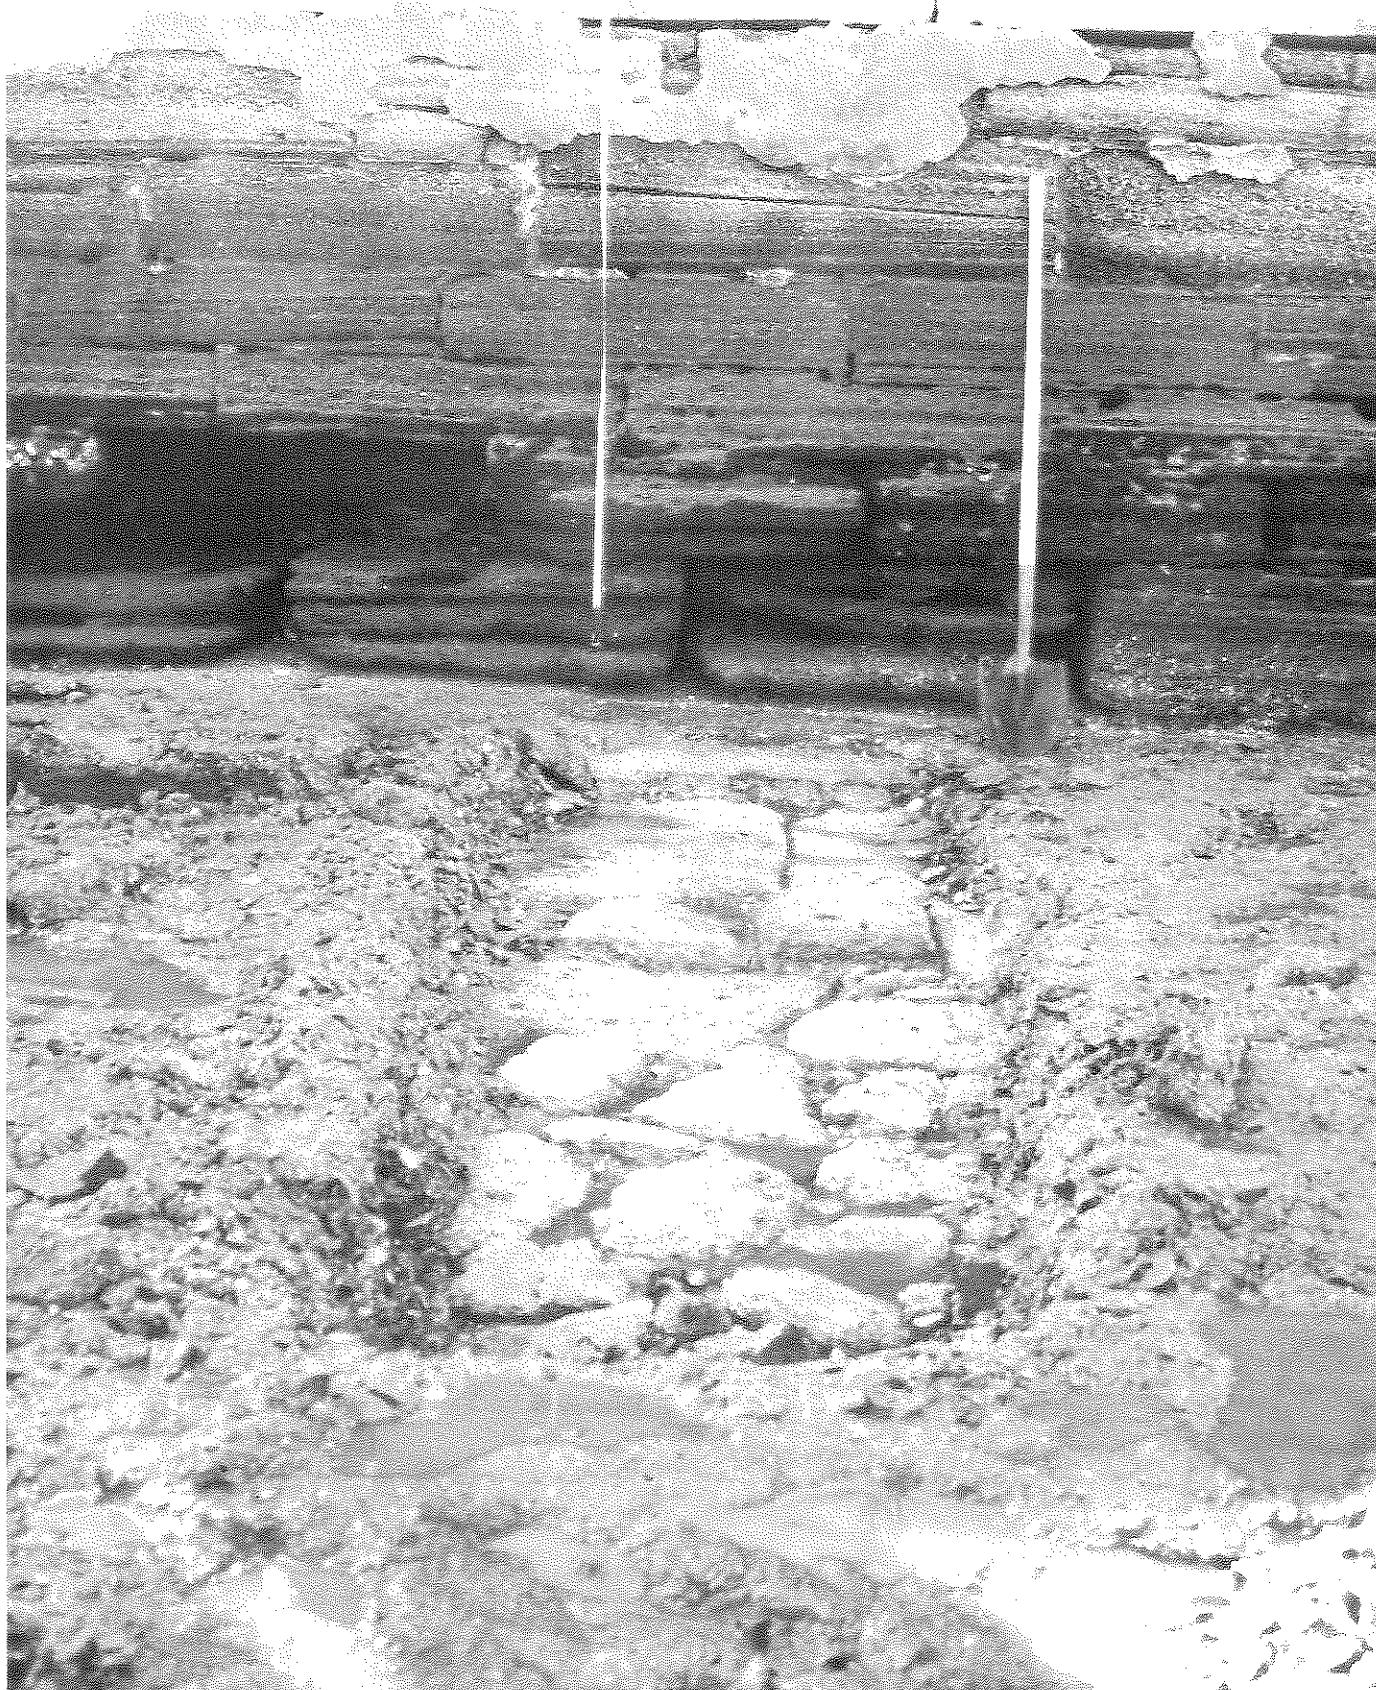
Figure 8. Profile of Historic Sea Wall Elements and Associated Sediments at Site A.
This is the field drawing.

Measurements show that the wall height from the top of the foundation stone to the top of the granite coping stone is 6 feet 4 inches and 6 feet 6 inches, respectively (Figure 8); both are within the estimates calculated from Benham's drawings. The foundation stone on which the wall rests is in excess of 1 foot 8 inches, which also is in agreement with the historical illustration. At this time, no attempt was made to determine the thickness of the foundation stone due to the potential impacts that such activity would have on the existing sea wall.⁷

Two types of erosional support mechanisms are found along the sea wall, neither of which is mutually exclusive. The first is a series of large coquina blocks placed directly adjacent and parallel to the foundation stones. The blocks extended an average of 2.5 feet from the foundation stone and were 7 inches lower than the foundation stone. The function of this alignment was probably similar to the concrete-filled trench proposed by Lt. Gilmer to protect the foundation. No attempt was made to determine the thickness of this component of the sea wall, as per the reason given for the foundation stone. In front of the blocks was a 5 ½ foot pavement of broken coquina stones, which were intentionally laid flat along the sloping edge of the Matanzas River. These stones are assumed to represent recycled building debris used as a rip-rap to limit the surface displacement of marsh deposits in front of the sea wall. The paver stones vary in size (Figure 9), but were on average 6 inches thick.

No in situ coquina stone was found beyond this approximate 10-foot barrier. What was apparent was a thick deposit of shell debris within a coarse-grain, sandy clay

matrix (Figure 8). Below this matrix were the fine-grain marsh sediments over which the historic sea wall had been constructed.

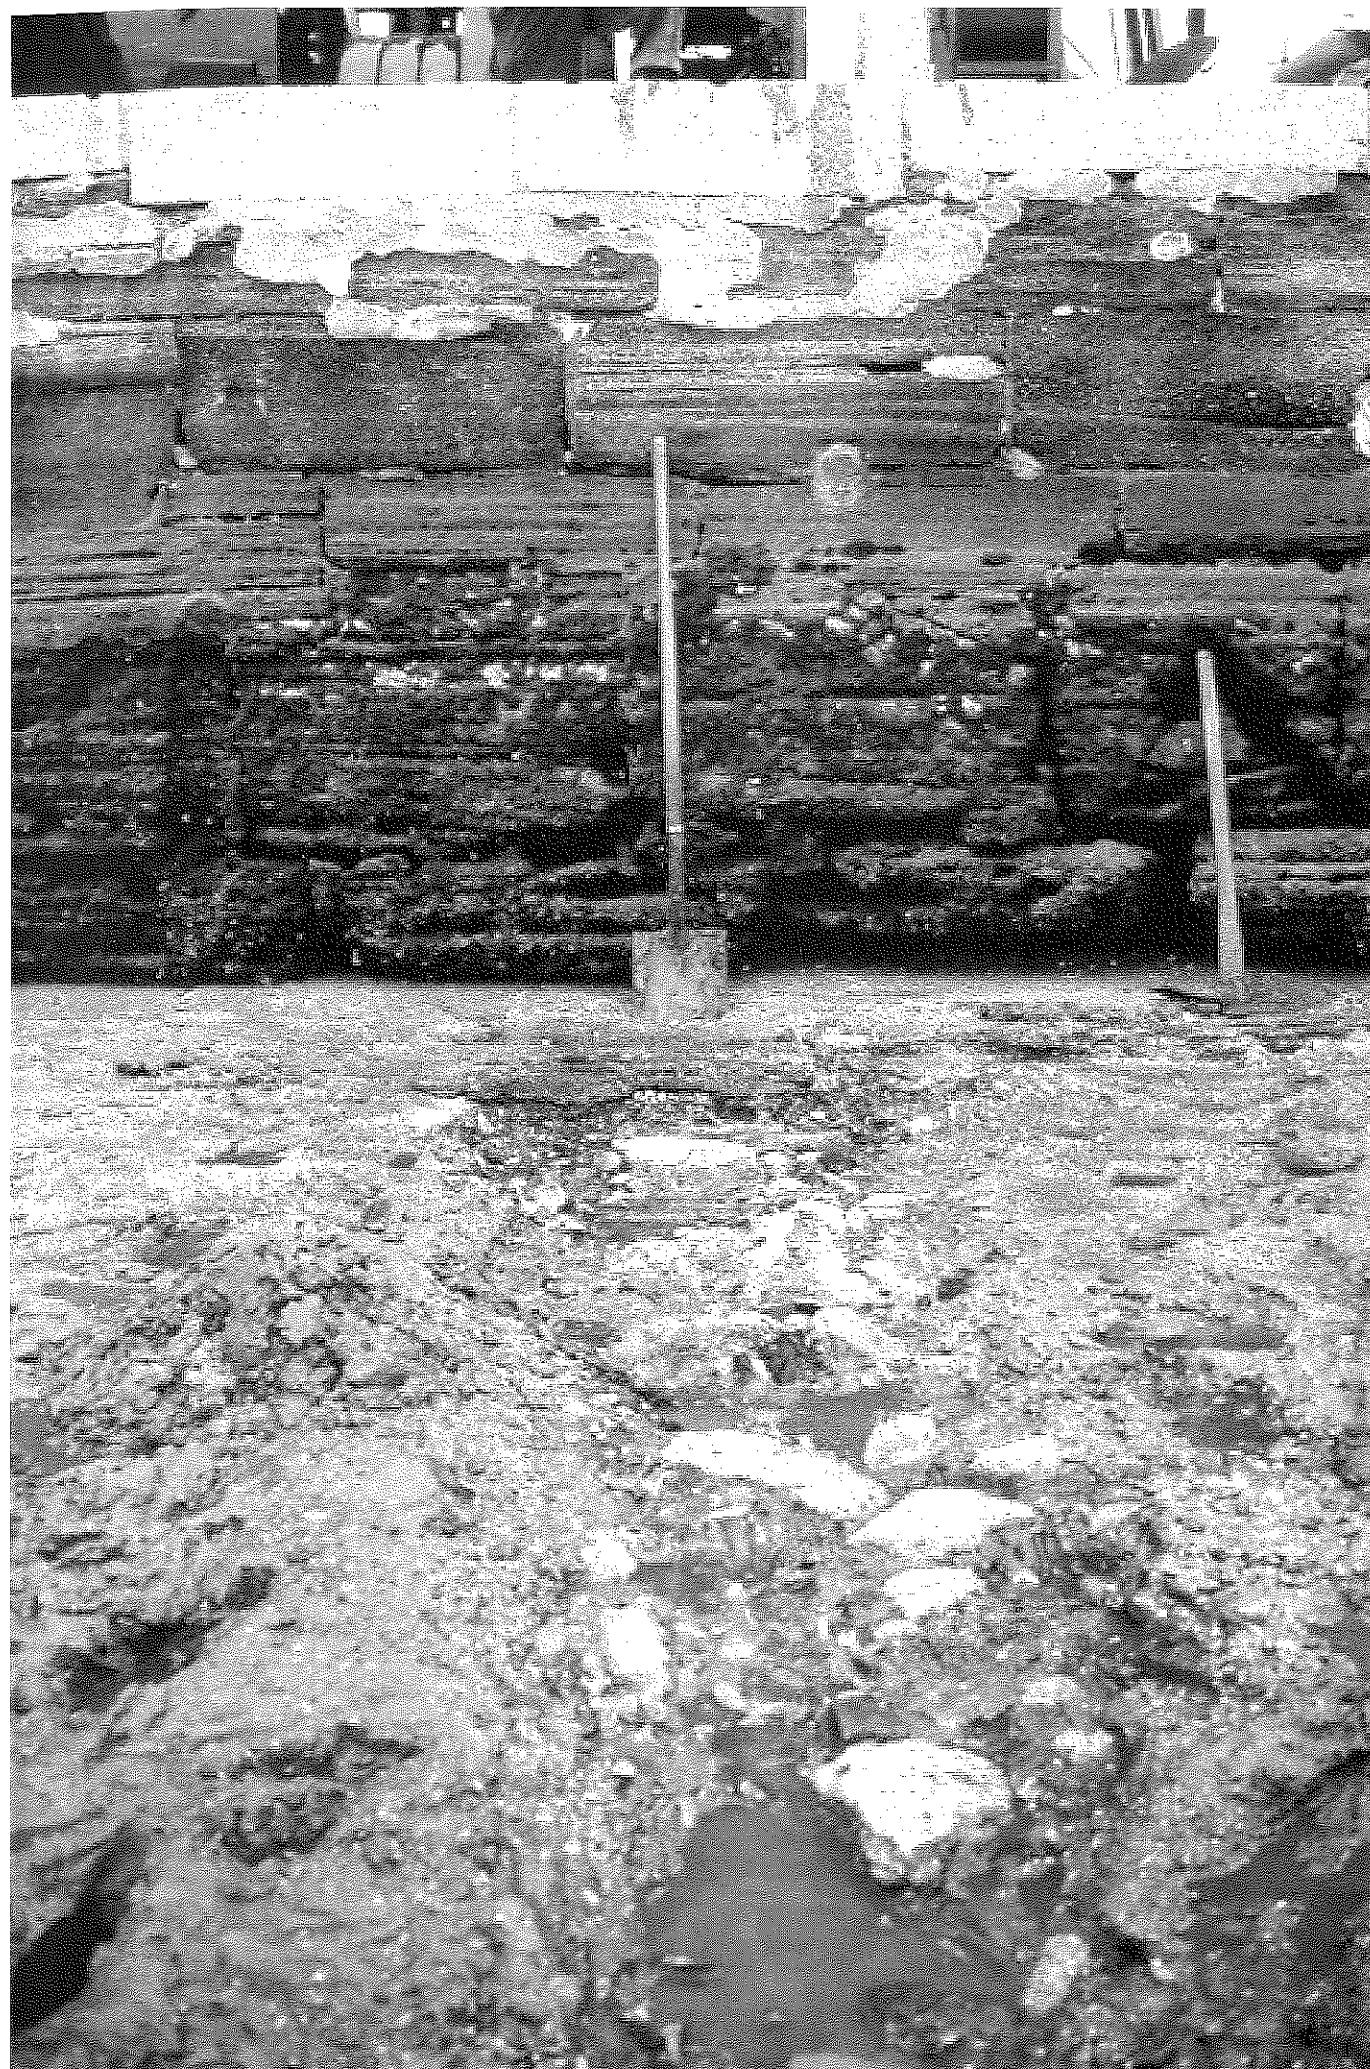
Figure 10. Photograph of Trench and Sea Wall at Site B.

The preservation of these erosional support mechanisms is more pronounced toward the south end of the existing historic sea wall and not at the north end, where the stones have been either displaced or scoured by tidal currents. This is clearly a function of the relationship between the sea wall and the tidal currents of the Matanzas River. At Site A, sediment and shell debris varies from 5 inches to 15 inches thick and provides a cover protecting that portion of the sea wall in the bay. At Site B, the amount of sediment and shell debris is substantially less, and many of the paver stones have been displaced or up-ended and the coquina blocks in front of the foundation stone are covered in algae (Figure 10).

During the City's investigation, numerous locations within the coquina-stone wall contained cavities where the stone had been removed and the opening scoured through tidal action. Most of the cavities occur toward the base of the wall, near the foundation stones (Figures 7 and 10). In some areas, these cavities are 3 feet deep—approximately half the thickness of the wall. Although these cavities were not measured, the one near Site B is very large. This site also happens to be near the location were the wall collapsed into the Matanzas River (Lewis 2001). The cause of this failure was attributed to tropical storm Gabrielle. Although conjectural, another cause for this failure may be

attributed to the sloping nature of the wall and the poorly preserved erosional control system along this section of the wall.

Development of the City of St. Augustine's planned construction of a new wall in front of the historic sea wall will need to take into consideration those other elements of the wall that are part of the erosional control system. As such, the 10-foot distance, which was originally proposed between the old sea wall and the new sea wall in community workshops and to the city commission, will need to be changed if these additional elements are considered. An alternative distance—one that would protect the historic fabric of the sea wall from adverse construction activities—is 12 feet. This is beyond the limits of the coquina stone pavers.
