## **Architectural Guidelines for Historic Preservation**

**Prepared by the Planning and Building Division**

**City of St. Augustine, Florida**

**Fourth Edition, October, 2011**

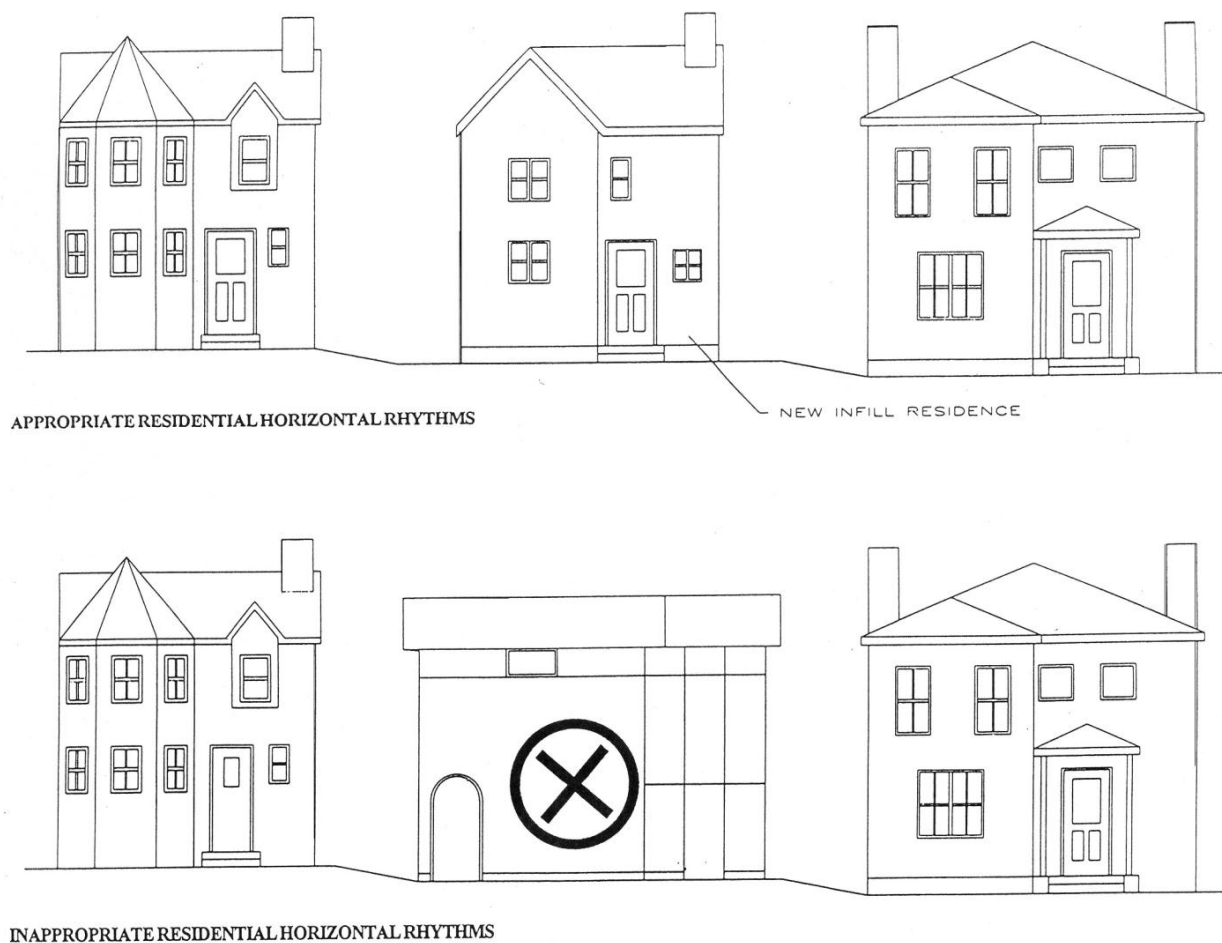
**Figure 7**

### **Residential Horizontal Rhythms**
