HISTORIC ST. AUGUSTINE SEAWALL

National Historic Preservation Act Section 106 Report

**Prepared by
Cecile-Marie Sastre, Ph. D.
Historian**

January 10, 2005

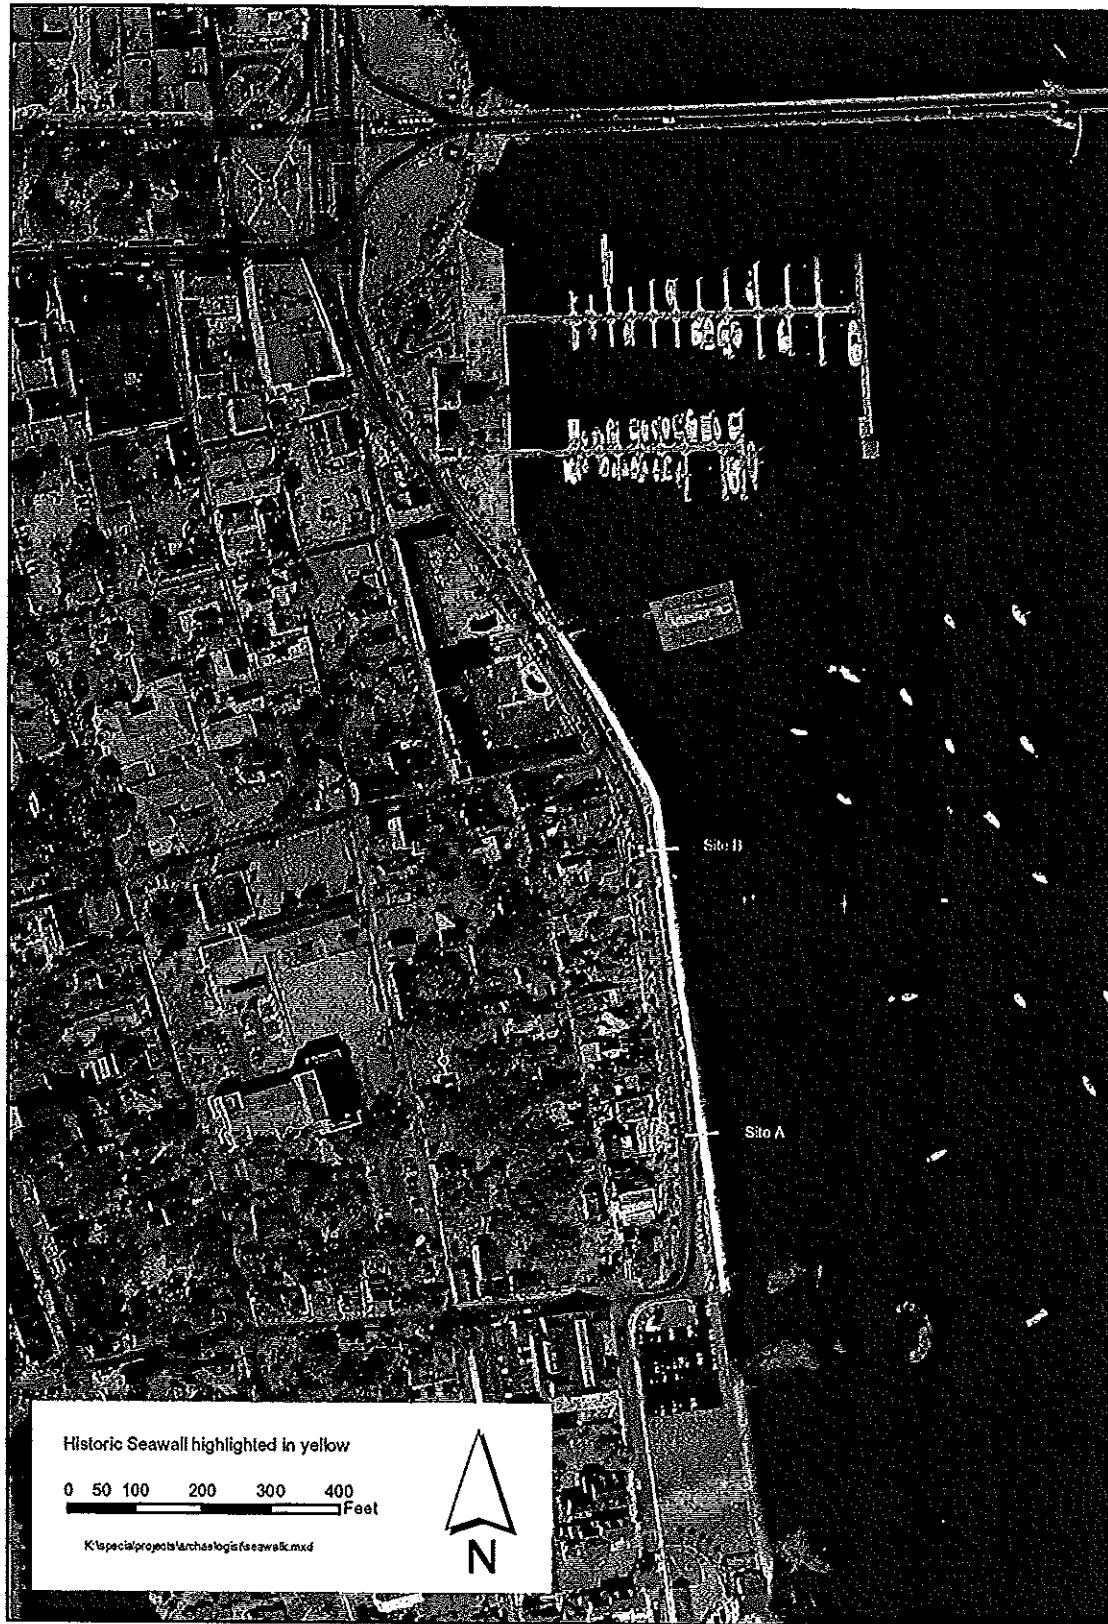
Figure 3. Photograph of Site A trench and historic seawall.

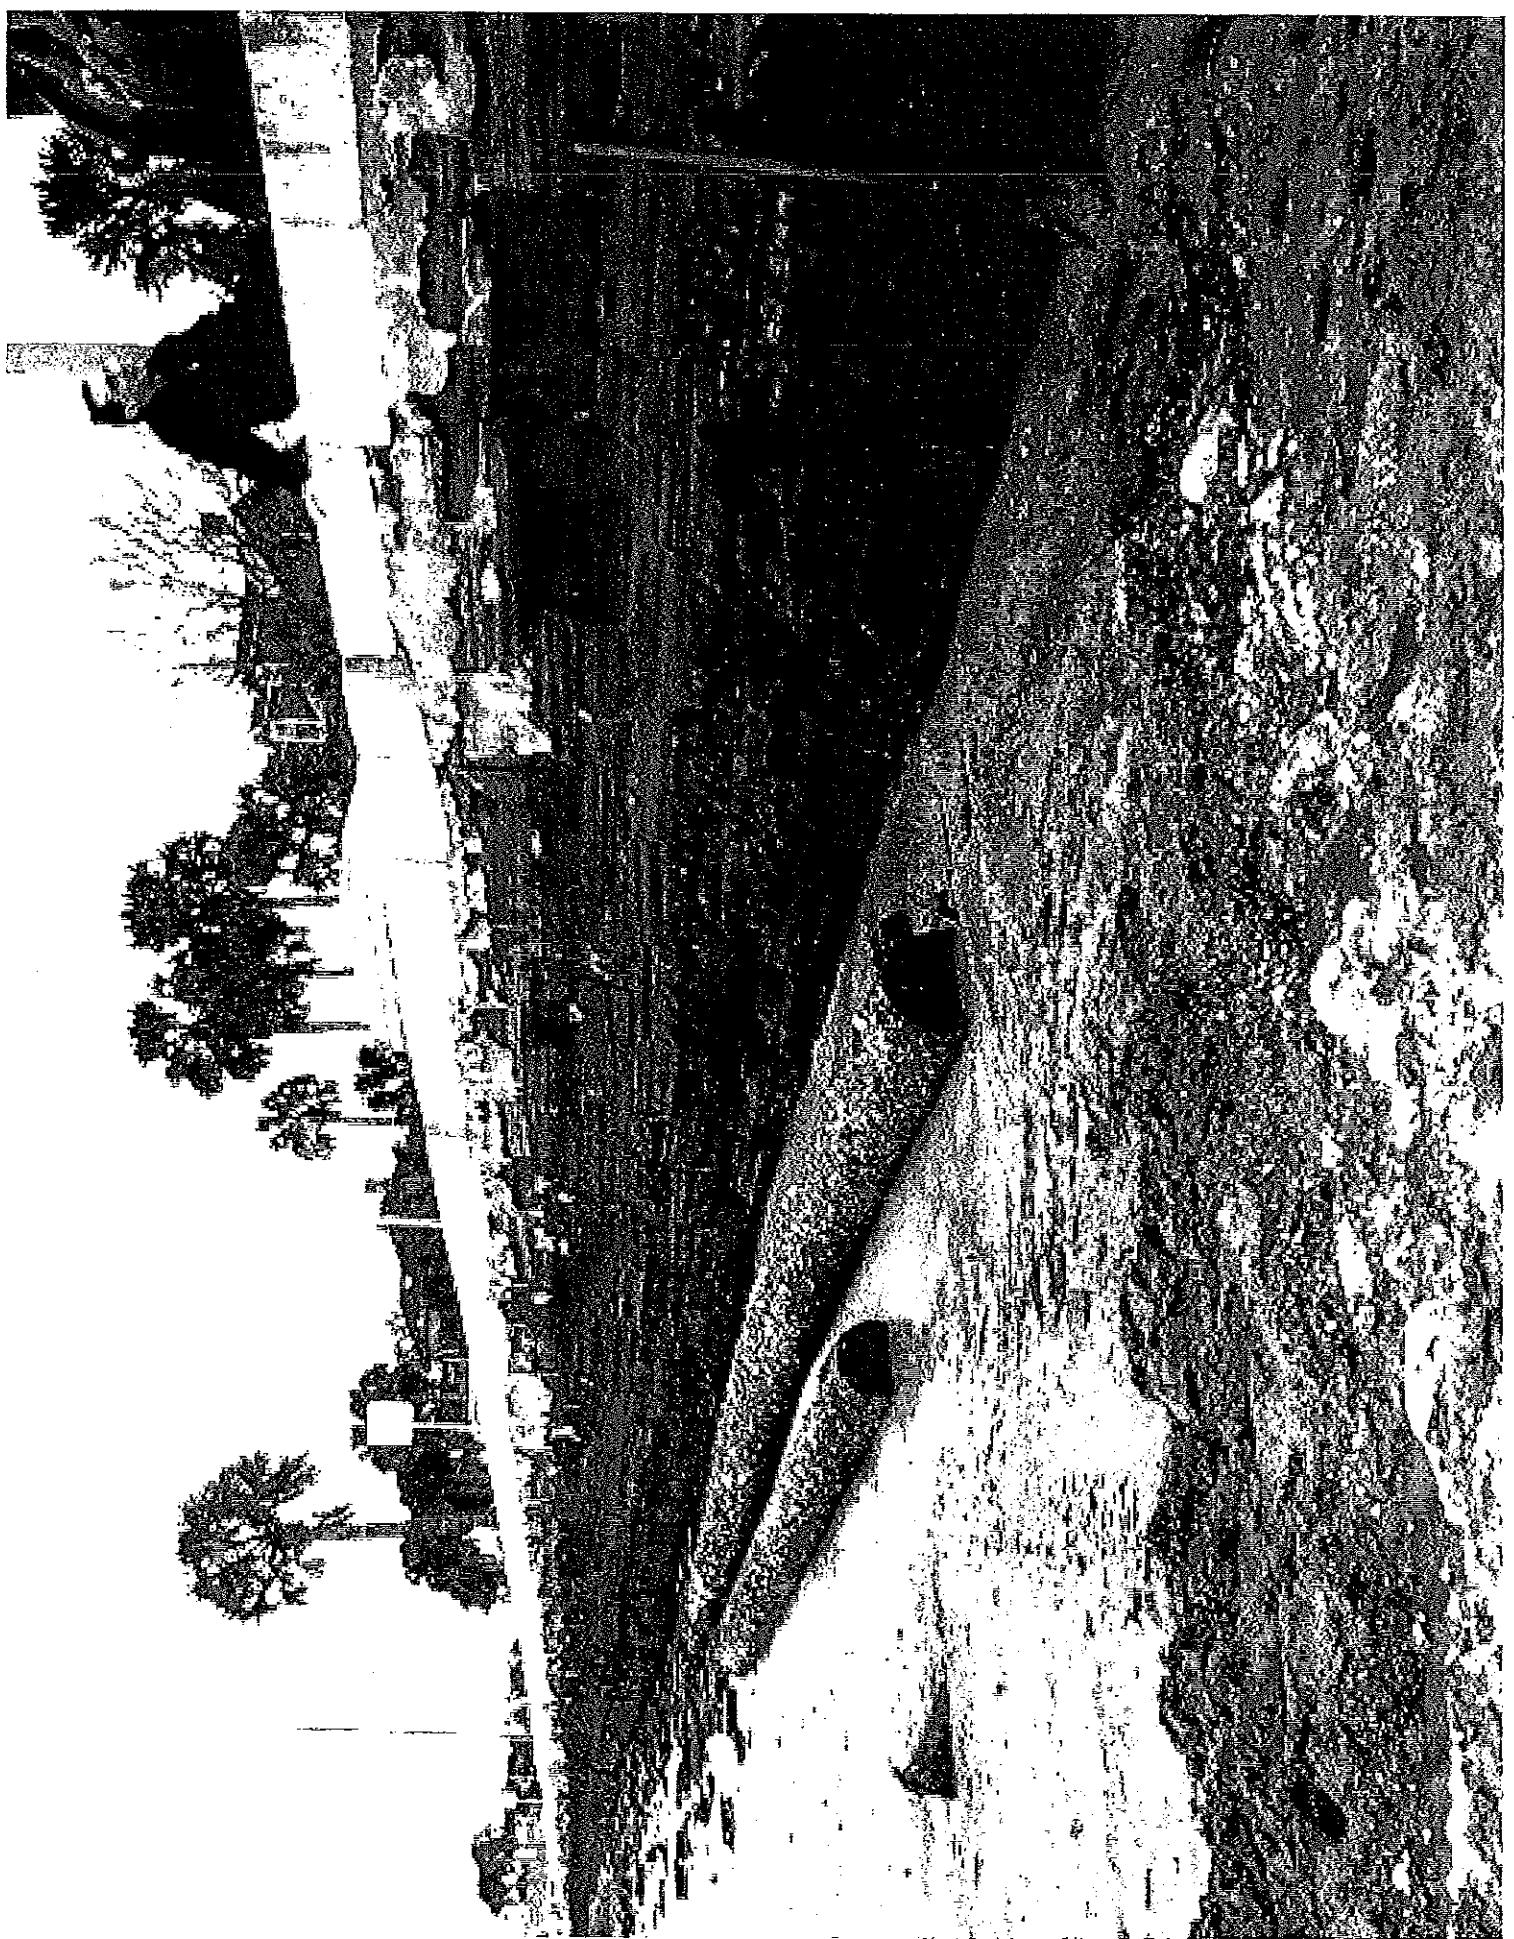
Figure 7. Late 19th century drawing of St. Augustine's seawall and waterfront showing pavers extending out from the seawall.

Two types of erosional support mechanisms are found along the sea wall, neither of which is mutually exclusive. The first is a series of large coquina blocks placed directly adjacent and parallel to the foundation stones [on the seaward side]. The blocks extended an average of 2.5 feet from the foundation stone[s] and were 7 inches lower than the foundation stone[s]. The function of this alignment was probably similar to the concrete-filled trench proposed by Lt. Gilmer to protect the foundation. No attempt was made to determine the thickness of this component of the sea wall, as per the reason given for the foundation stone[s]. In front of the blocks was a 5 1/2 foot pavement of broken coquina stones, which were intentionally laid flat along the sloping edge of the Matanzas River. These stones are

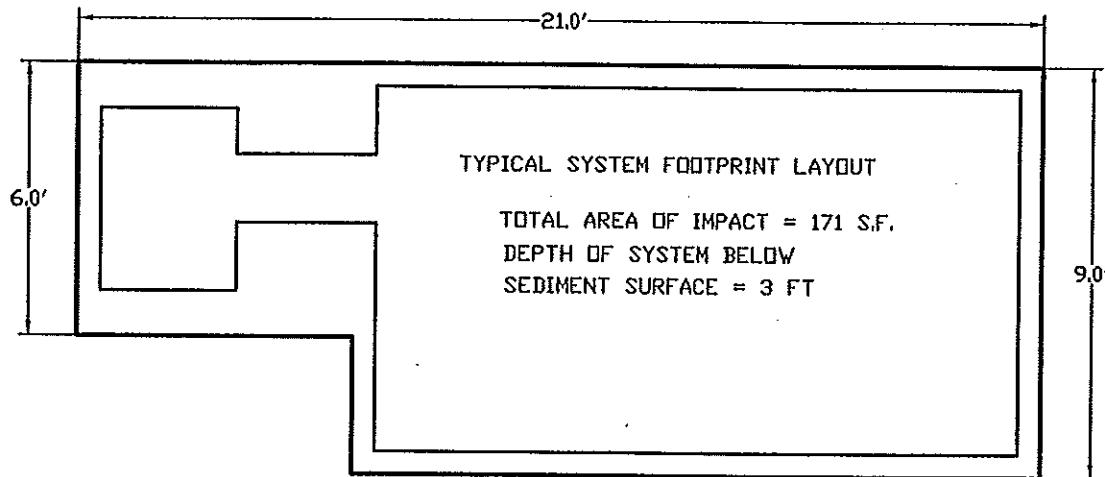
STORMWATER POLLUTANT REMOVAL VORTEX BOX SYSTEM-
FOOTPRINT AREA OF IMPACT

TOTAL NUMBER OF SYSTEMS = 3
TOTAL LINEAR FOOTAGE OF IMPACT ALONG SEAWALL TOE = 63 FT
TOTAL AREA OF IMPACT = 513 S.F.
