THE SECRETARY  
OF THE INTERIOR'S  
STANDARDS FOR  
REHABILITATION &

GUIDELINES  
ON **FLOOD**  
**ADAPTATION** FOR  
REHABILITATING  
HISTORIC  
BUILDINGS

U.S. Department of the Interior  
National Park Service  
Technical Preservation Services

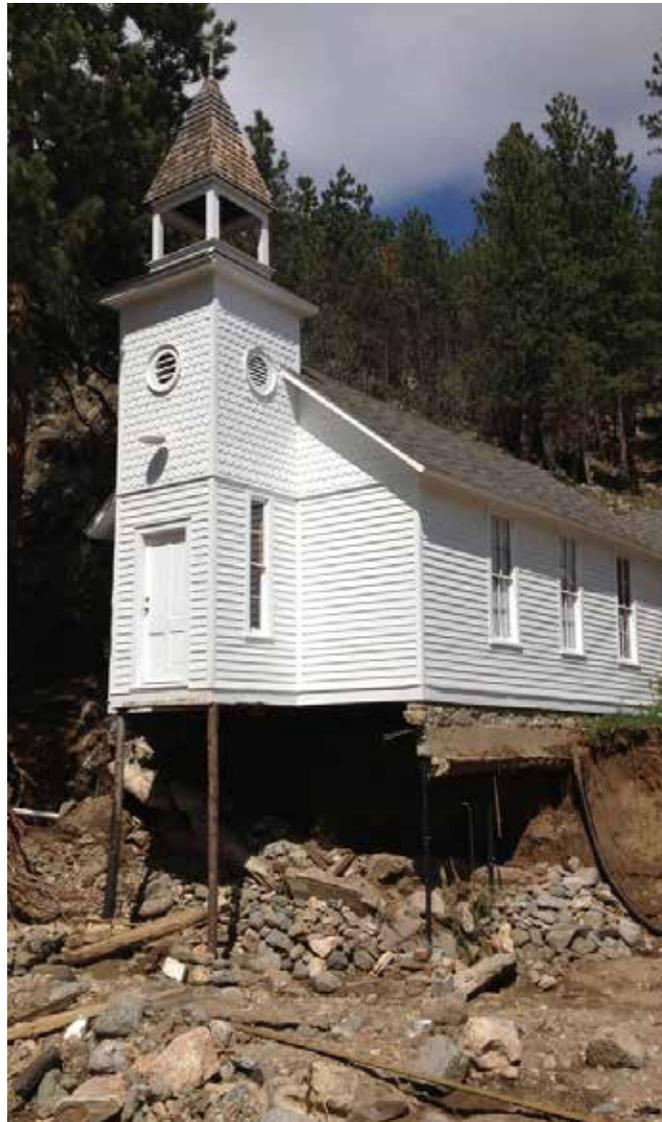
[9] Fast-moving flood waters can undermine a foundation or scour out land around a building. The Little Church of the Pines in Salina, CO, was left structurally compromised after heavy rains caused flooding in the Front Range of the Rocky Mountains in 2013. *Photo: Burton Construction burton-construction.com*

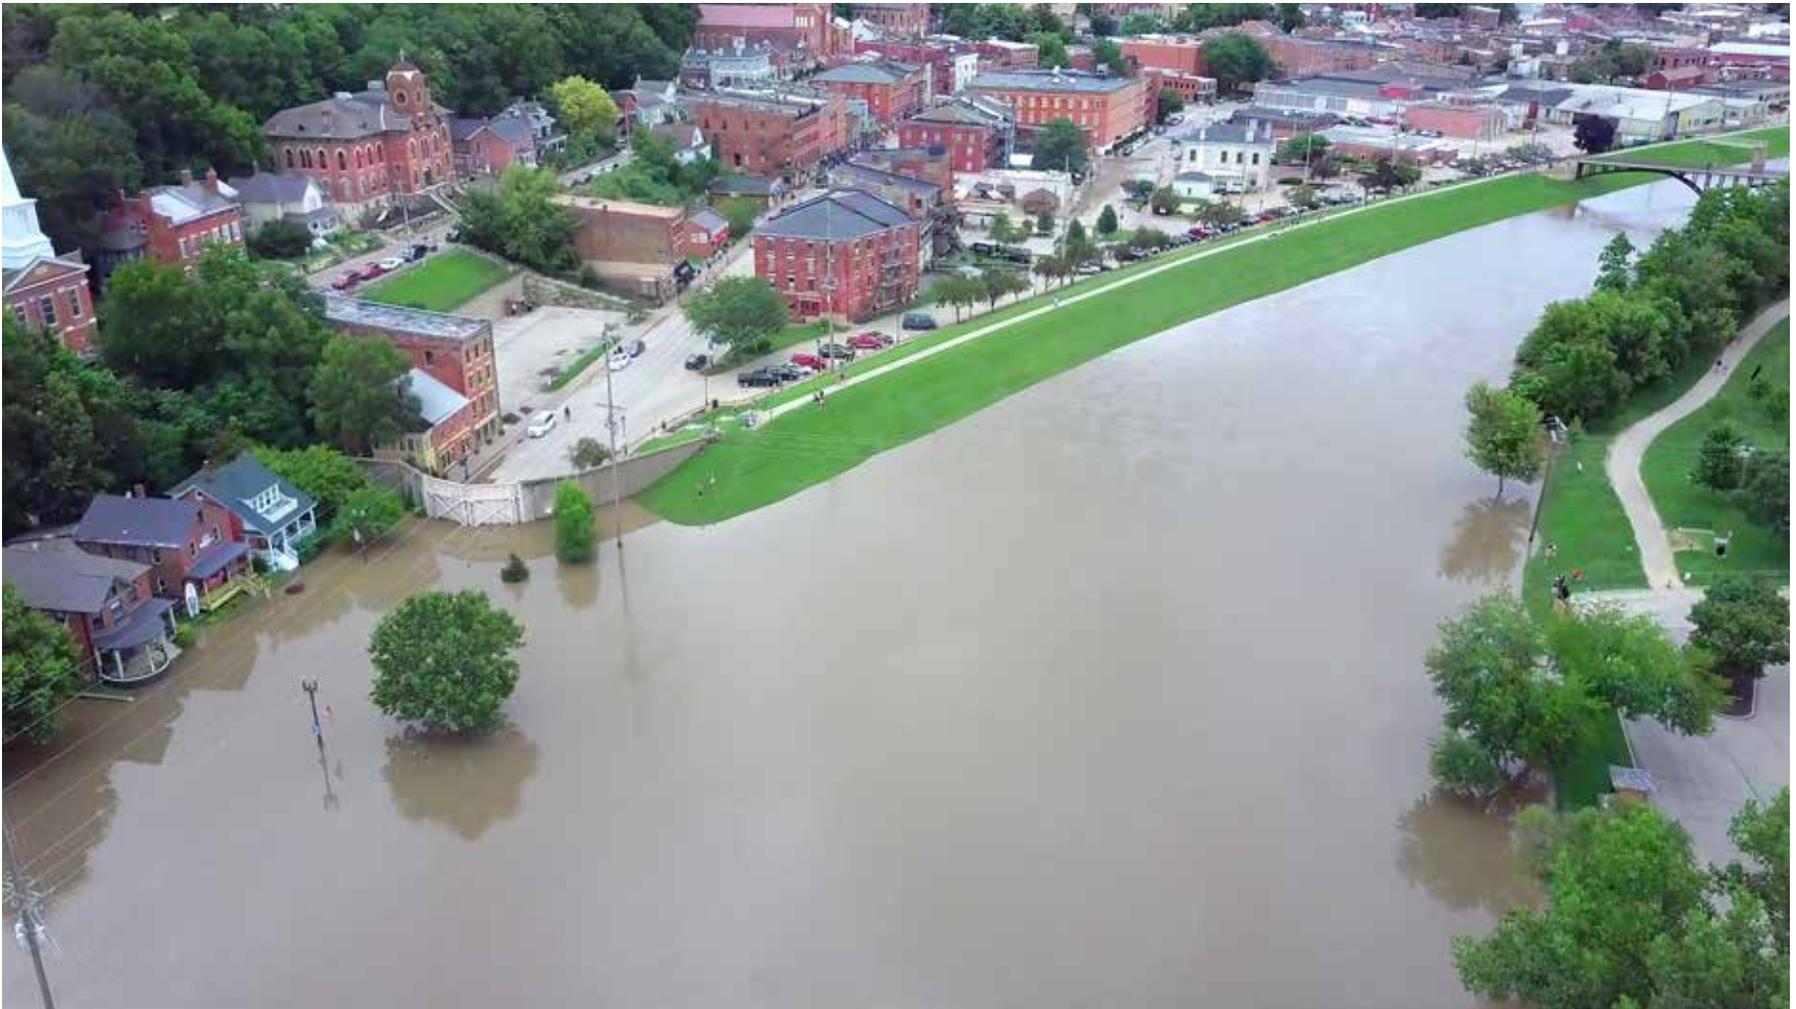
[19] Community-scale interventions, such as this combination of a flood wall, levee, and floodgates in Galena, IL, can protect multiple historic resources and maintain the character and integrity of entire historic districts and neighborhoods. *Photo: GalenaGuide.com*

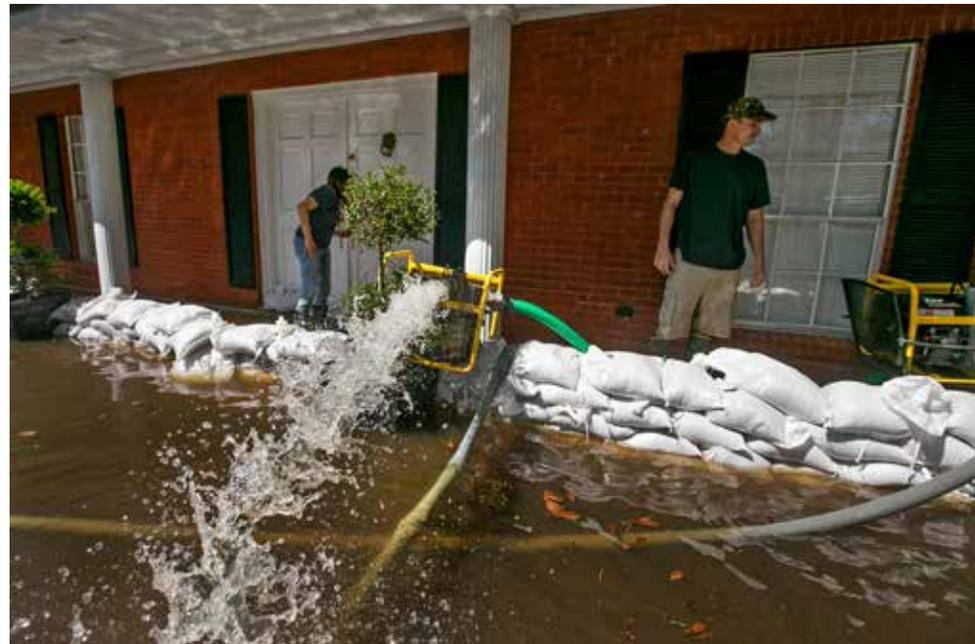
[26] Water can still seep through sandbag barriers. A property owner should have a pumping system with back-up generators to remove water from behind the barrier. Photo: Ted Jackson, NOLA.com | The Times-Picayune. The Advocate, 7/29/2019. The Times-Picayune/The Advocate

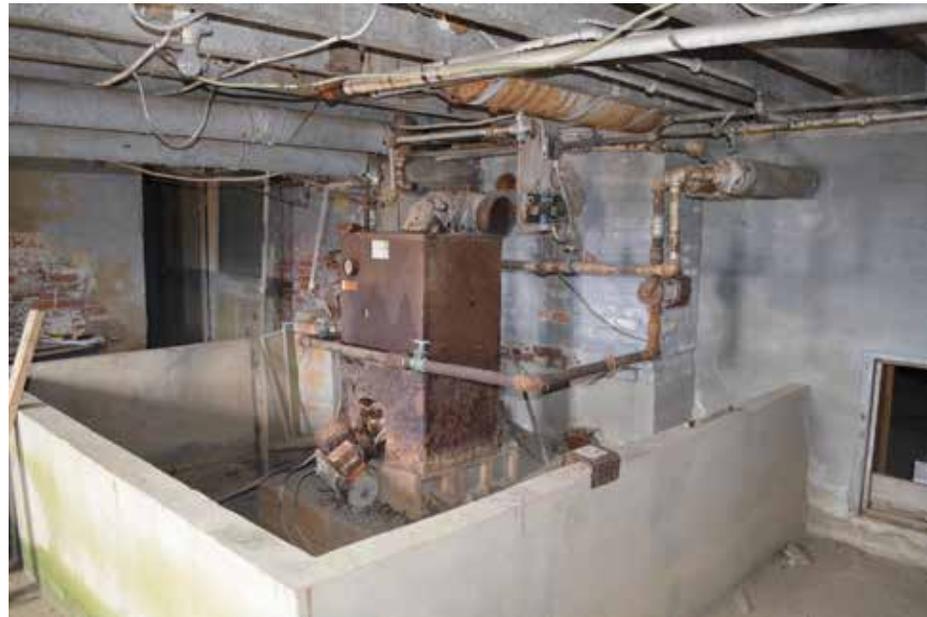
[42] Mechanical equipment that remains in a basement that is likely to flood should be enclosed behind waterproof walls. The walls may be partial height, as shown in this example, if flood waters are not expected to exceed that height. In other cases, waterproof enclosures must fully surround the equipment, which can be accessed by submarine-quality doors or hatches. *Photo: Quinn Evans*

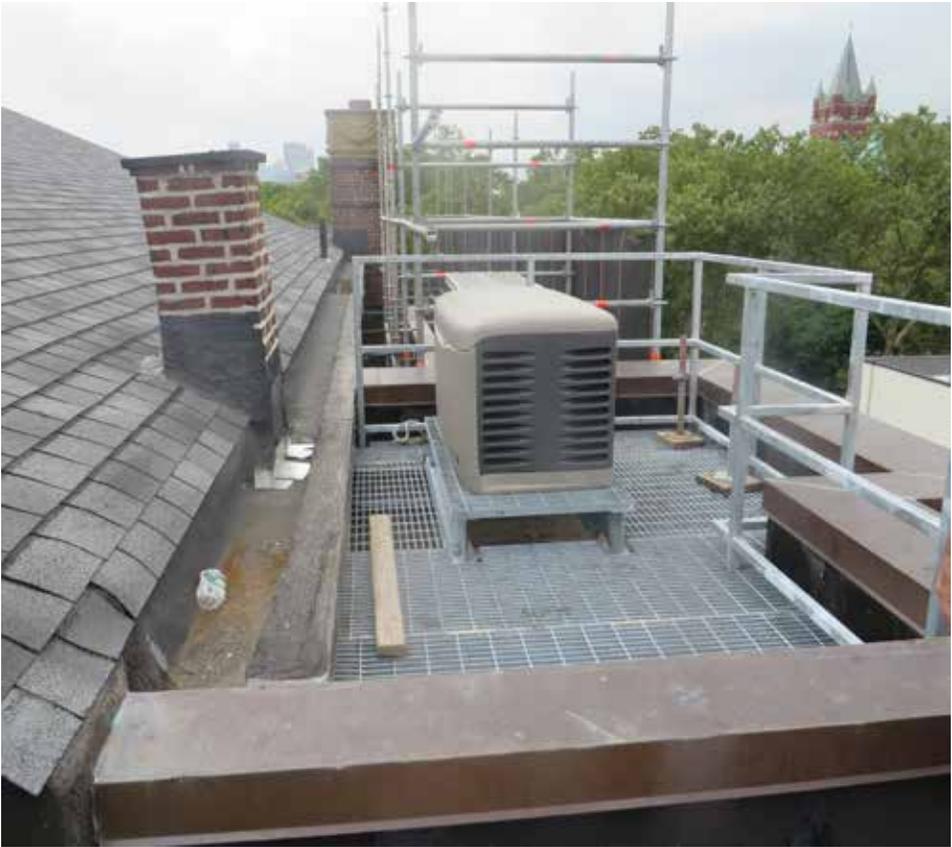
[46] For many buildings in flood-prone areas, having a generator on site may be a necessity to provide emergency power for pumps and other mechanical equipment. This public library in Hoboken, NJ, has a generator located on a flat roof high above any flood waters and not visible from the street. *Photo: David V. Abramson for Hoboken Public Library*

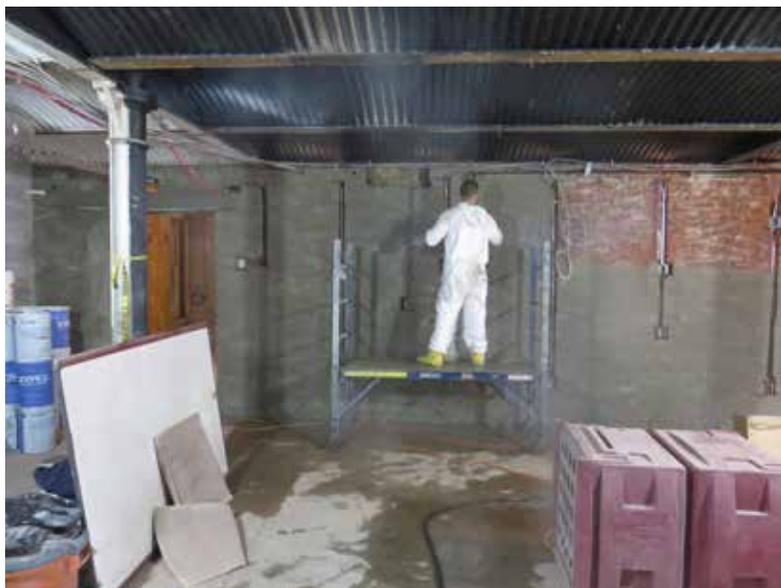
[48] A waterproof coating is applied to the interior surface of lower-level walls of the public library in Hoboken, NJ. Prior to applying such a coating, the product should be researched by building science professionals with knowledge of historic materials and methods to ensure that the coating will not cause damage to or accelerate deterioration of the structure. Photo: David V. Abramson for Hoboken Public Library

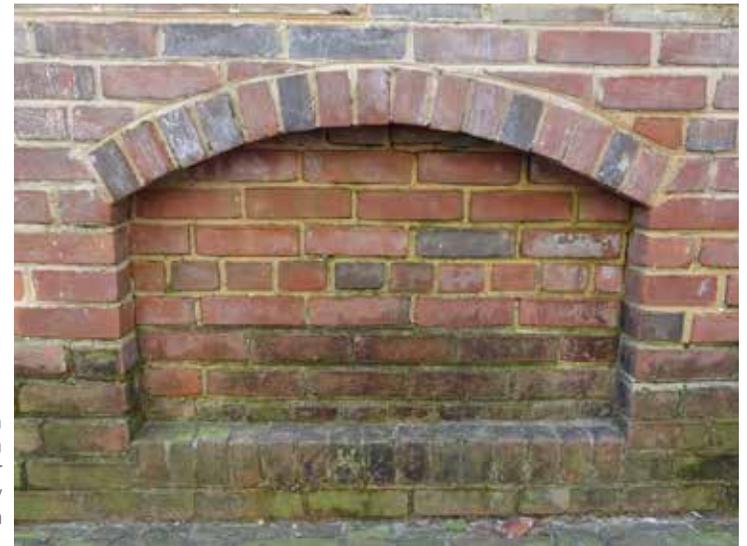
[50] To keep water out of a building, openings on secondary elevations may be permanently infilled with masonry to match or blend in with the walls. Any sills or lintels should be preserved in place, and the masonry infill should be inset to preserve the historic fenestration pattern. *Photo: Jennifer Parker/NPS*

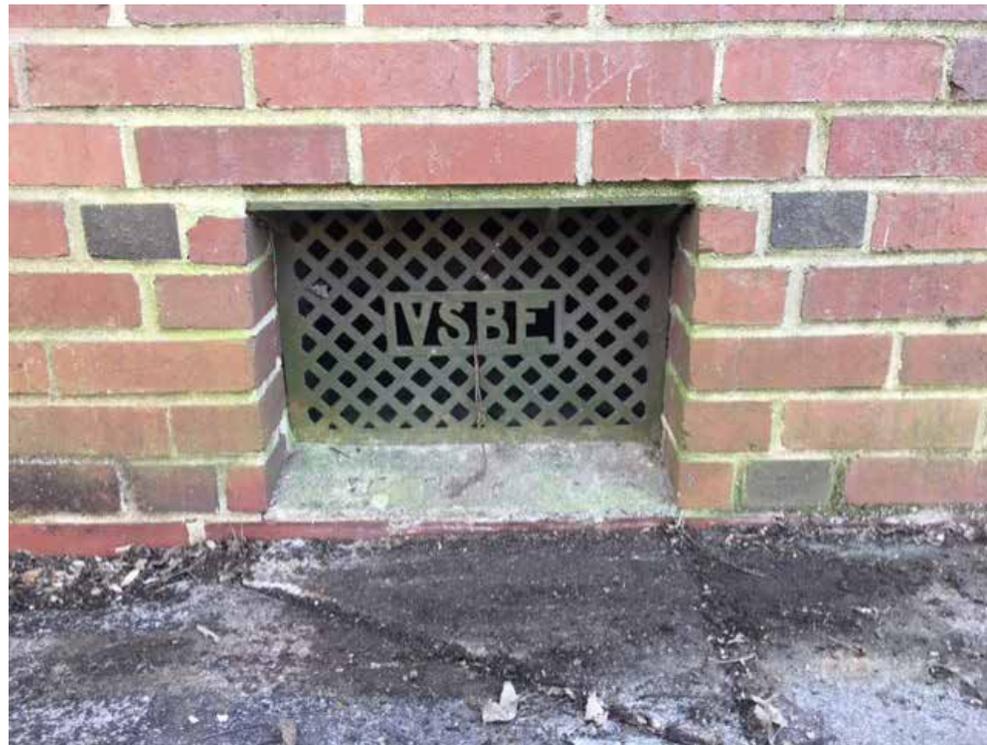
[56] To create a watertight seal around the building, any existing vents or openings below the established flood risk level must be sealed during a flood. Vents that cannot be sealed internally will require an exterior and/or interior cover to keep water from entering the building. *Photo: Chelius Carter*

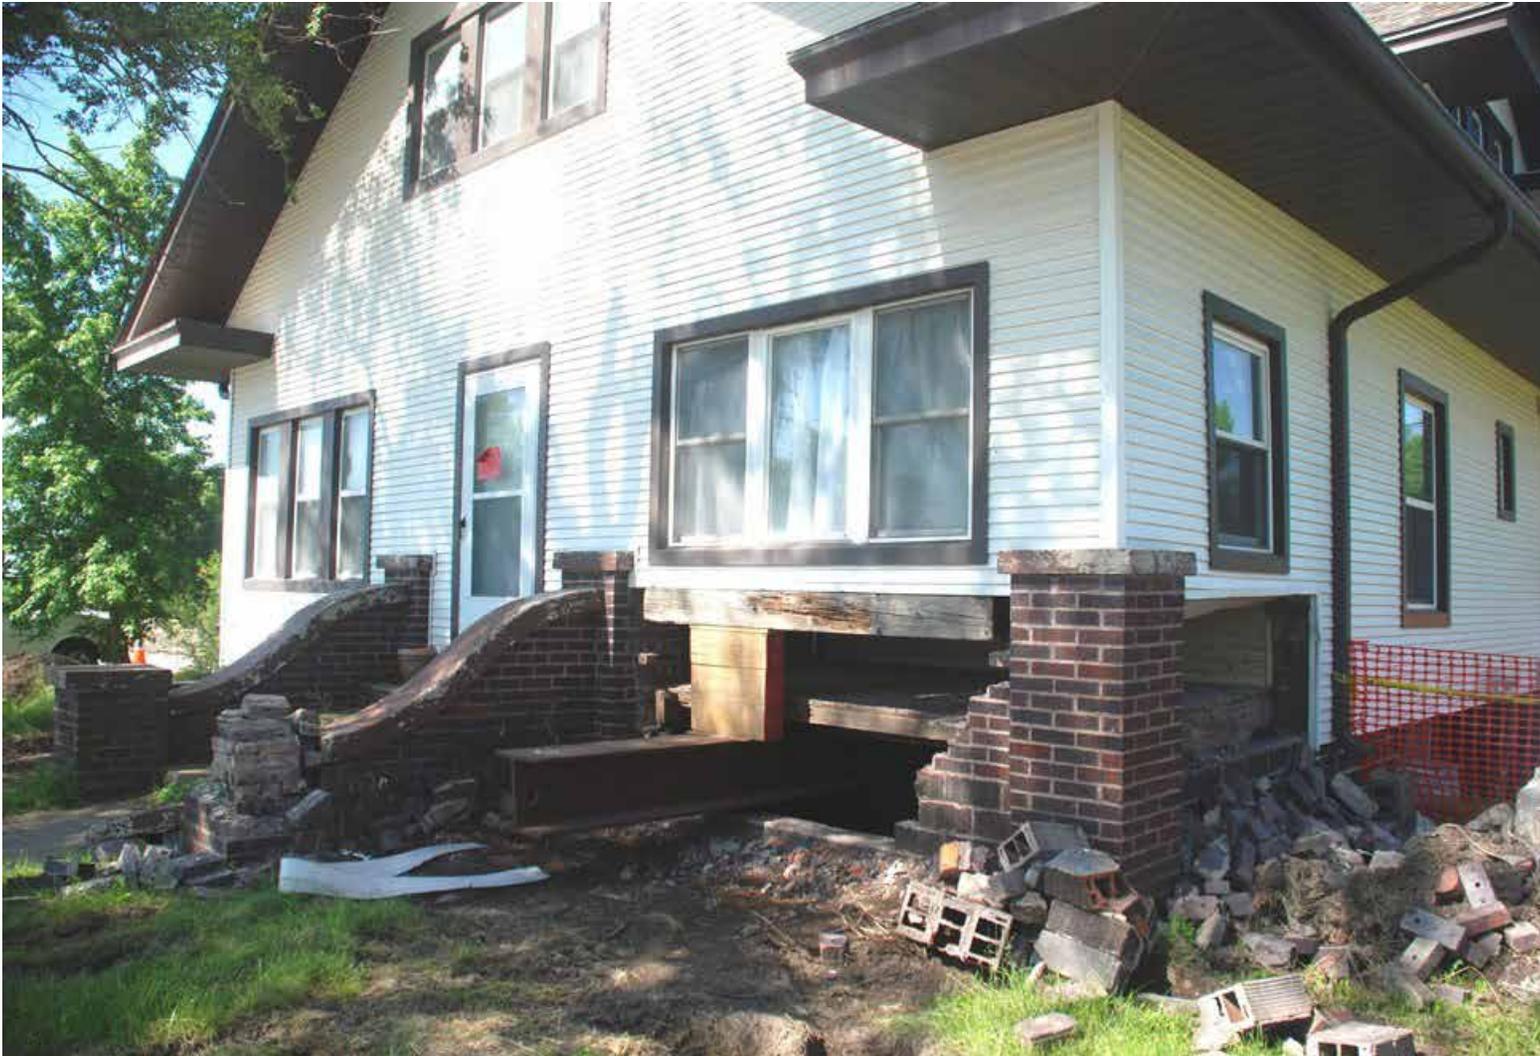
[72] Filling a basement requires access to bring the fill below grade and to maneuver compacting equipment in the space. In this example, a prior flood-damaged section of the foundation wall created an opening that allowed earthmoving equipment access to the basement. The exterior will be repaired once work is complete below grade.  
*Photo: Mitch Paine*

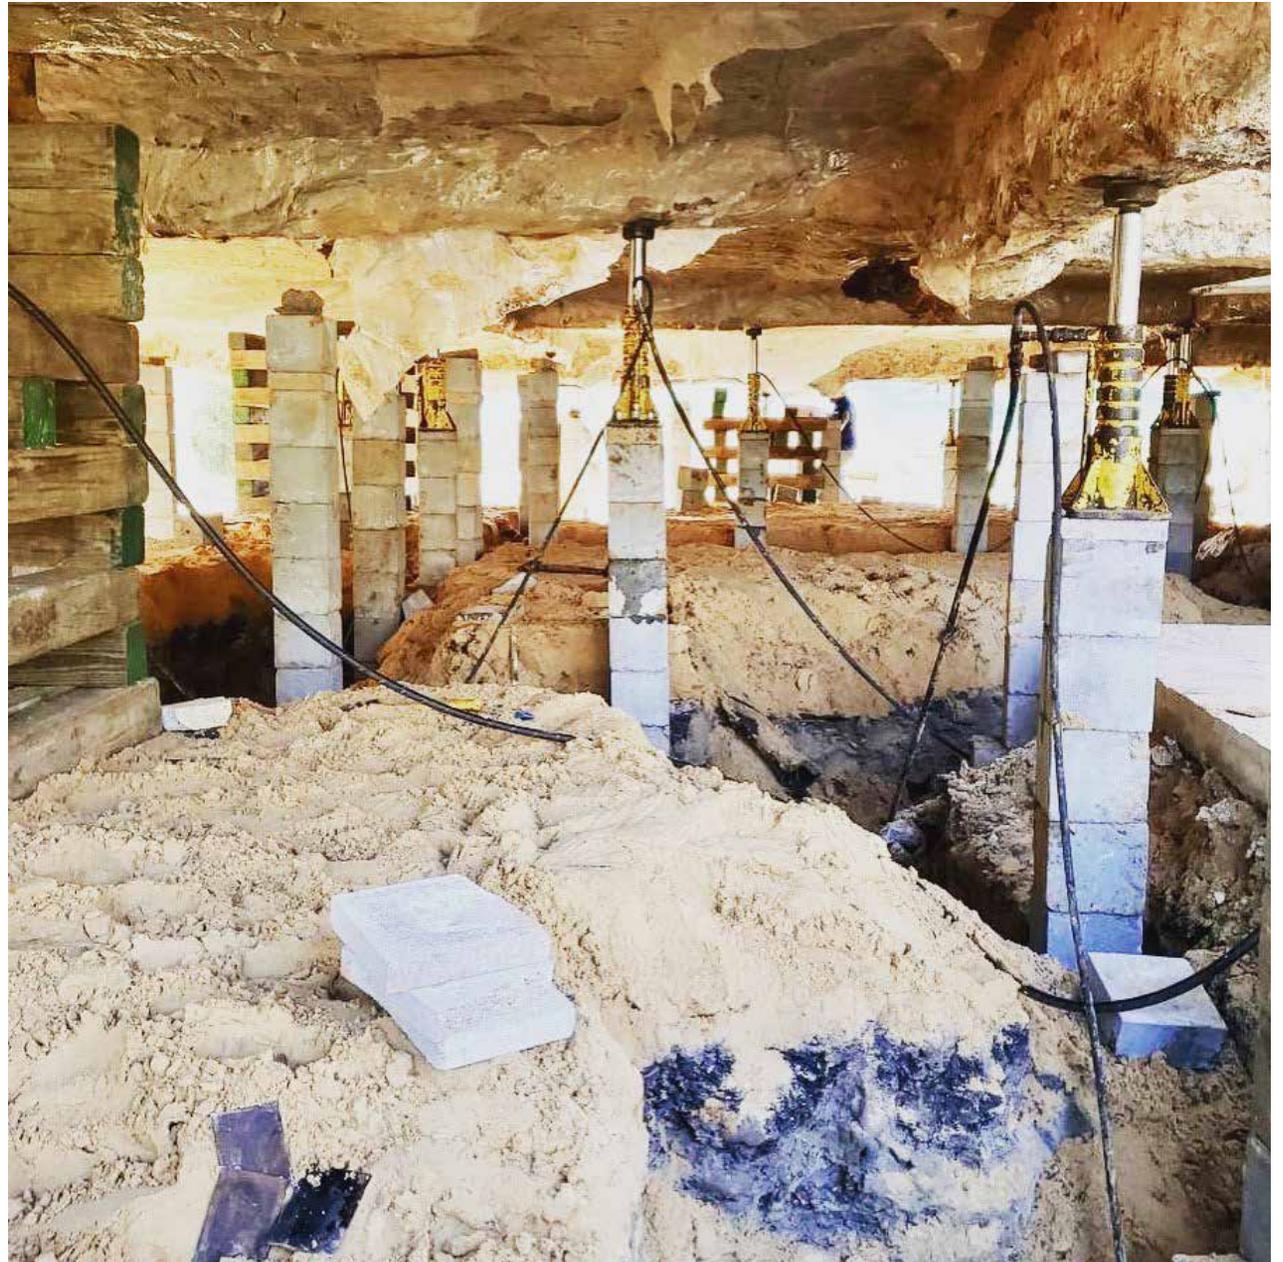
[79] Buildings on a concrete slab can be more challenging to lift. In some cases, as shown in this example, the existing slab can be lifted and still remain the floor for the interior spaces. In other instances, the slab may need to remain at grade, with a new elevated floor structure constructed above. *Photo: p3elevation.com*

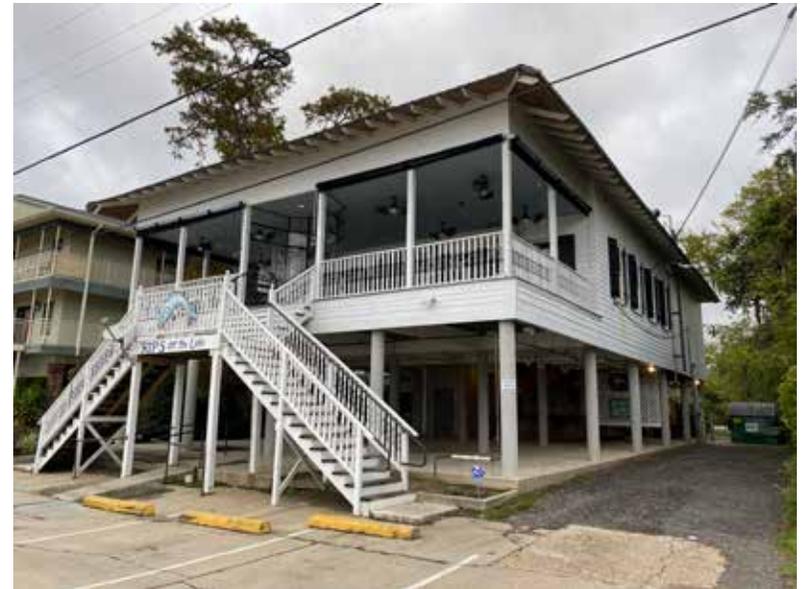
[89] This building in Louisiana has been raised on piers, but the foundation piers are set back from the face of the building, do not line up with the porch posts, and are visually undersized. New foundation piers, posts, and columns should have a visual appearance that more closely matches traditional foundation placement, size, and materials, even if that requires wrapping more modern, slender steel members with a masonry veneer. Photo: Roderick Scott

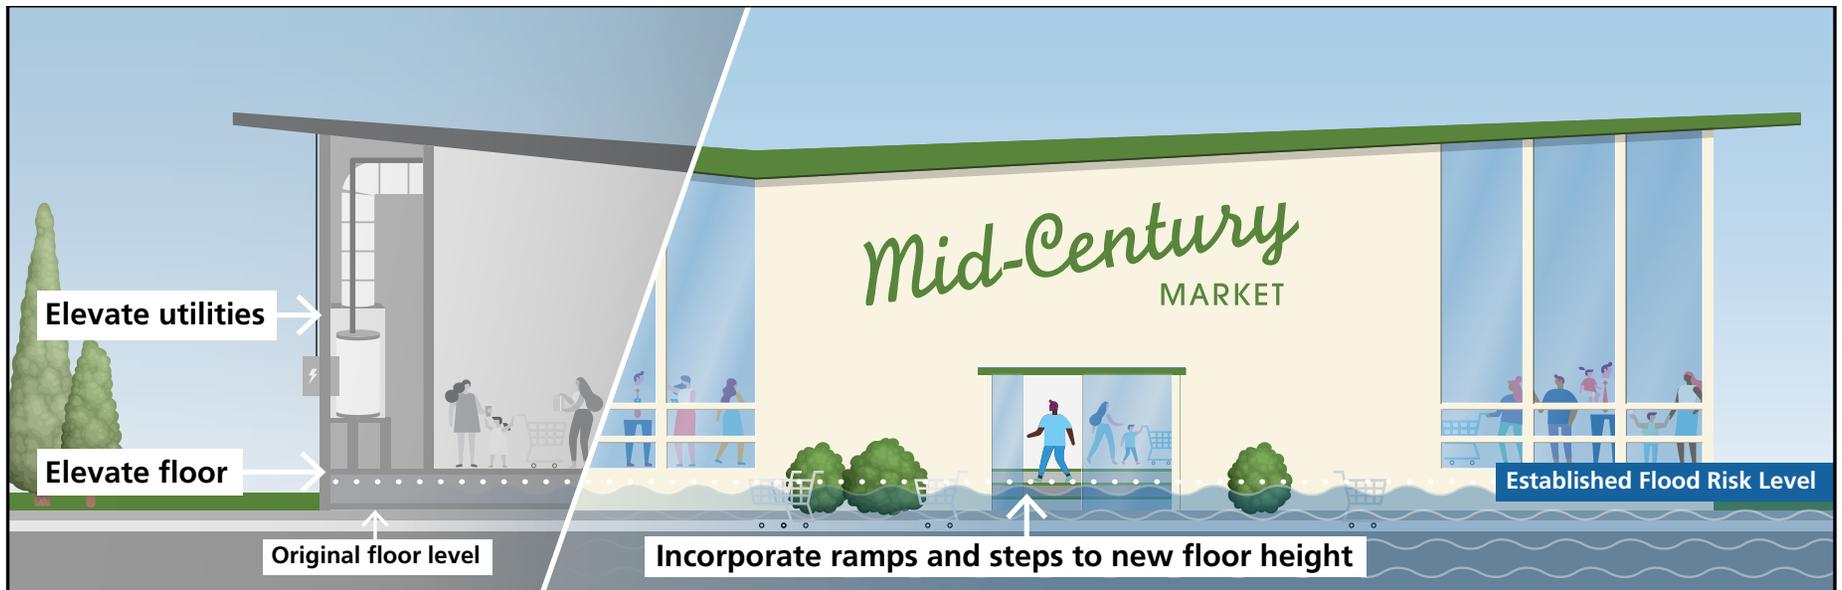
[100] Elevating the interior floor level above the established flood risk requires several building alterations, including constructing a new floor, elevating any utilities, and creating access to the new floor level. The original floor to ceiling height must be substantial enough to allow space for the new elevated first floor. *Graphic: Blank Space LLC for NPS*

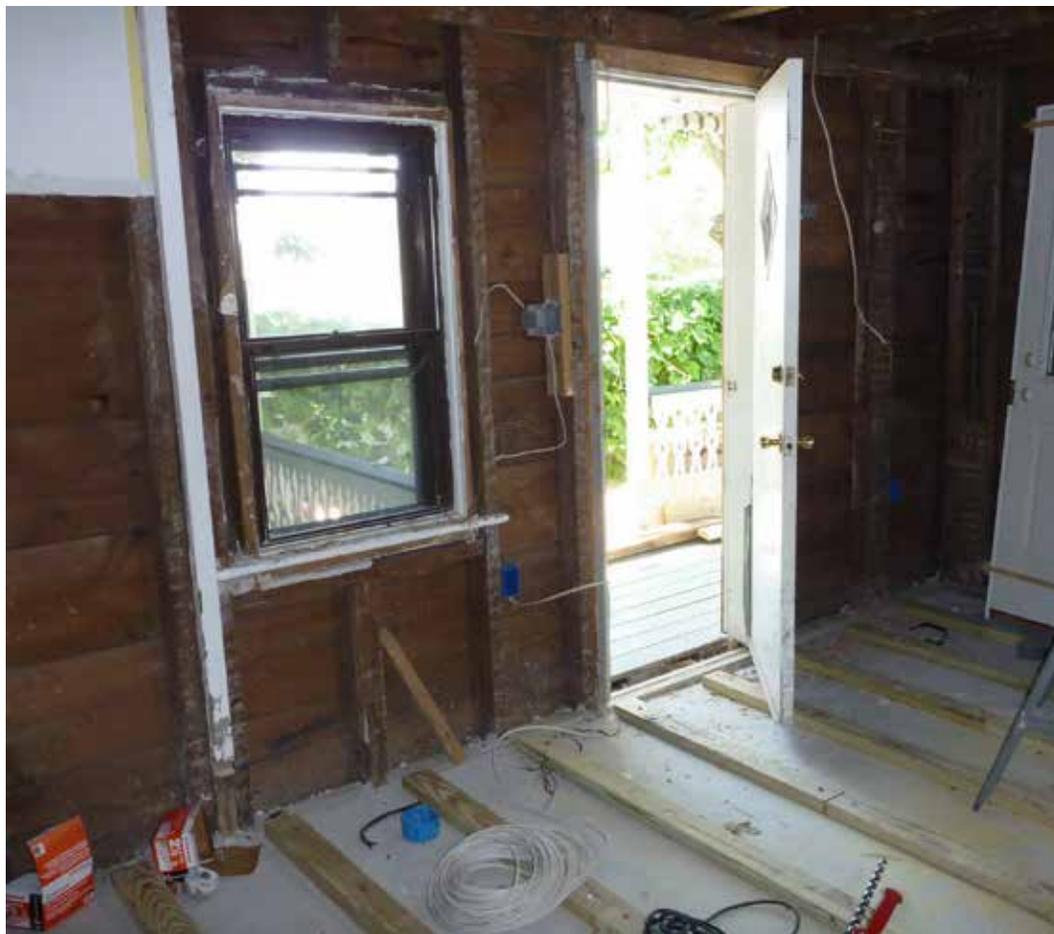
Figure 2: In-progress repairs after Hurricane Sandy. Walls are open to the interior for initial drying. A new concrete structural slab has been topped with treated wood sleepers in preparation for a new flood-damage resistant mahogany floor. Photo: Mary Delaney Krugman, JD, MSHP

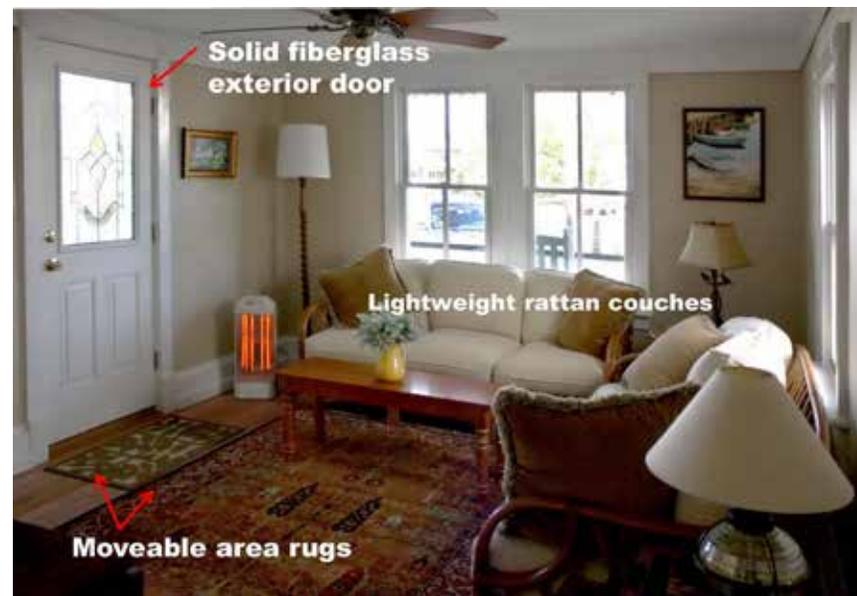
Figure 7: After repairs and wet floodproofing measures have been implemented, the new floor and wall surfaces are flood-damage resistant. The front door and windows were also replaced with more compatible designs using flood-damage resistant materials *Photo: Mary Delaney Krugman, JD, MSHP*

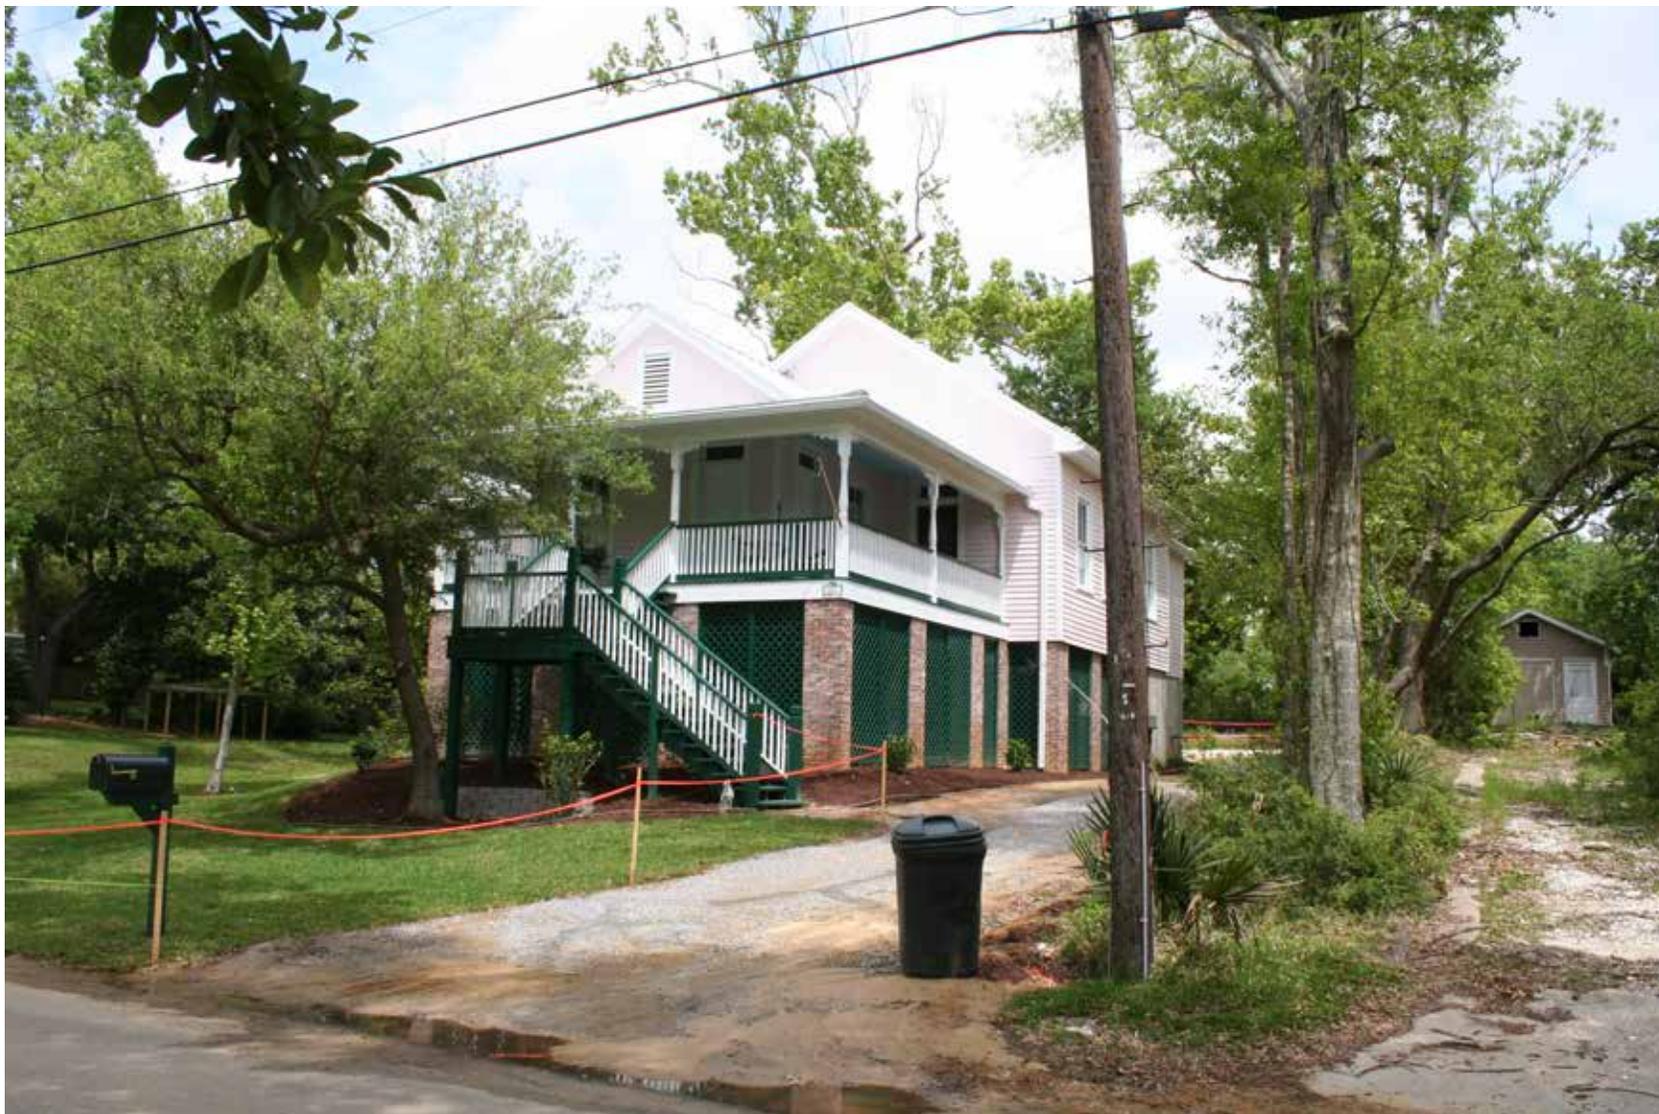
Figure 5: A taller foundation was constructed to elevate the house above the established flood risk level. While the house is higher than it was historically, the change is still in keeping with the historic character of the house, which had been on a tall foundation historically. The change is also consistent with historic regional traditions of adapting buildings to flood events. Additionally, the details of the foundation, with the brick piers and painted lattice, matches features of the historic design. The stairs access the porch in the historic location, but the extended run required by the taller foundation is turned 90 degrees below the landing to allow a surviving tree to remain in front of the house. A small retaining wall behind the tree holds fill that was added around the house to mask some of the change in height. *Photo: Mississippi Department of Archives and History, Mississippi Historic Resources Inventory (HRI) Database. <http://www.apps.mdah.ms.gov/Public>*

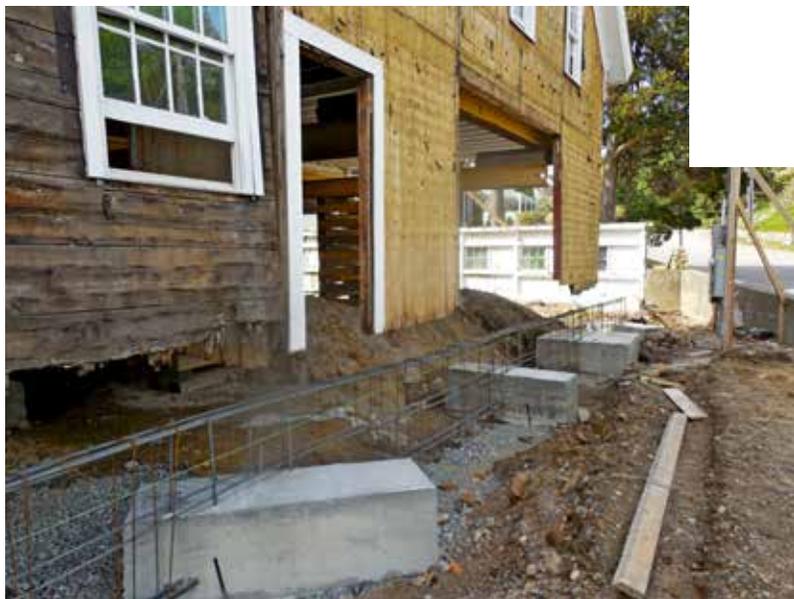
Figure 3: The structure was lifted in sections several feet in the air to provide space and access for foundation work. Photo: GNCB Consulting Engineers

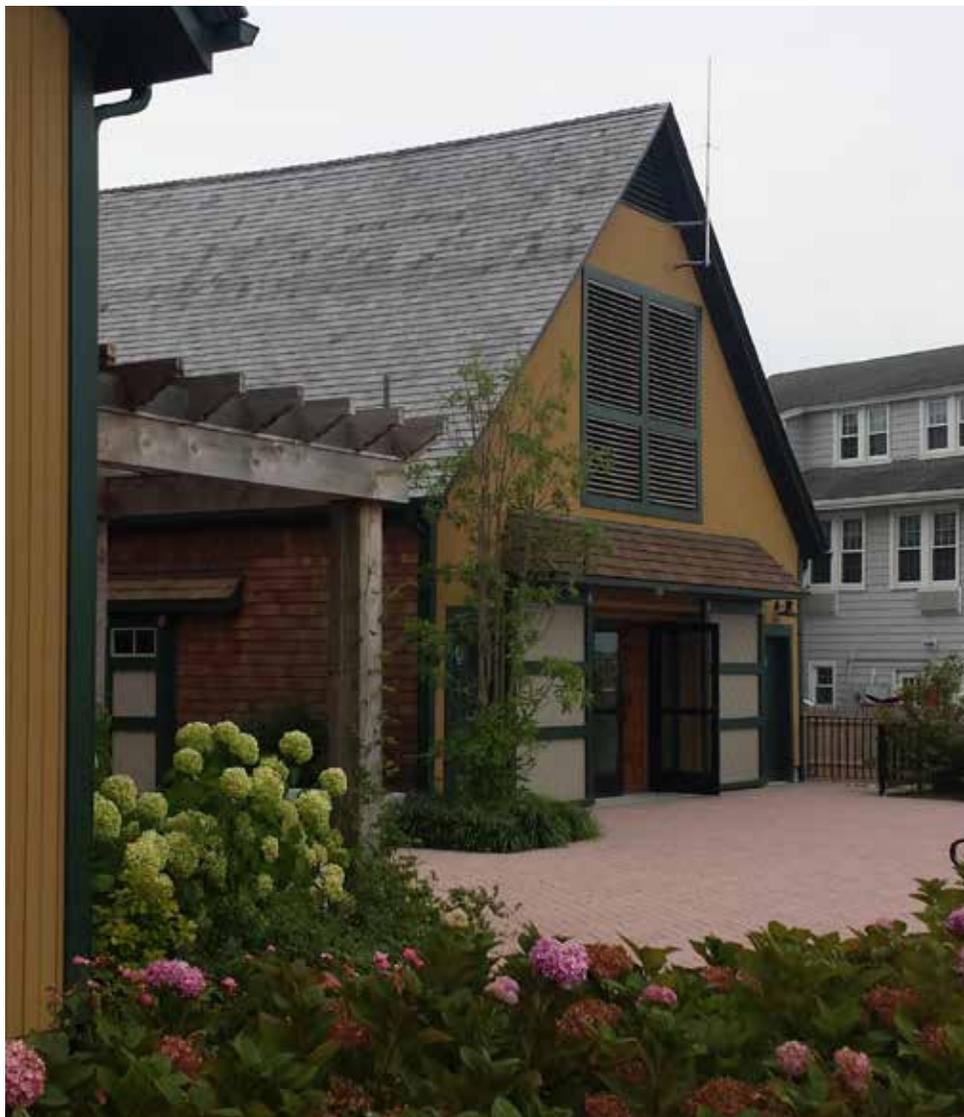
Figure 6: The mechanical room was relocated to the upper floor at the back of the building, discernible in this photo by the louvered vents. *Photo: Jennifer Wellock/NPS*
