# MODEL GUIDELINES FOR DESIGN REVIEW

A guide for developing standards for historic  
rehabilitation in Florida communities

Funded by  
Division of Historical Resources  
Florida Department of State  
Sandra B. Mortham, Secretary of State

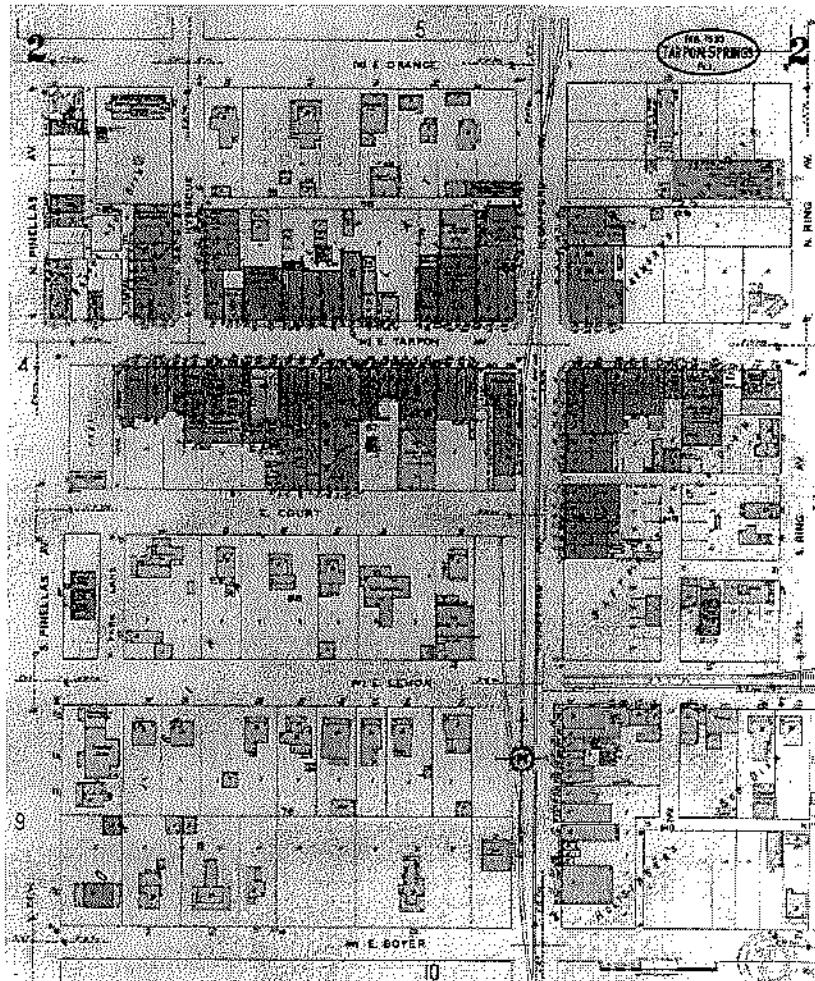
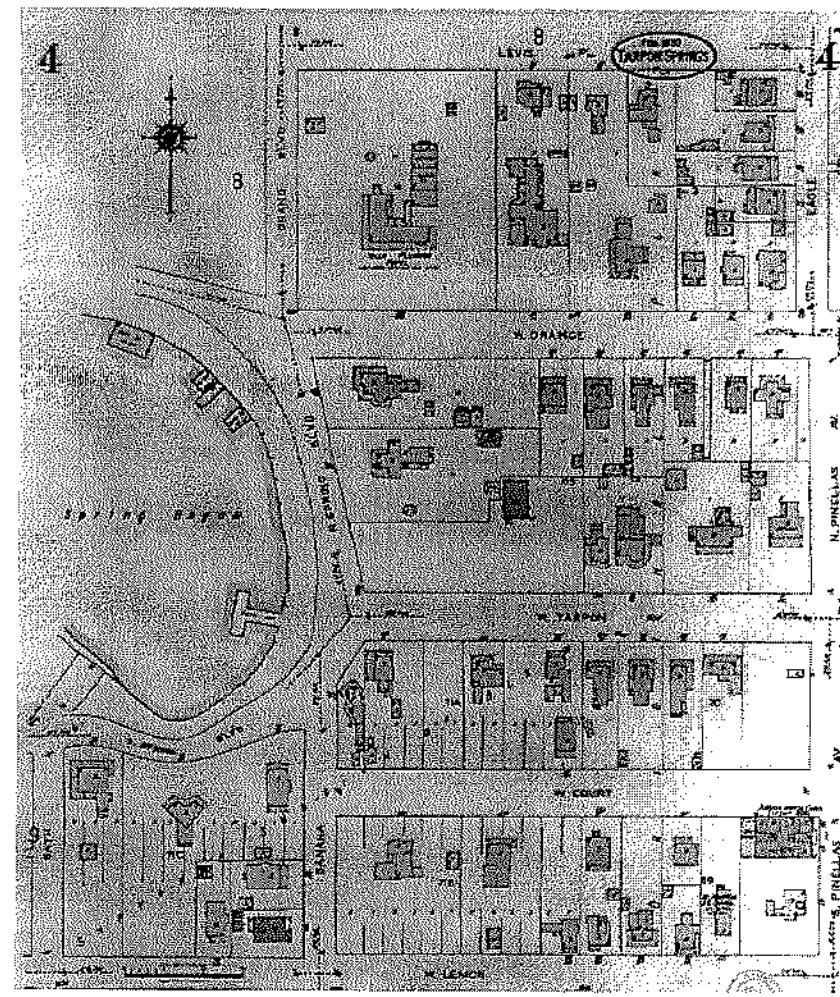
*Sanborn maps such as these are useful for analyzing the original physical appearance of a district.*

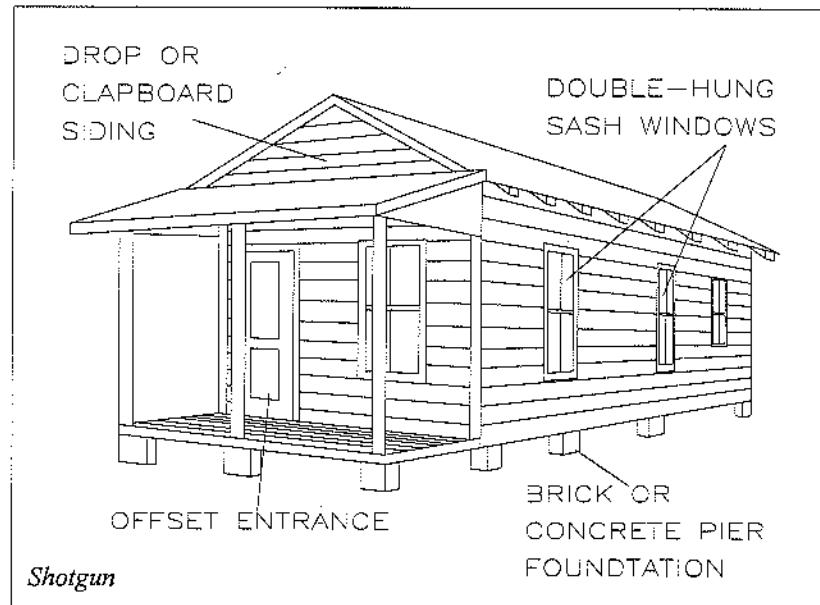
*Shotgun plan.*

- Plan: regular, rectangular.
- Foundation: brick or block piers.
- Height: one story.
- Primary exterior material: wood: weatherboard or drop-siding; less common, board and batten.
- Roof type: hip or gable; shed roof over porch.
- Roof surfacing: wood shingles; metal, V-crimp; composition shingles.
- Detailing: simple; jig-sawn woodwork on porches, doors, or under eaves

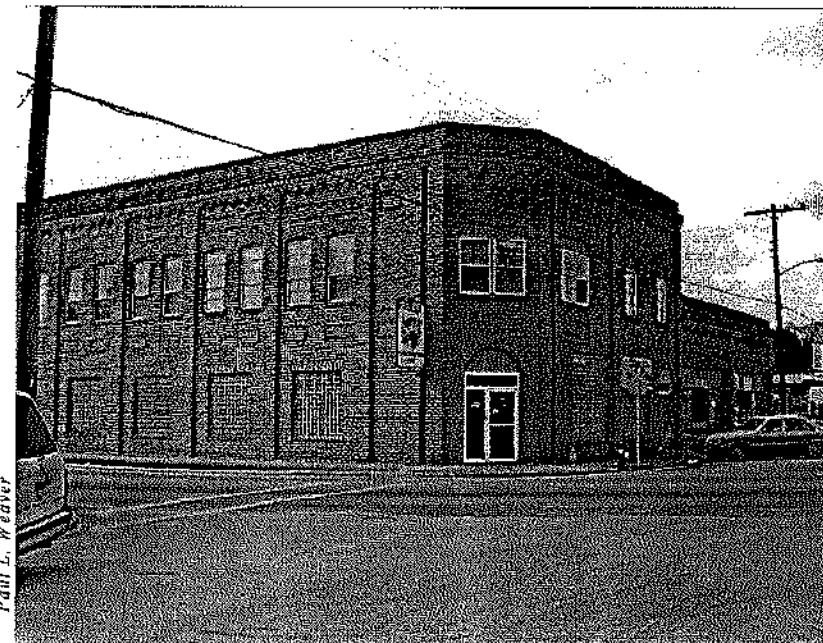
*This buff colored commercial building shows a wide variety of brick features and texture, Burnell.*

Brick construction usually employed fired brick in an English or common bond pattern. The most common wall dimensions were eight or twelve inches. After 1900 new colors and textures of brick appeared. Buff or yellow brick was among the most widely popular of these new types. In addition to commercial buildings, brick was increasingly used on a variety of buildings including private residences, apartments, schools, and governmental buildings. During the 1920s brick was frequently used as a veneer in combination with masonry or frame interior walls on a variety of buildings.

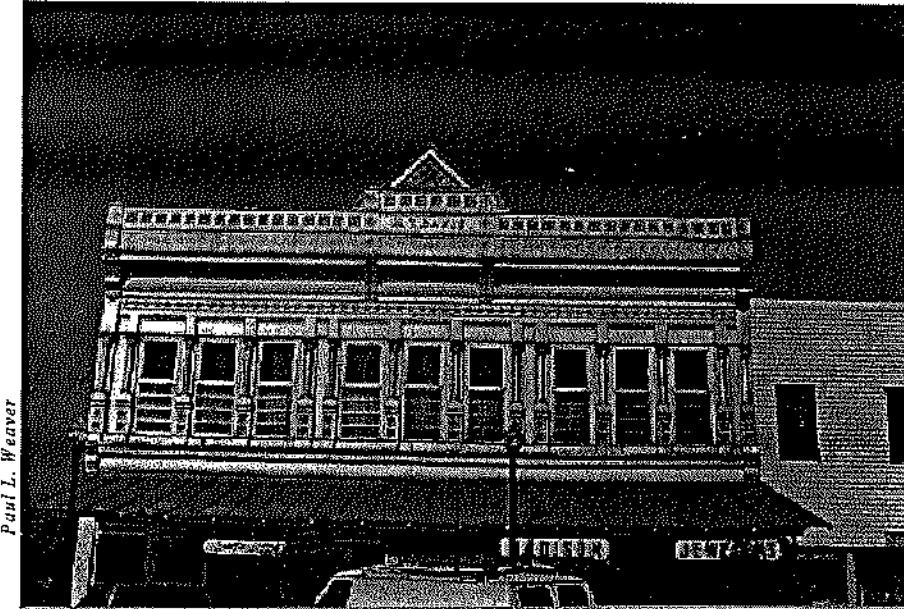
*Cast iron storefront, Madison.*

Use of cast iron in Florida began after the Civil War and lasted until about 1910. Almost exclusively reserved for commercial design, its surviving examples are found in retail buildings located throughout North Florida, the panhandle, and in Tampa.

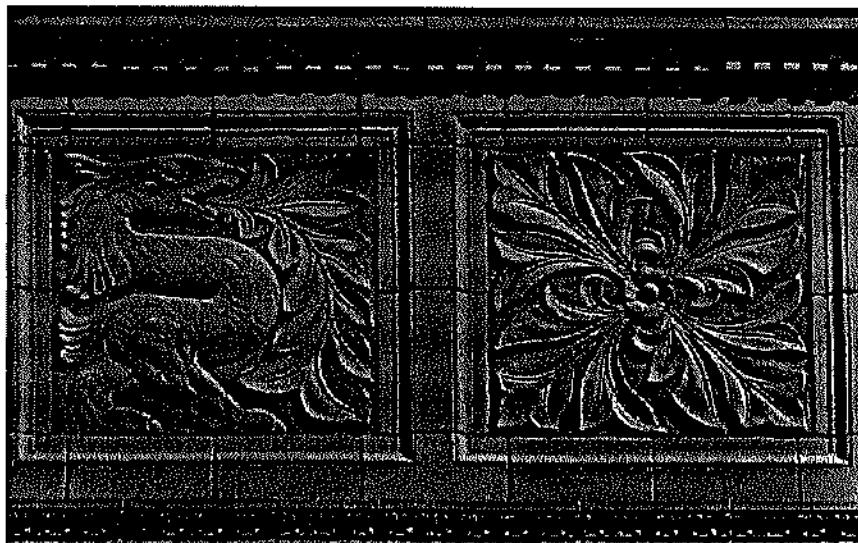
*Terra Cotta Spandrel, Levy Building, Jacksonville.*

Terra cotta, a popular building material in Florida from the mid-1880s through the 1920s, can be found in abundance of the Flagler Era buildings of St. Augustine, including the Ponce de Leon and Alcazar Hotels, and Grace and Flagler Memorial Presbyterian churches. During the Florida Land Boom of the 1920s it became closely associated with Mediterranean style buildings of the period, most frequently as roofing tile, for exterior ornament, and as a structural material.

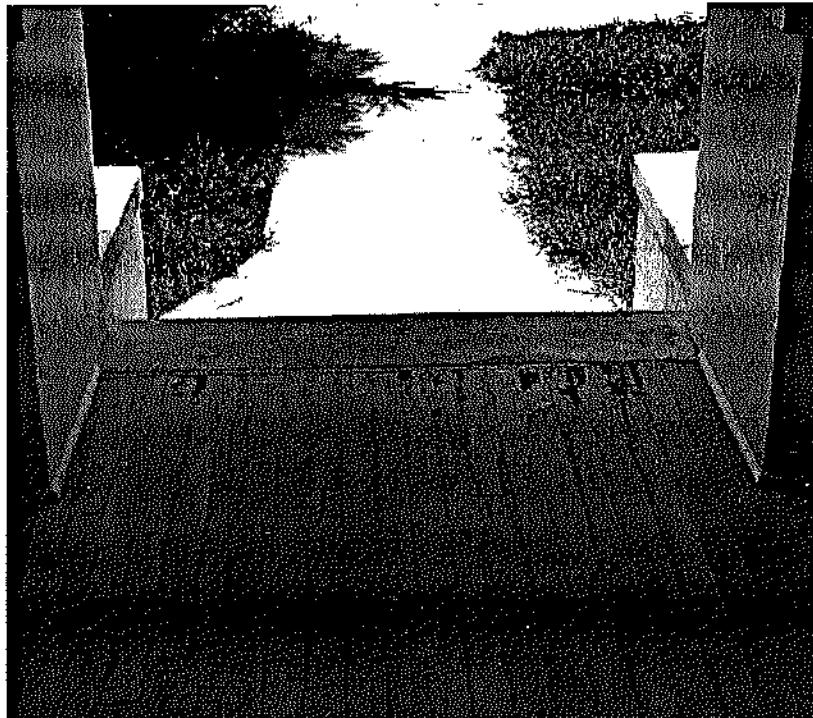
*Porch requiring selective repair and limited replacement of wood decking.*

Repairs are warranted when the physical condition of character-defining materials and features require it. Repair of historic material begins with the least degree of intervention possible, such as patching, piecing-in, splicing, consolidating, or otherwise reinforcing or upgrading the material according to recognized preservation methods. Repair also includes the limited replacement in kind or with a compatible substitute material of extensively deteriorated or missing parts of features when there are surviving prototypes. Although using the same kind of materials is always the preferred option, substitute materials are acceptable if the form and design as well as the substitute materials themselves convey the visual appearance of the remaining parts of the feature and finish.

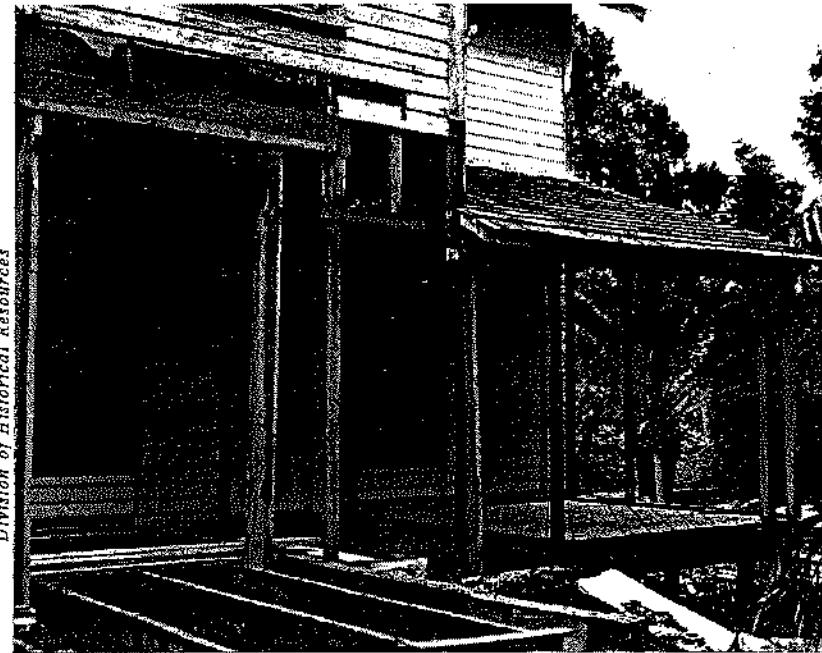
*Due to its condition, much of this porch must be replaced.*

Replacement is appropriate when an entire character-defining feature is not repairable. If the essential form and detailing are still evident so that the physical evidence can be used to re-establish the feature as an integral part of the rehabilitation project, then its replacement is appropriate. Like the guidance for repair, the preferred option is always replacement of the entire feature with the same material. Because this approach may not always be technically or economically feasible, provisions are made to consider the use of a compatible substitute material.

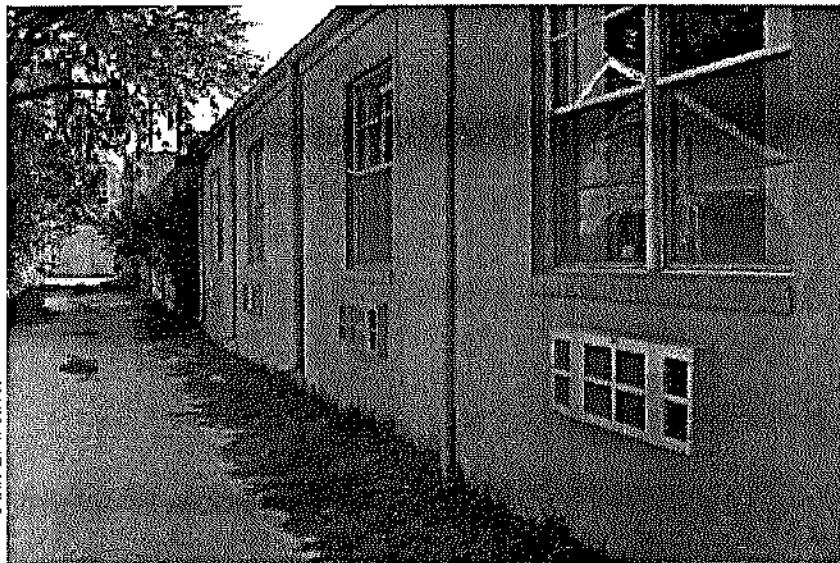
*Cutting through masonry walls to install air-conditioners should be avoided.*

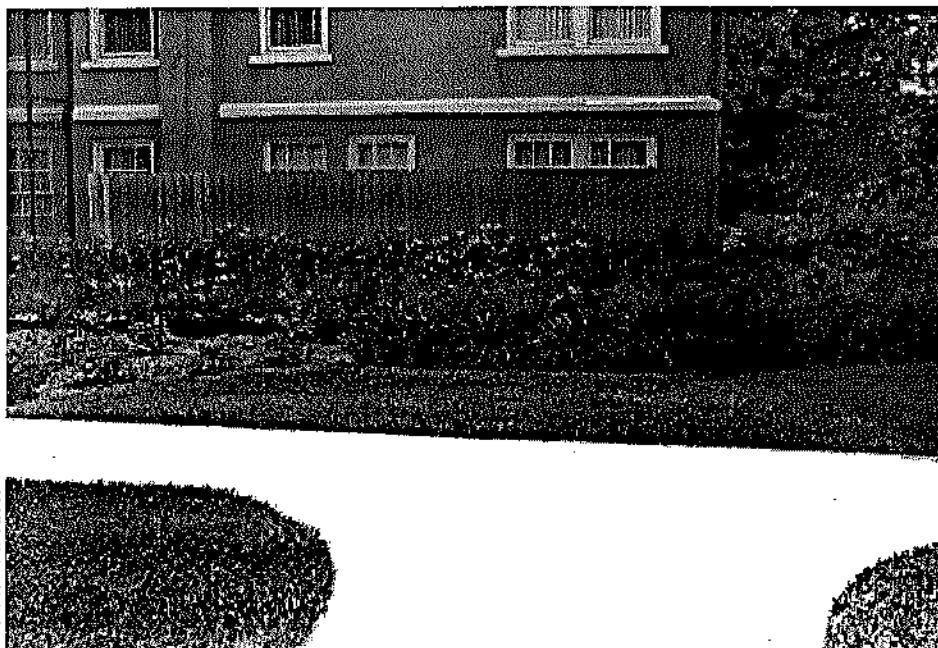
*Contemporary mechanical systems are located at the rear of this historic building and screened from view by a fence and landscaping.*

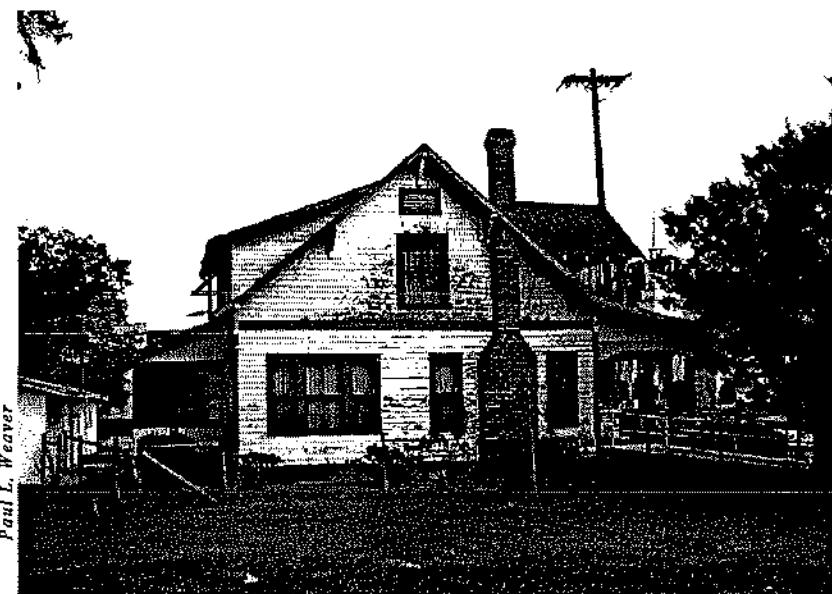
*Paul L. Weaver*  
Deteriorated paint surface requiring gentle prep work and repainting.

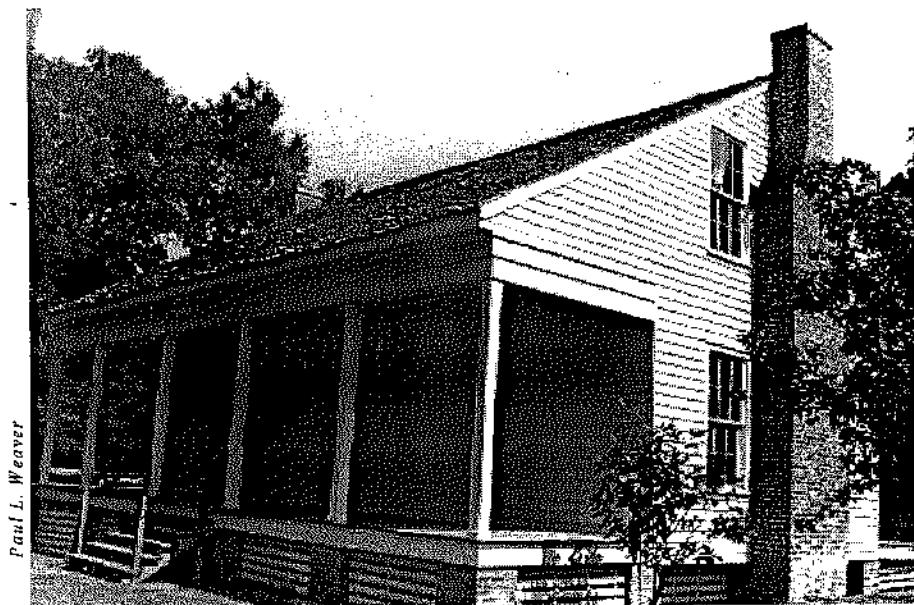
*The incised porch is an essential feature of this Gulf Coast Cottage.*

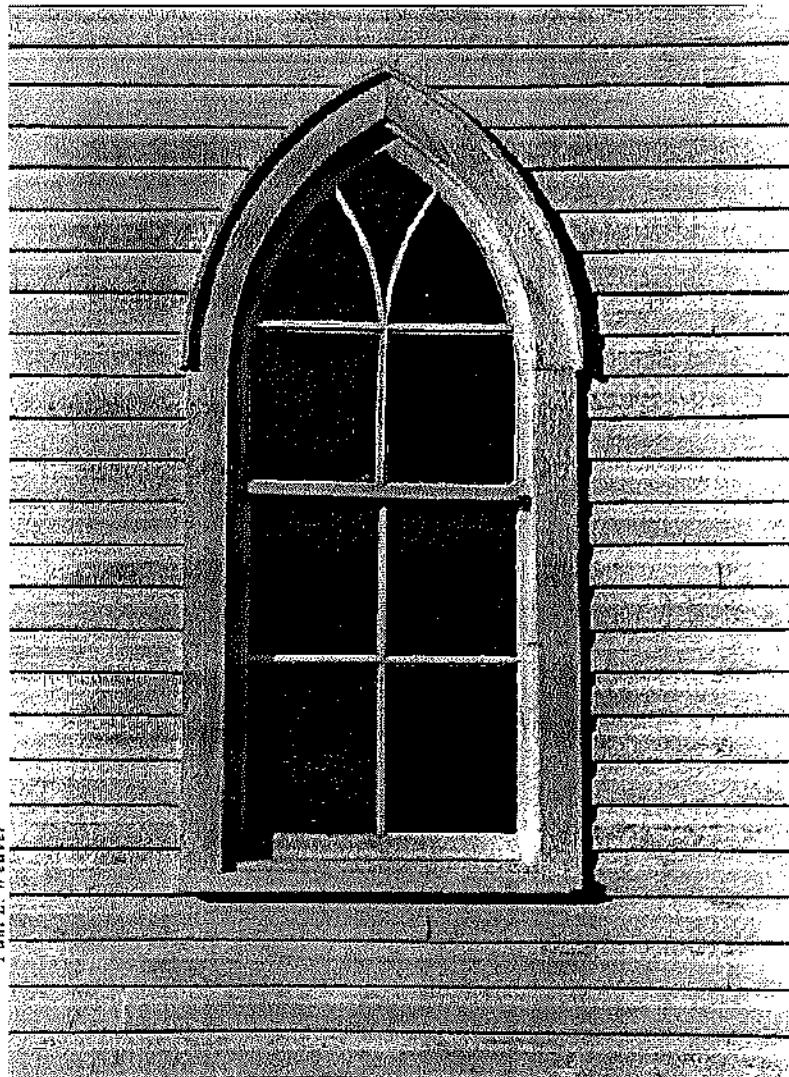
*This lancet window is an element of the Gothic style.*

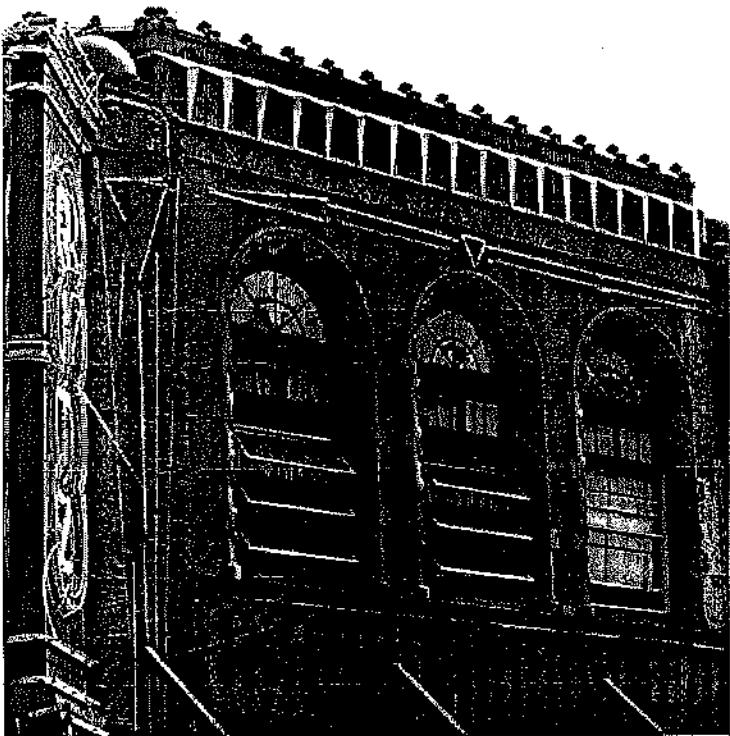
*Awning windows are an inappropriate alteration.*
