St. Augustine Town Plan
National Historic Landmark District
Coquina Structures Survey

FLOOD GUIDANCE
FOR HISTORIC
COQUINA STRUCTURES
CITY OF ST. AUGUSTINE

September 2021

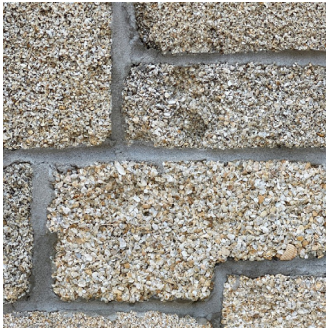
Dressed Coquina: units with two or more sides cut flat to be more geometric.

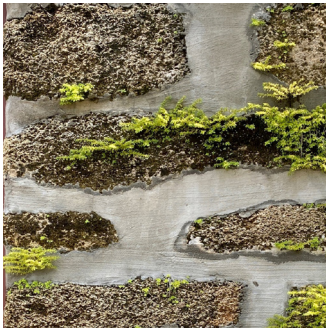
Undressed Coquina: units that have fewer than two sides cut or dressed; sometimes referred to as “rubble.”

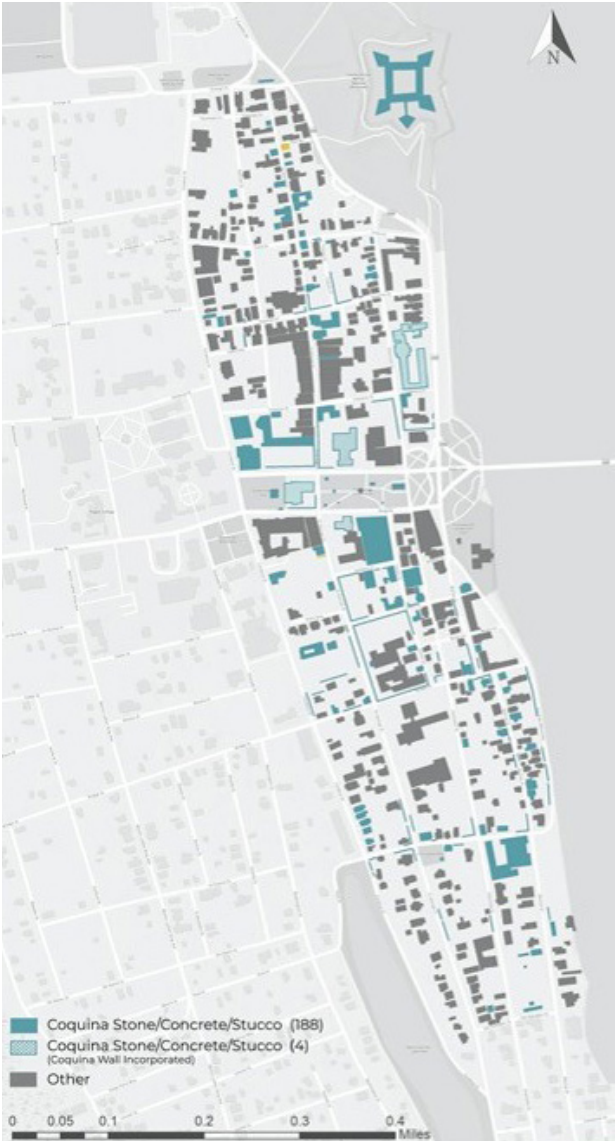
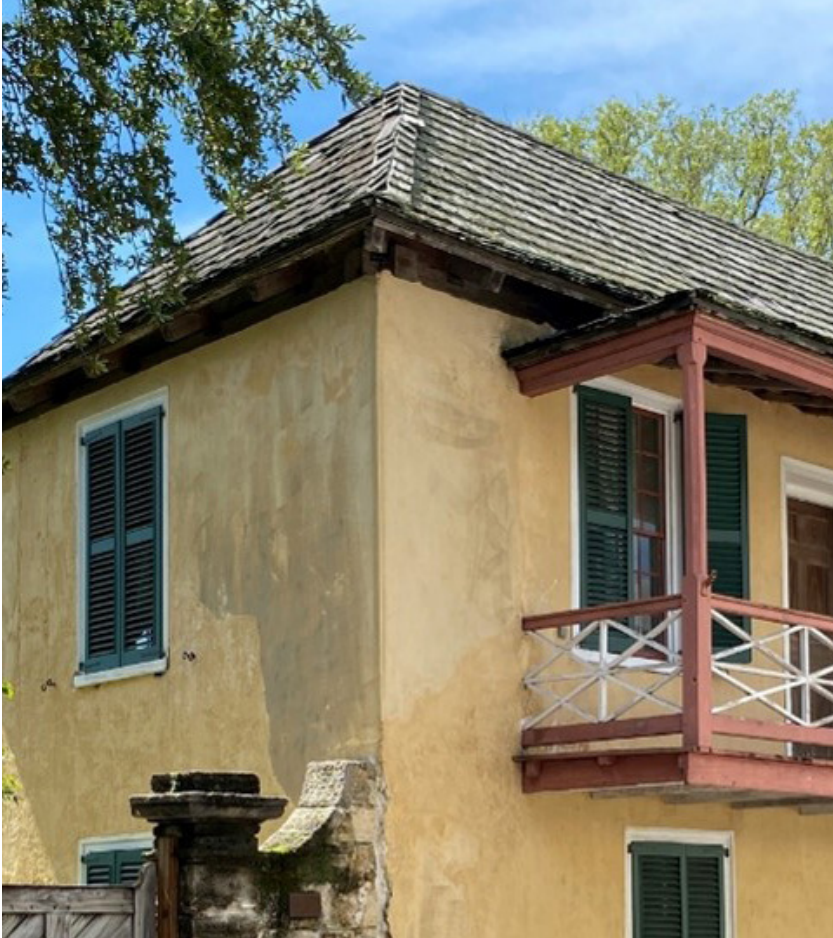
Coquina is found throughout the St. Augustine National Historic Landmark District. There are 40, pre-1821 structures including the Castillo de San Marcos, City Gates, and some 30 buildings.

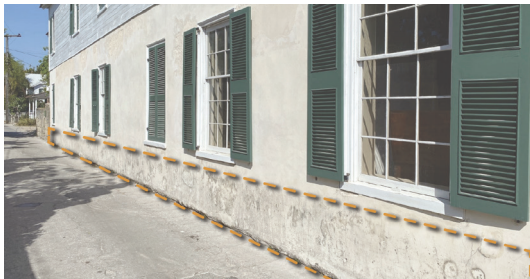
Rising damp appears as a darkened, stained area along the base of coquina buildings.

Coquina is a very porous material with a high rate of water absorption. Moisture naturally wicks or moves vertically within the coquina wall from the base of the lower stones to higher, dryer stones where the water evaporates. Inappropriate maintenance measures and repairs can alter the naturally occurring process of rising damp and cause damage to the historic materials and structure. When maintaining and altering historic coquina structures, consider the following:

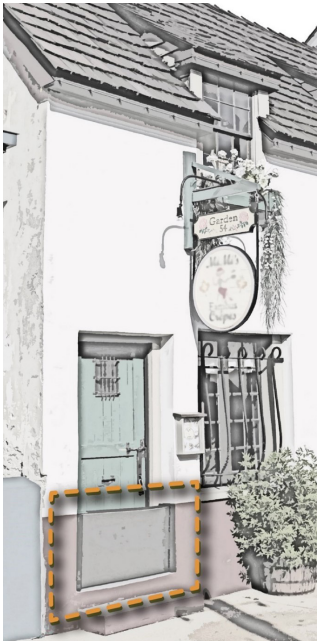
Install barriers at doors, windows, foundation vents, and other openings.

- Choose a system that minimizes damage to historic materials and that can be deployed quickly with minimum labor.
- Ensure the ability of the coquina wall and barriers to withstand the forces of flooding.
- Install non-corrosive fastening devices or channels at openings to attach temporary dams and barriers doing the best to conceal them and minimize the loss of historic material.
- Retain existing and / or introduce new landscape features including berms and garden walls that help act as a barrier to flood waters.

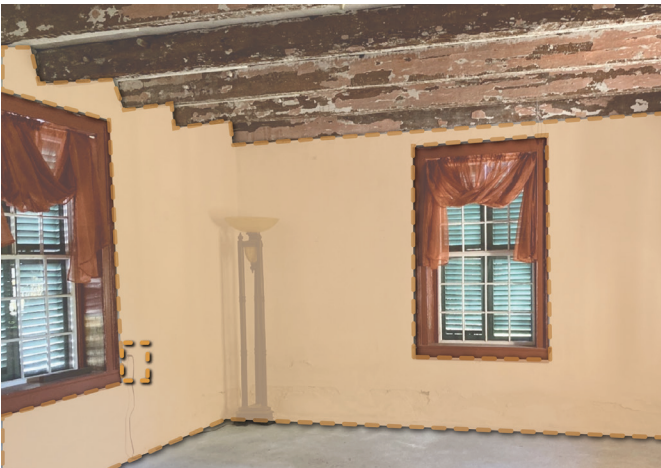
Replace inappropriate, non-permeable materials and finishes with historically appropriate materials and finishes like lime-based plaster that allow coquina walls to breathe and dry out after a flood event. Elevate electrical outlets.

- Evaluate and, where necessary, strengthen walls and overall structural systems to ensure they can withstand floodwater pressure and flood-borne debris.
- Integrate hydrostatic and other vents to help facilitate the flow of floodwaters.
- Retain historic materials and finishes that are flood-damage resistant and remove non-historic materials and finishes that trap moisture.
- Install Ground Fault Circuit Interrupter (GFCI) and raise electrical outlets to protect the electrical system and help reduce the risk of fire.
- Design a system for draining floodwaters away from the building perimeter.
- Retain existing and / or introduce new landscape features including salt-resistant, native plant species, rain gardens, and other features that help absorb water.

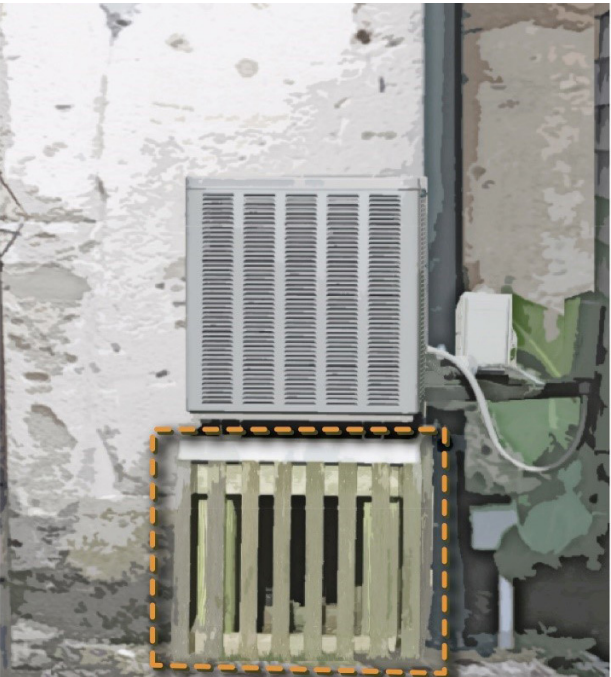
Elevate exterior equipment like air-handling units following the Historic Architecture Review Board (HARB) guidelines.

- Elevate HVAC units and other mechanical equipment and conceal them with landscaping, wooden lattice or slats or other screening elements as per the guidelines of the Historic Architectural Review Board.
- Place all utilities and equipment on elevated platforms should be securely anchored to meet wind-resistant requirements.
- Raise electrical elements such as outlets, switches, junction boxes, meters, and wiring above base flood elevation.
- Secure propane and other fuel tanks so that they do not float during a flood.
