City of St. Augustine, Florida

**Archaeological Investigations Along the Seaward Side
of St. Augustine's Historic 19th-Century Sea Wall**

Carl D. Halbirt
City Archaeologist

January 20, 2004

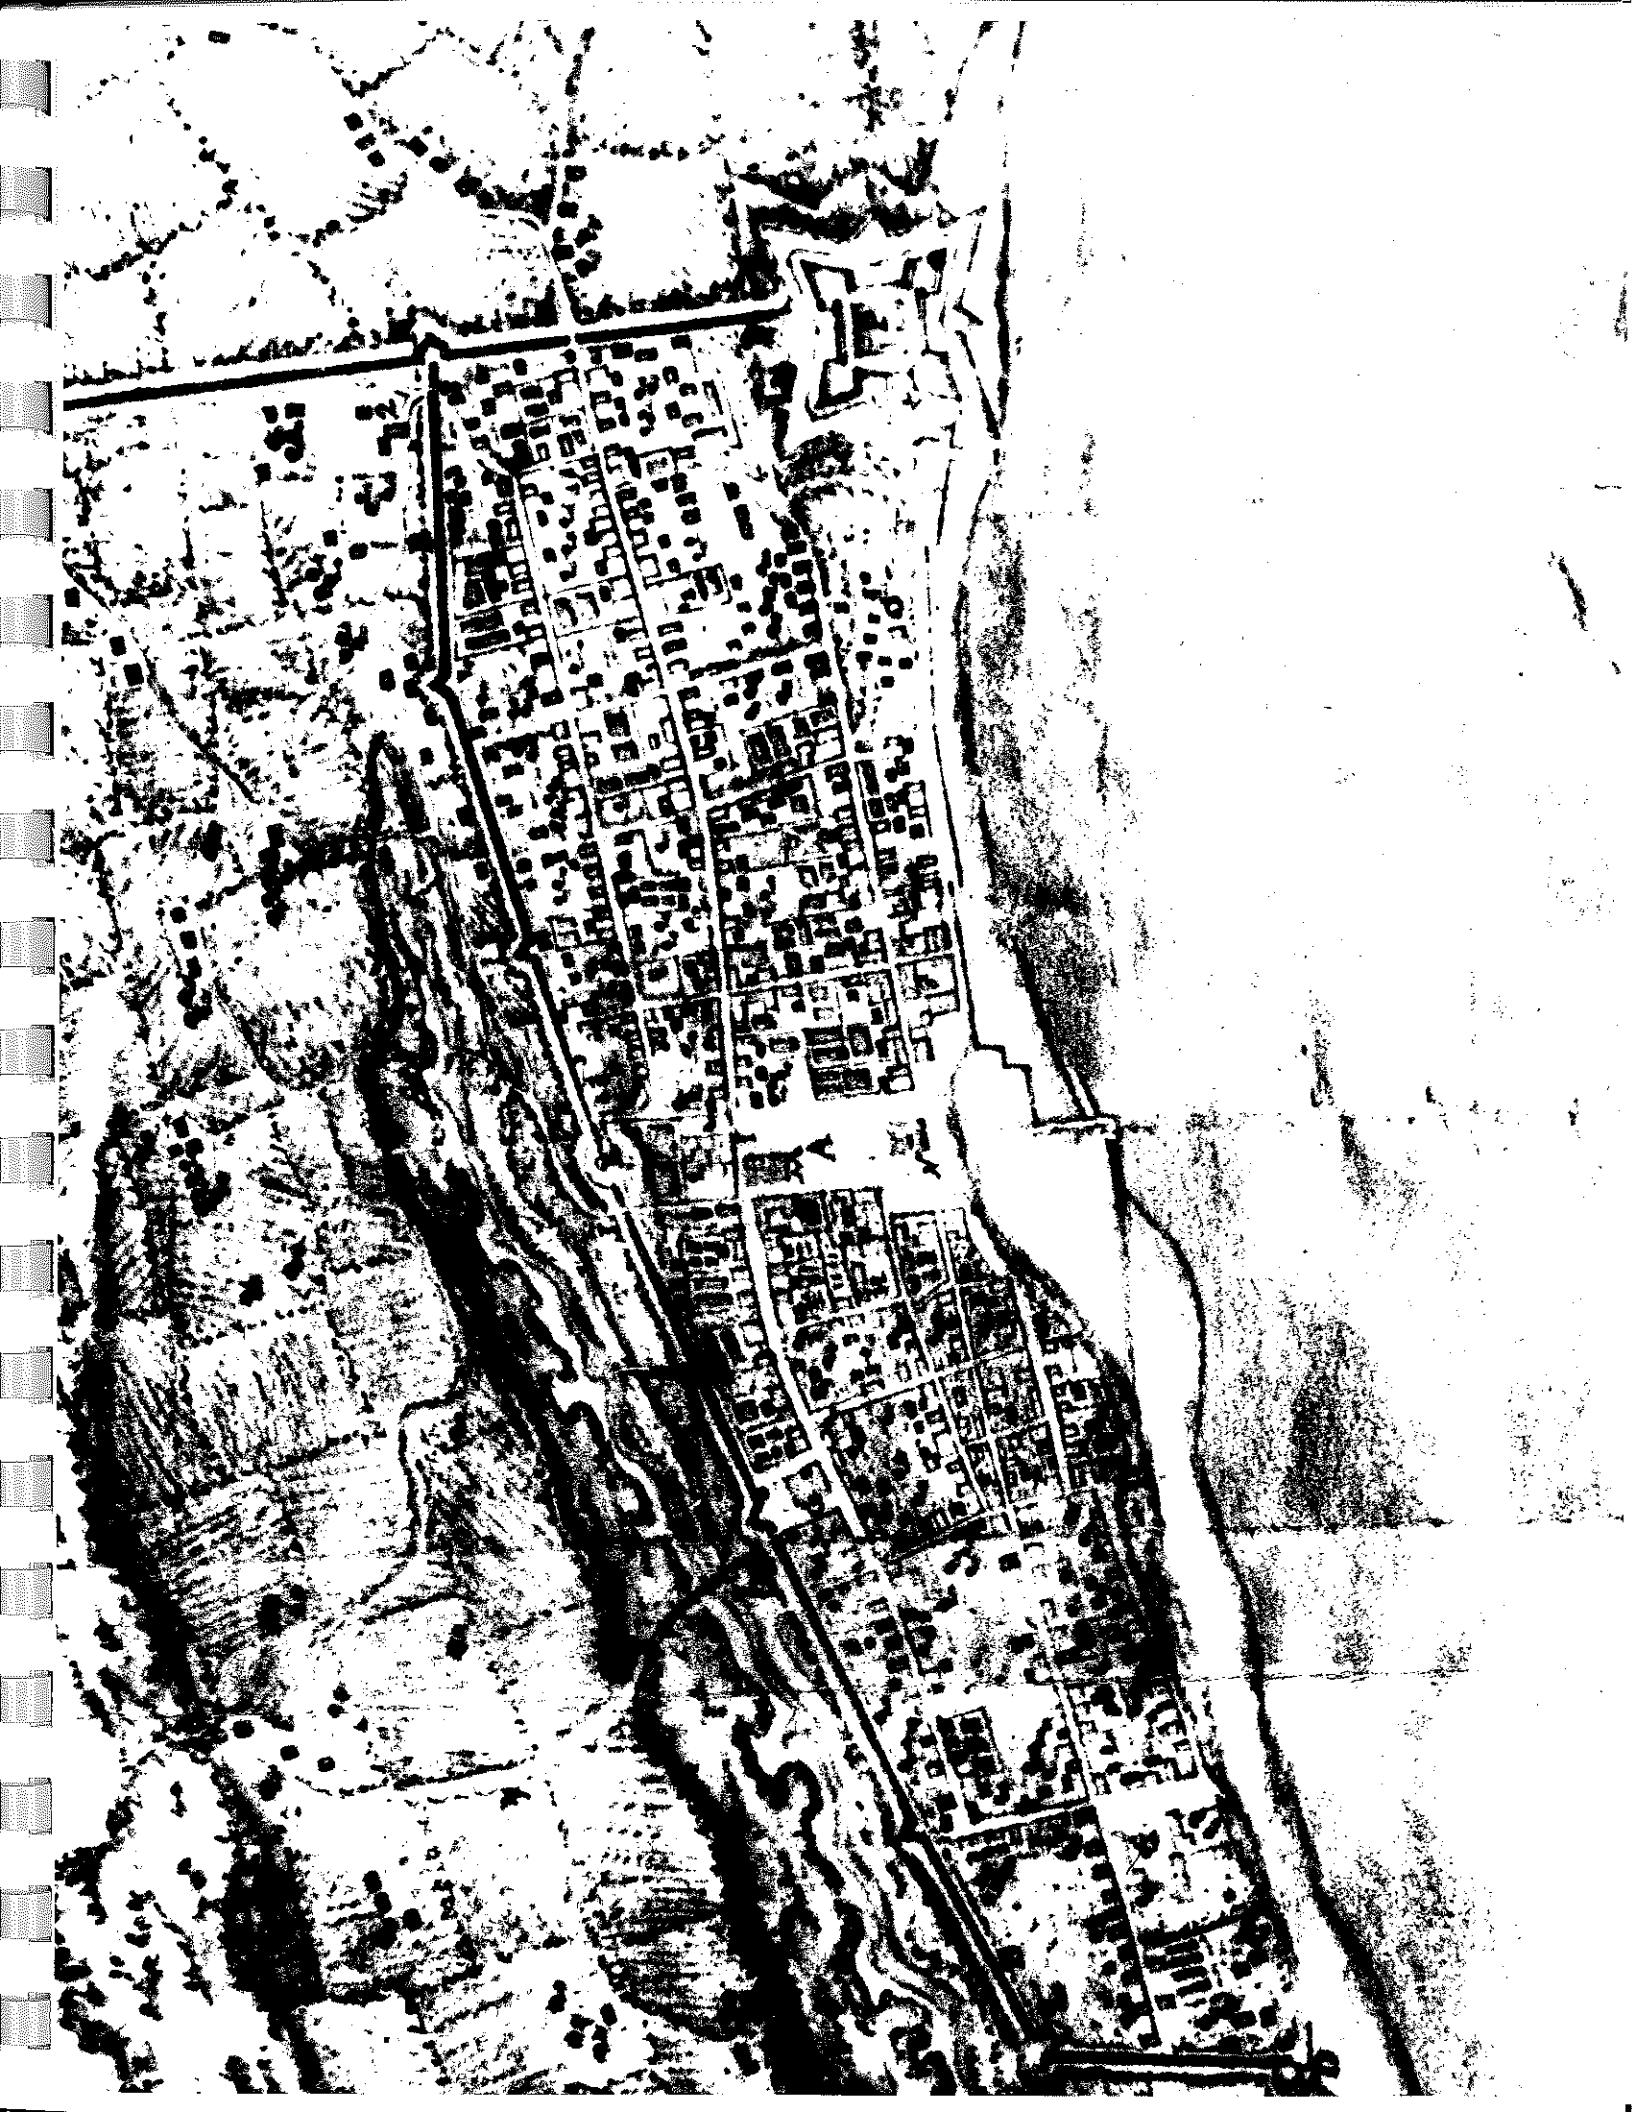
Figure 2. A Section of the Pablo Castelló 1763 “Plano de Presidio de Sn. Agustín” Illustrating the Dock Extending off the Sea Wall.

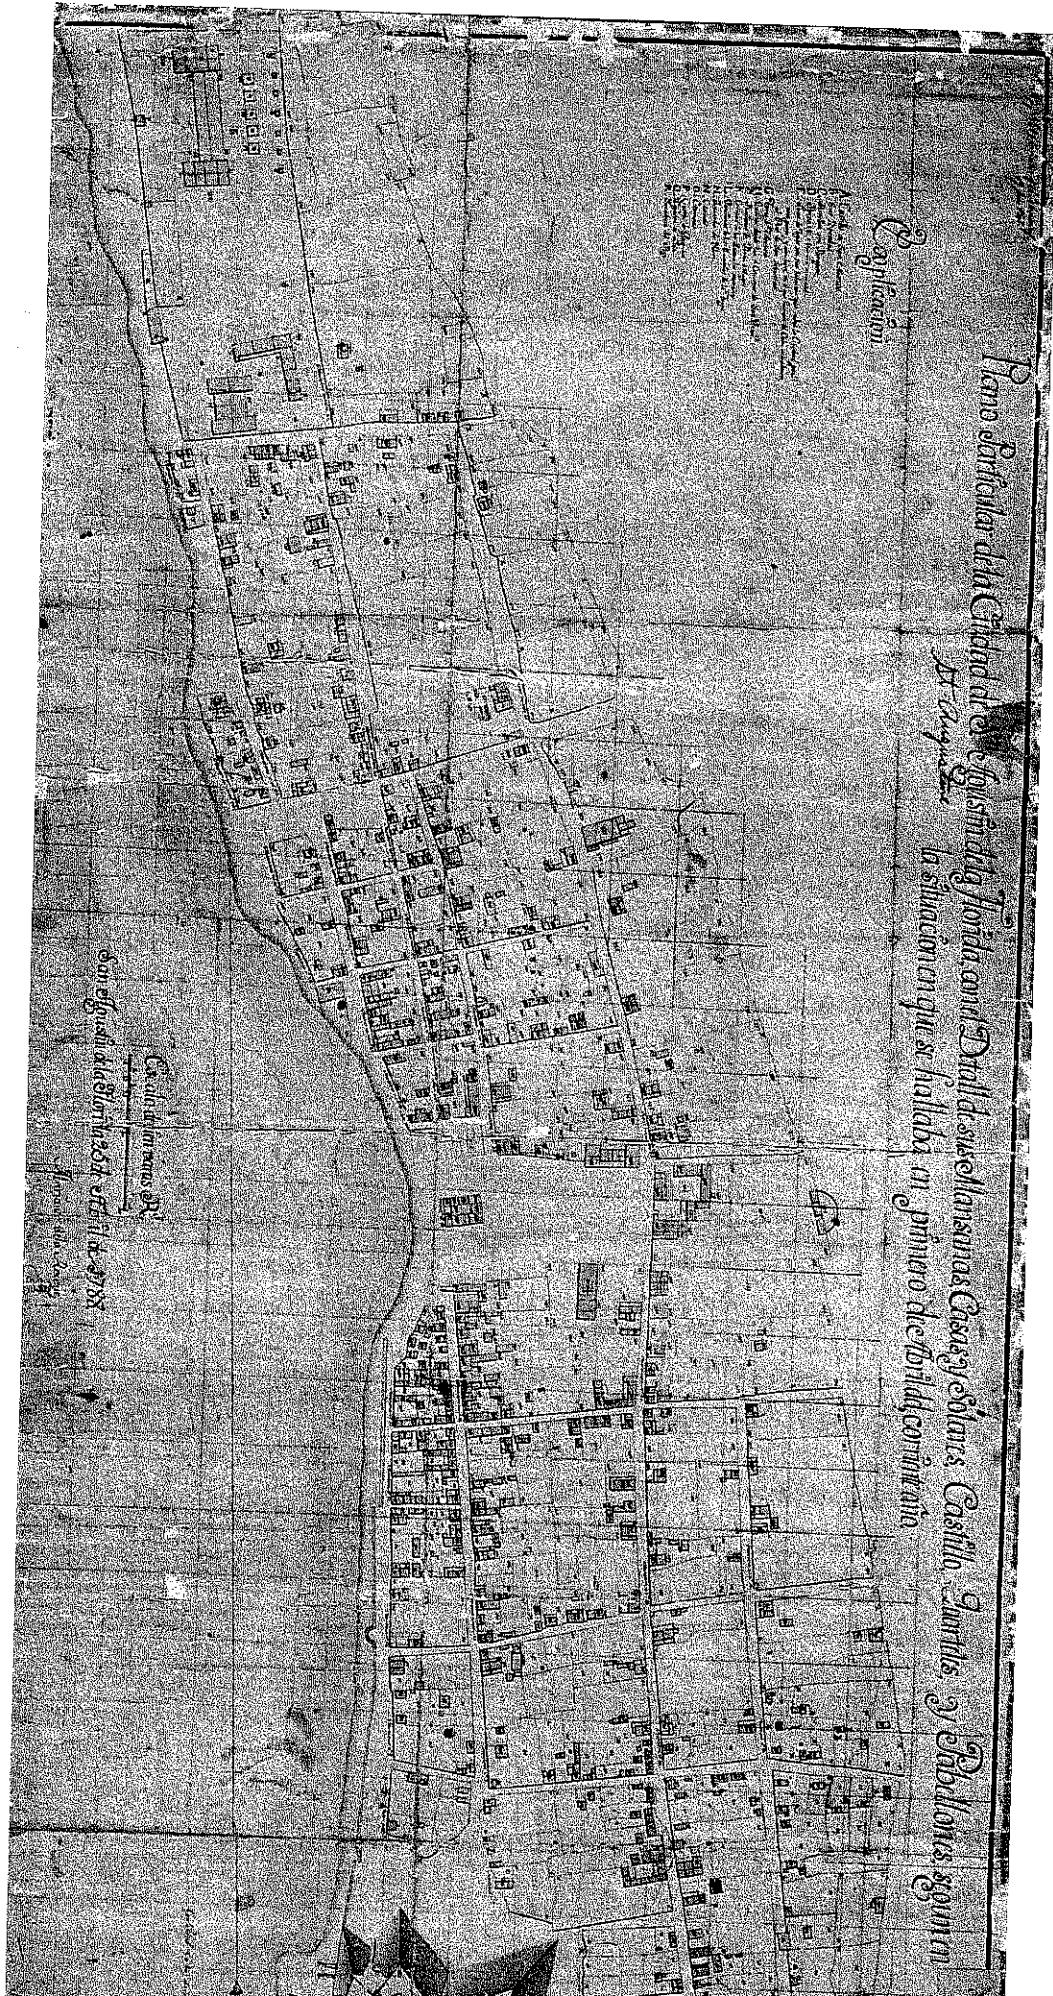
Figure 3. Mariano de la Rocque 1788 “Plano General de la Plaza de Sn. Augstín de la Florida.”

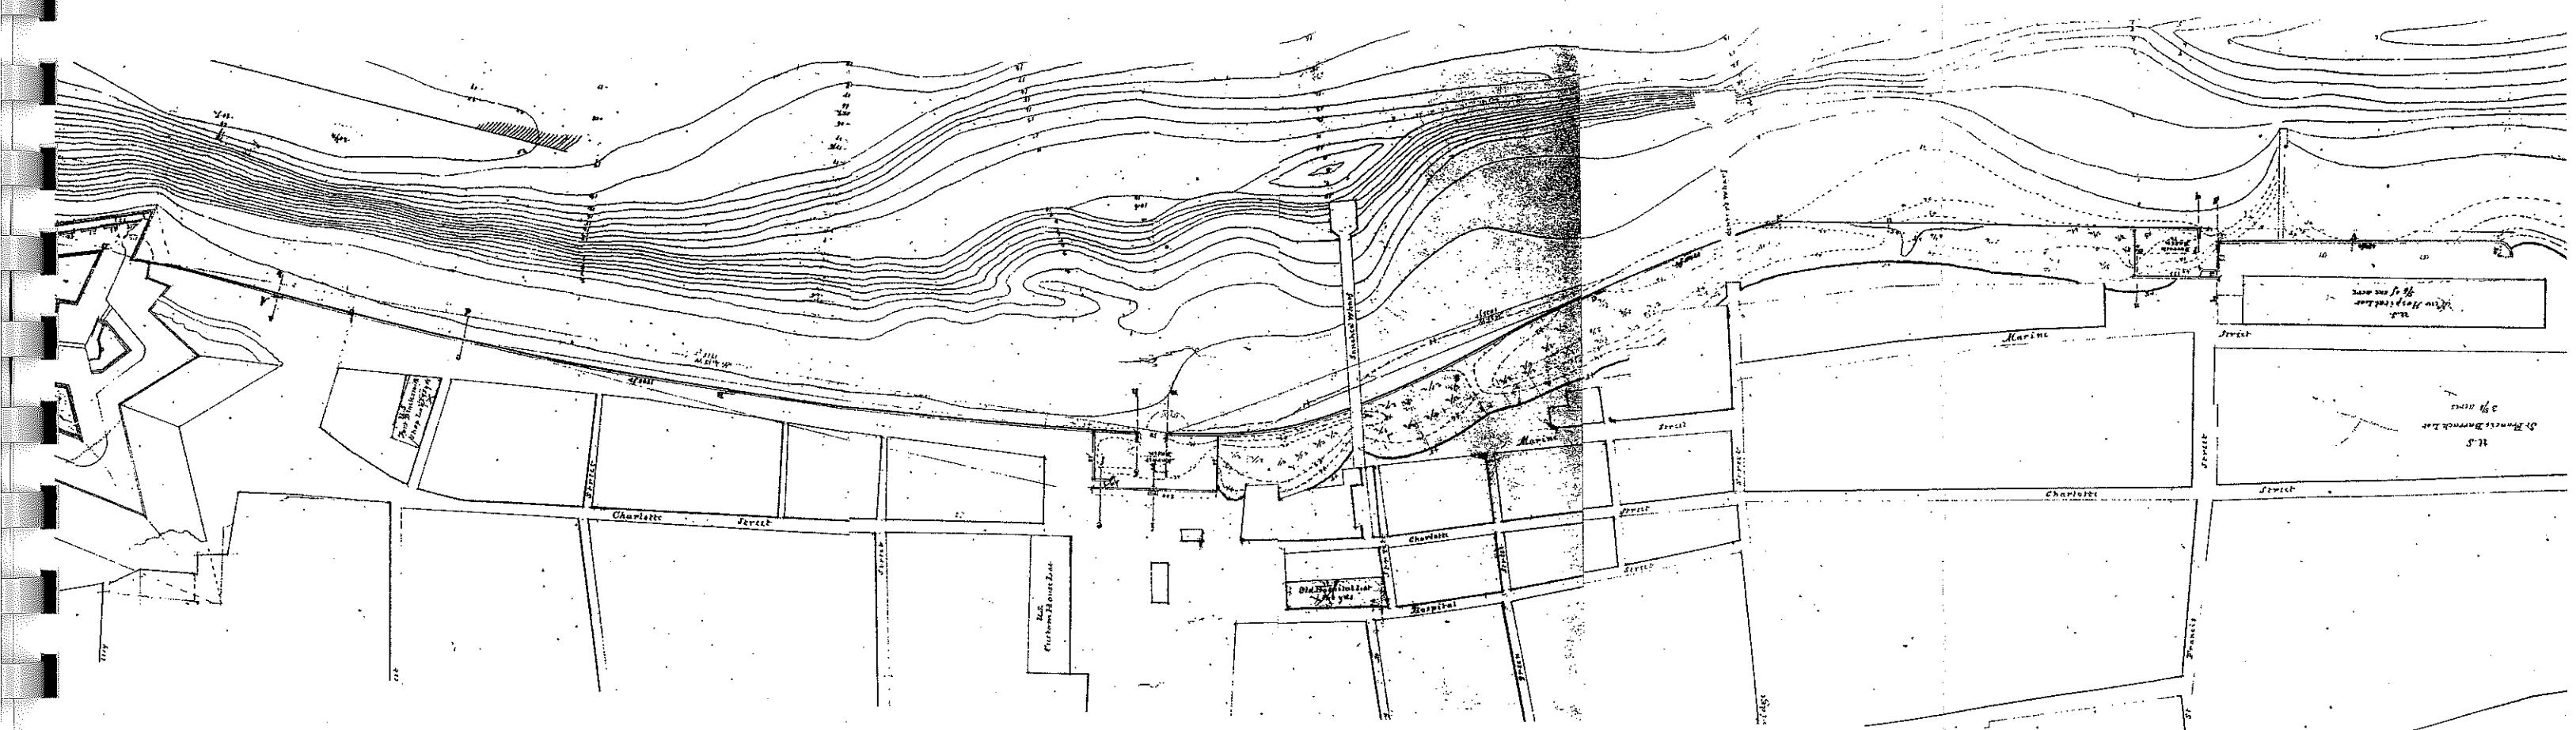
According to calculations derived from Lt. Benham's 1842 illustration of the sea wall (Figure 5), the wall varied from 6 to 7 feet high and was approximately 6 feet wide at its base. In cross-section, the wall becomes progressively narrower from base to top, eventually becoming 3 feet wide at the granite coping stone. The leeward side of the wall (i.e., the side facing the city) is characterized by a series of steps. The seaward side is essentially vertical. Supporting the wall was a massive coquina-stone foundation that appears to be in excess of 2 feet thick by 7 feet wide. This foundation was placed in marsh sediments that occur approximately 2 feet above the average low water mark for 1842. According to Benham's 1842 illustration, the average high water mark would occur approximately 4.5 feet below the top of the wall and common gale force winds would be 2 feet below the top of the wall. Only during severe gale force winds (e.g., the Gale of 1804, which probably was a hurricane) would tides overflow the wall. According

Figure 5. Lt. Henry Benham's 1841 Plan of the Sea Wall at St. Augustine.
