FLOOD MITIGATION DESIGN GUIDANCE FOR HISTORIC COQUINA BUILDINGS

CITY OF ST. AUGUSTINE, FLORIDA

September 2021

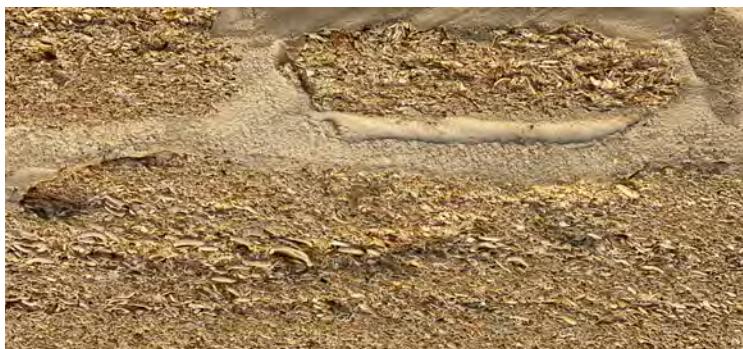
Coquina Masonry

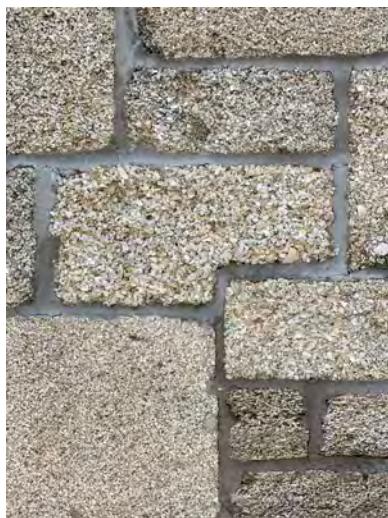
Dressed Coquina

Dressed Coquina: Quarried or "found" Coquina where TWO OR MORE sides have been cut flat having a regular geometry with respect to each other.

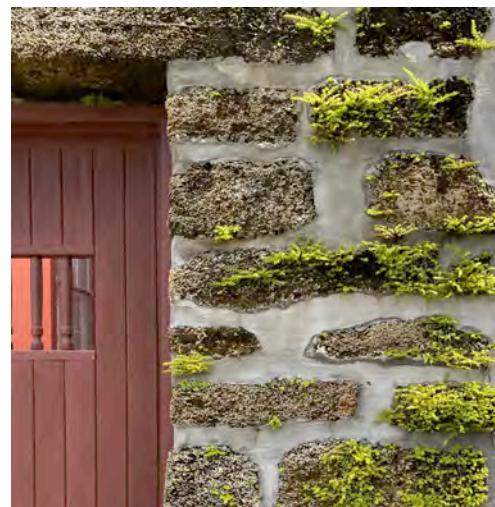
Un-Dressed Coquina

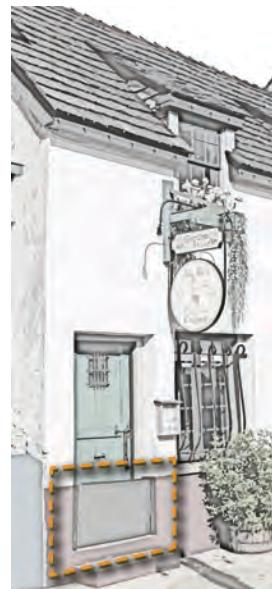
54 St George Street
St Augustine FL
Door Dam Example

Temporary dams are intended to encircle a building or close gaps in floodwalls. Temporary floodgates are removable barriers installed in windows, doorways, and other openings. Depending on the condition of the opening - the temporary barriers can be pressure fit to the opening and avoid permanently installed brackets. This helps maintain the historical integrity of the structures. In some cases permanently installed brackets are appropriate and do not impact the historical integrity. Flood wrapping systems cover the most vulnerable portion of an existing structure to create a temporary impervious barrier. Wrapping systems do not lend additional strength or stability to a structure, therefore any building using such a system must be able to withstand the forces of the flood waters. No temporary system is fail proof. There can be water seepage with these materials and systems, and they should be used in conjunction with pumps and emergency generators. Generators should be elevated above the established design flood elevation. If a temporary measure is breached or overtopped, the deployed system should be immediately removed once flood waters have receded to promote drying. With any of these systems, if custom-sized or special components are needed for certain locations (like a floodgate for a specific-size opening), it is important that they be easy to locate and identify to facilitate timely installation when flooding is predicted.

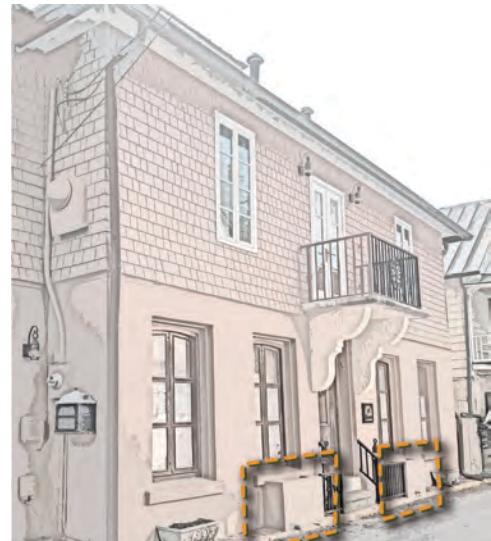
The low walls surrounding the vent still allow for air circulation but in some circumstances, the installation of a fan to provide additional air circulation in the crawl space is recommended.

The low walls should be compatible with the historic building. If crawl space vents have been previously sealed, investigation should be undertaken to determine if the vent closures are watertight and, if not, they should be sealed.

71 Marine Street, St Augustine FL
Low Protective Walls at Crawl Spaces

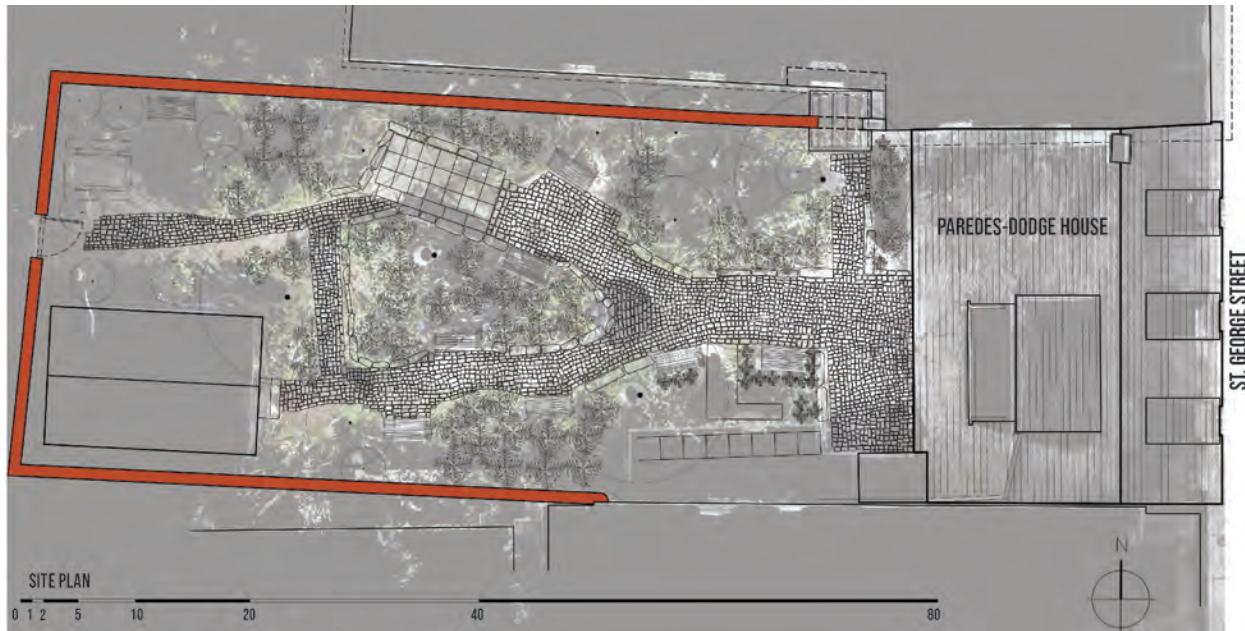
In some cases, properties that are enclosed by a perimeter wall can take advantage of site floodproofing that will protect the entire site from inundation. This is a highly advantageous solution in St. Augustine where many sites are walled. In the case of Site Floodproofing, walls are assessed in terms of height and structural ability to resist hydrostatic pressure. Temporary or permanent operating flood doors are prepared or installed and one or more sump pumps

are recommended, if needed, to effectively control water on the site and reduce hydrostatic pressure as floodwaters recede.

54 St George Street, St Augustine FL - Site Floodproofing example (walls shown in red)

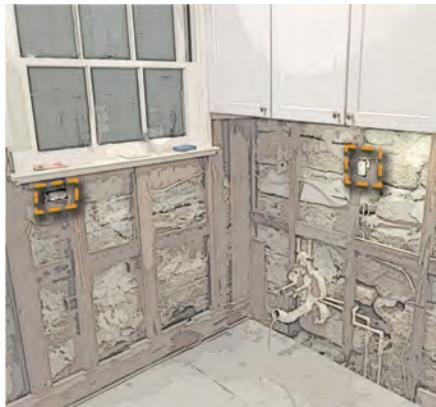
172 Avenida Menendez
St Augustine FL
Example of raising electrical outlets

It is recommended that all utilities be relocated above the established design flood elevation or to protect them in place with a watertight or impermeable enclosure. Likewise, it is recommended that electrical outlets and panels are relocated above the established design flood elevation in a manner compatible with the historic character of the building by placing them in less visible locations and possibly concealing them with existing features such as a door frame or chair rail.

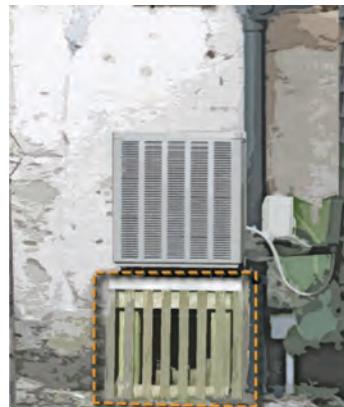
Utilities and mechanical systems for historic buildings are often placed in side and back yards to conceal them from sight. Any part of these systems in such flood-vulnerable locations should be elevated or relocated above the established design flood elevation. Utilities and mechanical systems should be relocated to utilitarian or other secondary spaces in historic buildings that are unlikely to flood. Exterior utilities and mechanical systems should similarly be elevated to protect them from flooding, and placed in locations that minimize, as much as possible their visibility and impact on the historic character and appearance of the building. Consider relocating HVAC equipment to rear roof lines not readily visible from the street. When planning a project involving mechanical, electrical, plumbing, or fire suppression systems, it is helpful to be aware of the service life of the various features of the systems involved.

Example of raising utilities

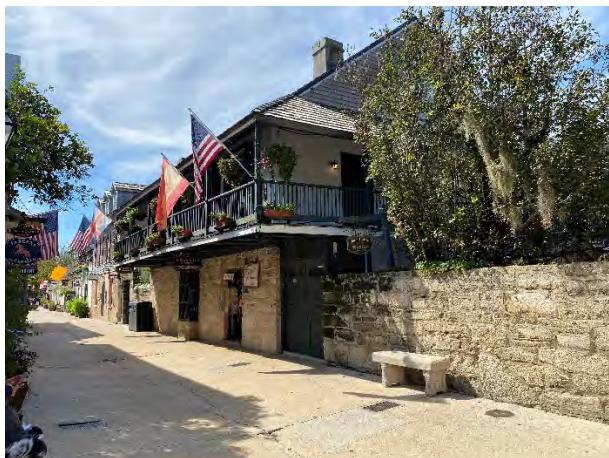
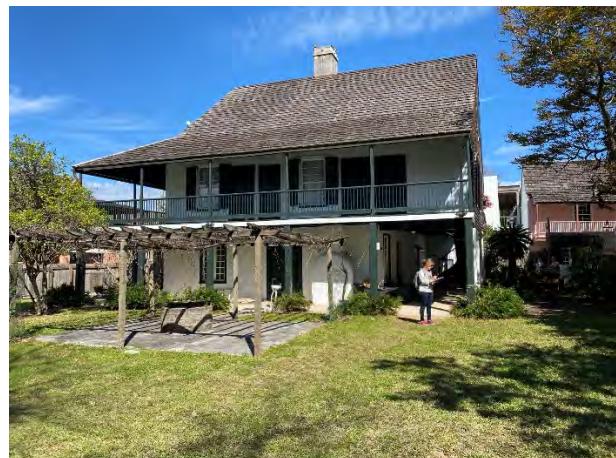
Address:	46 St. George Street
Name:	Arrivas House
Ownership:	University of Florida
Construction Date:	1740
Additions/alterations:	1926, 1937
Restoration Date:	1962
Exterior walls:	Stucco / exposed coquina
First Floor Elevation (FFE):	
Flood Risk Level:	Low. Flood zone "X" BFE 7'
Window Sill Height (abv FFE):	24" (min)
Case Study (y/n):	Yes
Site Walls (y/n):	Yes

This resource is only one of three buildings included in the study that has exposed coquina on the entirety of the public façade. The north, south, and west facades are painted stucco over coquina. All exterior walls are coquina masonry with painted plaster on the interior. This resource has not been inundated in a named storm event however heavy localized rain poses a periodic concern in the rear yard. The building is air-conditioned but limited visual access prevents observation of rising damp or potential condensation issues. From our limited observations of the interior (displays were covering most of the walls) the first floor suffers slight rising damp issues due largely to the higher elevation and extensive roof and porch overhangs around the building.

This resource can be protected by temporary measures including improvements to the water resistance of the two sealed doorways and temporary floodgates at the two open doorways. Protecting the exposed coquina could be undertaken through the use of sheet waterproofing to avoid staining and subsequent cleaning although any trapped moisture that can damage coquina if not removed quickly after a storm.

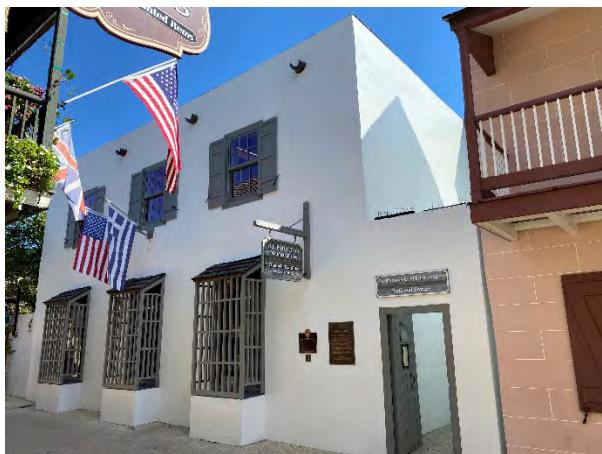
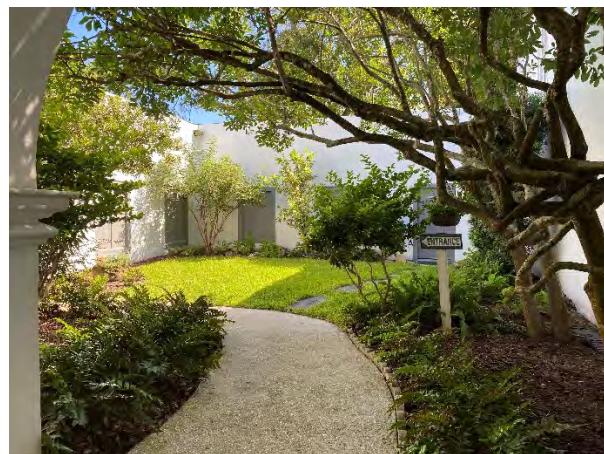
Address:	41 St. George Street
Name:	Avero House
Ownership:	Greek Orthodox Archdiocese
Construction Date:	1743
Additions/alterations:	
Restoration Date:	1970
Exterior walls:	Stucco
First Floor Elevation (FFE):	
Flood Risk Level:	Low. Flood zone "X" BFE 7'
Window Sill Height (abv FFE):	24"
Case Study (y/n):	No
Site Walls (y/n):	Yes

All of the exterior walls of this resource are coquina masonry with painted stucco in excellent condition on the exterior and painted plaster on the interior. This resource has not been inundated in a named storm event and heavy localized rain seems not to pose a concern as the enclosed courtyard drains through the main entry into St. George Street.

While site flood proofing measures could be applied to this property, sealing the door facing St George Street would eliminate the means by which the water in the courtyard could escape. The building alone could be protected by temporary measures including removable pressure fit floodgates.

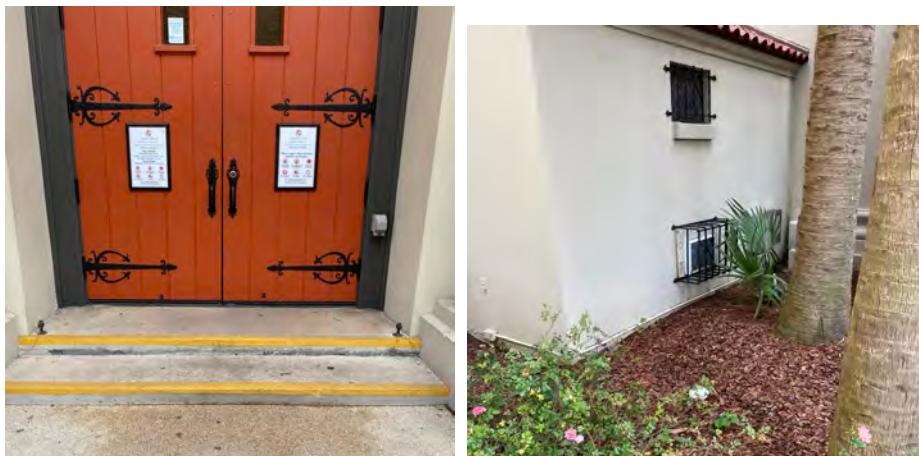
Address:	38 Cathedral Place
Name:	Cathedral of St. Augustine
Ownership:	Catholic Diocese
Construction Date:	1797
Additions/alterations:	1894
Restoration Date:	1966
Exterior walls:	Stucco
First Floor Elevation (FFE):	
Flood Risk Level:	Moderate. Zone "AE" BFE 7' (29% in Zone "X")
Window Sill Height (abv FFE):	60"
Case Study (y/n):	No
Site Walls (y/n):	Yes

This resource "fronts" on Cathedral Place but has significant exposure to St. George Street. Exterior walls are thick coquina masonry with stucco in excellent condition on the exterior and stone veneer and plaster on the interior. The site is separated from the streets by a 36" (min) concrete wall with significant gates and gaps along the perimeter. Doorways are raised less than 5" from the street and all windows sills are very high. Through-wall air conditioning units at floor level pose the greatest opportunity for water infiltration.

Alternatively, the building alone can be flood proofed with removable pressure fit floodgates at the doors that do not require permanent brackets. In the event of a significant flood event, the air conditioning units will need to be removed and the openings covered with flood barriers. In either method, door dams will be required on Cathedral Place.

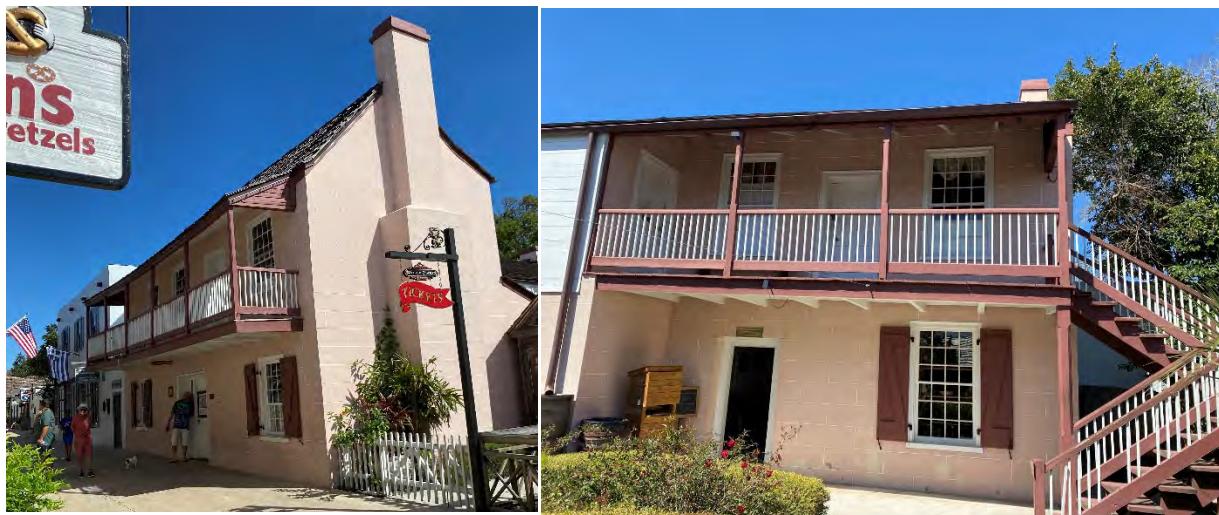
Address:	43 St. George Street
Name:	Demesa-Sanchez House
Ownership:	University of Florida
Construction Date:	1764
Additions/alterations:	c. 1791, 1857
Restoration Date:	1959, 1980
Exterior walls:	Stucco, wood siding
First Floor Elevation (FFE):	
Flood Risk Level:	Moderate. Zone "AE" BFE 7' (74%) BFE 8' (14%)
Window Sill Height (abv FFE):	18" – kitchen windows above main floor elev.
Case Study (y/n):	Yes
Site Walls (y/n):	No

The majority of the first floor exterior walls are coquina masonry with painted stucco on the exterior and painted plaster on the interior. Floors are wood in areas and concrete in the rear 1821 kitchen addition (recessed 4" from the main house level). This resource had minor flooding in a recent named storm event however heavy localized rain poses a periodic concern. The building is air conditioned but apparently not enough to cause vapor drive or condensation problems. However, the air conditioning's unique under floor distribution system provides a potential pathway for water infiltration.

Although not significantly inundated, this resource should be carefully protected against future water damage. Protection by temporary measures including removable pressure fit floodgates at the three doorways is recommended. Installing a sump and pump to remove water that infiltrates the air conditioning system would be useful if the underground floor distribution system is inundated in future flooding events.

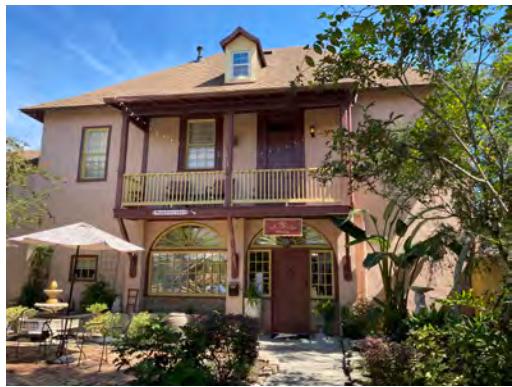
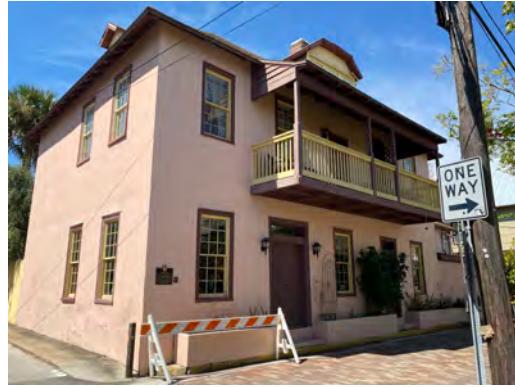
Address:	21 Aviles Street
Name:	Don Manuel Solana House
Ownership:	Private
Construction Date:	1803
Additions/alterations:	c. 1880, c.1970
Restoration Date:	
Exterior walls:	Stucco
First Floor Elevation (FFE):	
Flood Risk Level:	Low. Zone "X" (70%) BFE 7' Zone "AE" (30%) BFE 7'
Window Sill Height (abv FFE):	24"
Case Study (y/n):	No
Site Walls (y/n):	No

The first floor is historic coquina masonry with painted stucco on the exterior. Access to the interior was limited. This resource has not been inundated in a recent named storm. The nuisance flooding concern is reduced largely due to the fact that the site rises as much as 20" above Charlotte Street. The site is not walled and is open to adjacent properties. The two ground-level doorway openings facing Aviles Street are almost at grade level and the one door facing Charlotte Street threshold height is 22".

Although not recently inundated, future-flooding events may impact this resource. Protection by temporary measures including removable pressure fit door floodgates is recommended.

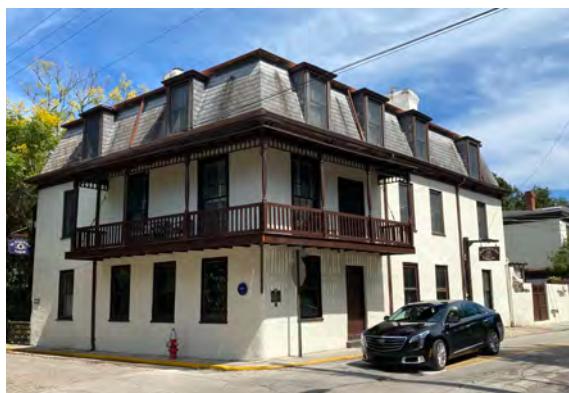
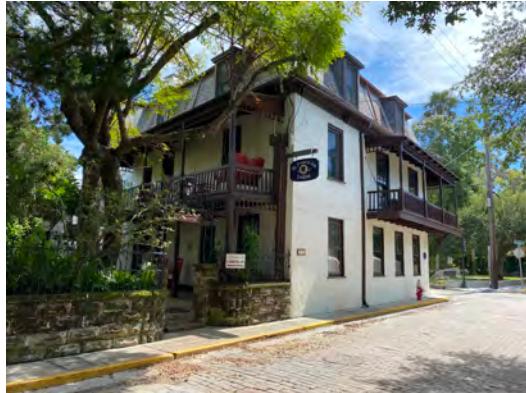
Address:	279 St. George Street
Name:	Dummet House – St. Francis Inn
Ownership:	Private
Construction Date:	1791
Additions/alterations:	c. 1888, c. 1903, c. 1976
Restoration Date:	
Exterior walls:	Stucco
First Floor Elevation (FFE):	
Flood Risk Level:	High. Zone "AE" BFE 8'
Window Sill Height (abv FFE):	36"
Case Study (y/n):	No
Site Walls (y/n):	Yes

The first floor exterior walls are coquina masonry with painted stucco in fair condition on the exterior and painted plaster on the interior. This resource was inundated in a recent named storm to a depth of 24" but localized storms or nuisance flooding does not pose a concern largely due to the fact that the floor level is approximately 8" above street level. The door on St. Francis Street has been sealed shut. The site is walled with a low coquina garden wall on St. George and CMU / coquina walls encompassing the rest of the site. The wall has significant openings but appears sound.

This resource is a good candidate for dry floodproofing. Two alternatives for flood protection are site floodproofing the property at the surrounding wall or floodproofing the building. Although the garden wall has significant openings, installing permanent brackets for floodgates at the site wall would not significantly impact existing historic fabric and would block flooding through these openings. A generator could be installed with a sump pump to remove water accumulating in the yard. Alternatively, the building alone can be floodproofed with the doors closed and removable pressure fit door floodgates. The existing doorway on St. Francis should be reinforced against hydrostatic pressure.

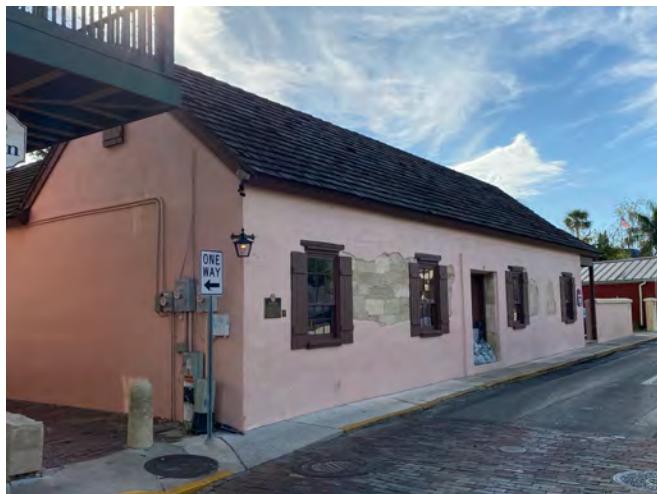
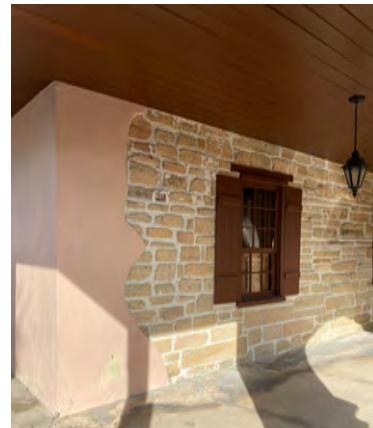
Address:	110 Charlotte Street
Name:	Espinosa-Sanchez House
Ownership:	Private
Construction Date:	1756
Additions/alterations:	1790s, 1920s
Restoration Date:	1965
Exterior walls:	Coquina, Stucco
First Floor Elevation (FFE):	
Flood Risk Level:	Severe. Zone "AE" BFE 8'
Window Sill Height (abv FFE):	27"
Case Study (y/n):	No
Site Walls (y/n):	No

This resource is one of three buildings in this study that has exposed coquina on an entire public façade. The north, south, and west facades are painted stucco over coquina in good condition with "windows" into the coquina substrate. All exterior walls are coquina masonry. There are three ground-level doorway openings - the threshold height for the door facing west at Charlotte Street is 12", the door facing east towards Avenida Menendez threshold height is 4" and the threshold height for the door facing north to the alley is 6". The site is not walled.

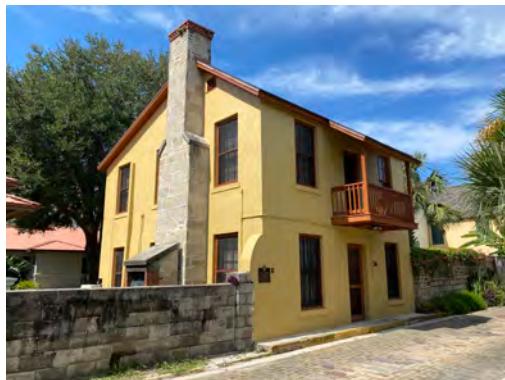
Address:	36 Aviles Street
Name:	Gaspar Papy House
Ownership:	Sisters of St. Joseph
Construction Date:	1810
Additions/alterations:	1944
Restoration Date:	
Exterior walls:	Stucco, coquina
First Floor Elevation (FFE):	
Flood Risk Level:	Moderate. Zone "AE" BFE 7'
Window Sill Height (abv FFE):	17"
Case Study (y/n):	No
Site Walls (y/n):	Yes

Perimeter walls are painted stucco on the exterior in excellent condition and unknown material on the interior. According to the owners, the interior of this building has been extensively re-built with little remaining historic fabric. Recent named storm events have inundated this resource to a reported depth of several inches. There are three doors into the building, one from Aviles Street with a 6" curb and two within the courtyard at grade. The site is walled but has numerous large openings. Window sills are low and the natural grade rises above the interior floor elevation on the south side.

This resource is a good candidate for dry floodproofing of the building. The building alone can be floodproofed with temporary measures including removable pressure fit door floodgates set in between the door jambs and without the use of permanently installed brackets. Window floodgates would also be recommended because the sills are low.

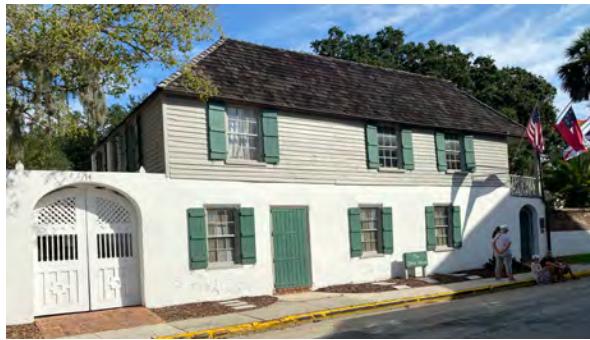
Address:	14 St. Francis Street
Name:	Gonzalez-Alvarez House (Oldest House)
Ownership:	St. Augustine Historical Society
Construction Date:	1723
Additions/alterations:	1791
Restoration Date:	1960
Exterior walls:	Stucco, wood siding, coquina
First Floor Elevation (FFE):	
Flood Risk Level:	Severe. Zone "AE" BFE 8'
Window Sill Height (abv FFE):	26"
Case Study (y/n):	Yes
Site Walls (y/n):	Yes

Perimeter walls are painted stucco on the exterior in fair condition and a patchwork of various plaster-type materials on the interior. Recent named storm events have inundated this resource to a reported depth of several inches. There are multiple doors into the building and only one with a 6" curb; the others open into the courtyard at grade. There is a site wall it but includes several buildings including numerous large openings.

The natural and unadorned state of the interior of this resource suggests that it is a good candidate for wet floodproofing. For storm events, the furniture and artifacts on the first floor can be removed to the second floor and the spaces lightly washed and dried after they have been inundated. Alternatively, the building alone could be temporarily floodproofed with the doors closed and removable pressure fit door floodgates without the use of permanently installed brackets.

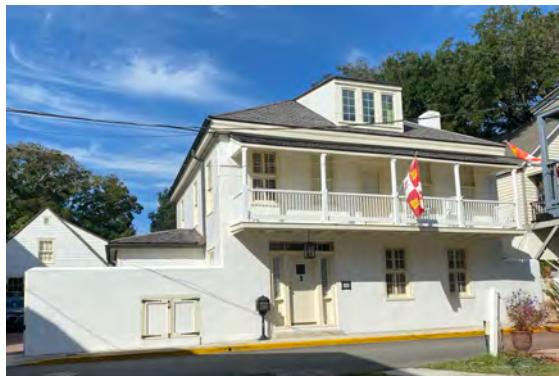
Address:	56 Marine Street
Name:	Gonzalez-Jones House
Ownership:	Private
Construction Date:	1763
Additions/alterations:	Early 20c., 1980s
Restoration Date:	
Exterior walls:	Stucco, siding
First Floor Elevation (FFE):	
Flood Risk Level:	Severe. Zone "AE" BFE 8'
Window Sill Height (abv FFE):	42" from curb. 49" from street
Case Study (y/n):	No
Site Walls (y/n):	Yes

First floor perimeter walls are painted stucco on the exterior in excellent condition and unknown material on the interior. Flooding history is unavailable but its elevation suggests that it is likely the property would have been inundated during recent named storm events. The one door into the building from Aviles Street has a sill 18" up from the Marine Street. Access to the rear of the house and interior was not available. The entire site appears to be enclosed with a tall and structurally sound wall containing two large openings, which includes a large vehicular opening.

This resource is an excellent candidate for site floodproofing with only the two openings in the site wall and the main door of the house needing temporary floodgate protection. The building alone may be floodproofed but openings to the side and rear were not observable.

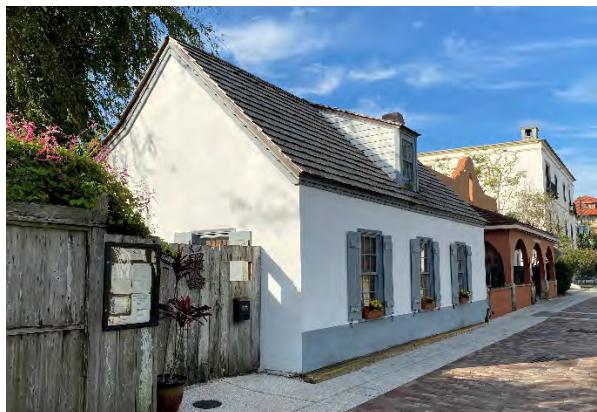
Address:	57 Treasury Street
Name:	Joaneda House
Ownership:	University of Florida
Construction Date:	1806
Additions/alterations:	c. 1920, c. 1986
Restoration Date:	1976
Exterior walls:	Stucco, wood siding
First Floor Elevation (FFE):	
Flood Risk Level:	High. Zone "AE" BFE 7'
Window Sill Height (abv FFE):	28" (at street) 23" interior
Case Study (y/n):	Yes
Site Walls (y/n):	No

This resource is a valuable example of Second Spanish Period colonial architecture and the "St. Augustine plan" with the original fabric intact. Perimeter walls are painted stucco on the exterior and painted plaster on the interior. This resource was severely inundated in both recent named storm events with water levels reportedly reaching 36" deep in the main room on the first floor. Heavy localized rain also flowed into the building (the floor is at grade in the rear) until the owner installed a trench drain. The site is not walled and is open to adjacent properties. The one main entry door is at grade as is the one to the kitchen addition. The first floor appears not to have any rising damp issues despite its low elevation and short overhangs.

Two options exist for addressing future inundation. Wet floodproofing - removing or elevating furniture and materials to the upper floor and allow the water to enter and exit the building and then cleaning and drying the interior. Dry floodproofing – protect the first floor against flooding by temporary measures including removable pressure fit floodgates at the two doorways. The fairly straightforward nature of the shutters suggests the possibility of altering the existing shutters with gaskets to act as flood protection in the closed position rather than installing dam brackets. The integrity of the shutters should be evaluated prior to installing a gasket and using them as a temporary floodproofing measure. Installing a sump and pump on the interior of the structure is recommended to remove any water inundation.

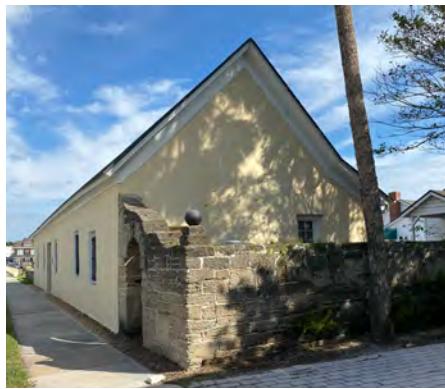
Address:	99 Marine Street
Name:	Kings Bakery
Ownership:	US Parade Grounds
Construction Date:	1796
Additions/alterations:	
Restoration Date:	
Exterior walls:	Stucco
First Floor Elevation (FFE):	
Flood Risk Level:	Severe. Zone "AE" BFE 8'
Window Sill Height (abv FFE):	26"
Case Study (y/n):	No
Site Walls (y/n):	No

The perimeter walls are painted stucco on the exterior in excellent condition and painted plaster on the interior. This resource was inundated severely in both recent named storm events and is unique in that the entire eastern façade has been removed and the first floor is used for parking.

The current flood mitigation strategy is a combination of wet floodproofing and abandonment of the first floor. Given its location and severity of flooding, these are sound strategies.

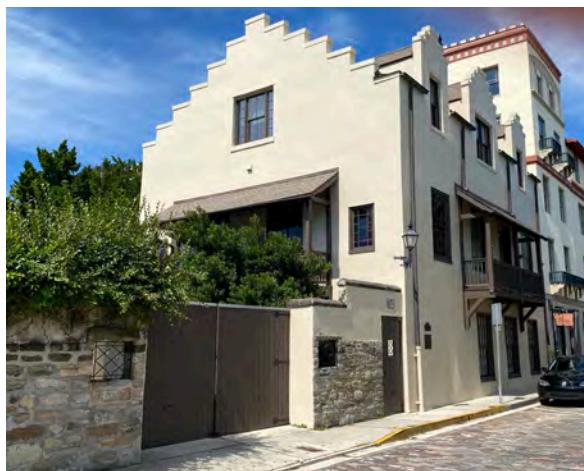
Address:	214 St. George Street
Name:	Lindsley (Horruytiner) House
Ownership:	Private
Construction Date:	1763
Additions/alterations:	1889, 1915, 1977
Restoration Date:	
Exterior walls:	Stucco, wood
First Floor Elevation (FFE):	
Flood Risk Level:	Low. Zone "X" BFE 7'
Window Sill Height (abv FFE):	23" above sidewalk
Case Study (y/n):	No
Site Walls (y/n):	Yes

Perimeter walls are painted stucco in excellent condition on the exterior. The interior was not accessible. The site is walled and is completely closed to the neighboring properties.

Protection by temporary measures, including removable pressure fit door and window floodgates, should be considered. This resource is also a good candidate for site floodproofing. Temporary door floodgates can be installed at the narrow site wall opening and the vehicle gates can be made watertight, provided the wall is capable of supporting the hydrostatic forces. A check valve should be installed on the yard drain if one exists and a sump pump to remove water that enters around the protection measures would be helpful.

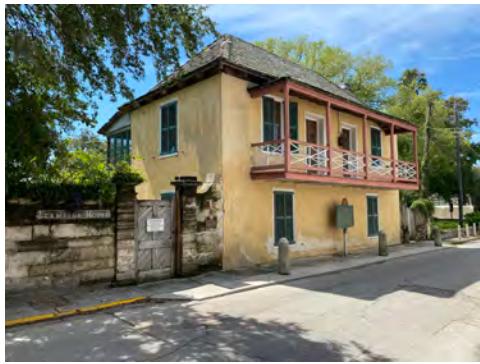
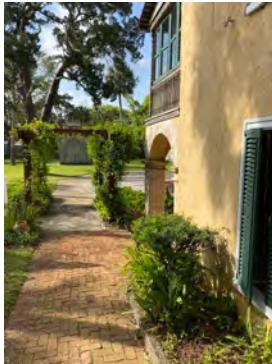
Address:	31 St. Francis Street
Name:	Llambias House
Ownership:	City of St. Augustine
Construction Date:	1763
Additions/alterations:	1780s
Restoration Date:	1954
Exterior walls:	Stucco
First Floor Elevation (FFE):	
Flood Risk Level:	High. Zone "AE" BFE 8'
Window Sill Height (abv FFE):	19" from sidewalk
Case Study (y/n):	Yes
Site Walls (y/n):	No (see * below)

This resource is a valuable example of Second Spanish Period colonial architecture with the original fabric intact. Perimeter walls are painted stucco in good condition on the exterior and plaster on the interior. The site is partially walled and also open to adjacent properties; however there is considerable site area for mitigation design.

Two options exist for addressing future inundation. Wet floodproofing - removing or elevating furniture and materials to the upper floor and allowing the water to enter and exit the building and then cleaning and drying the interior. Dry floodproofing – protect the first floor against flooding by temporary measures including removable pressure fit floodgates at the two doorways. *This property was also the study of *RESILIENT HERITAGE In the Nation's Oldest City* project report August 2020, which suggested sheet waterproofing and berms around the site.

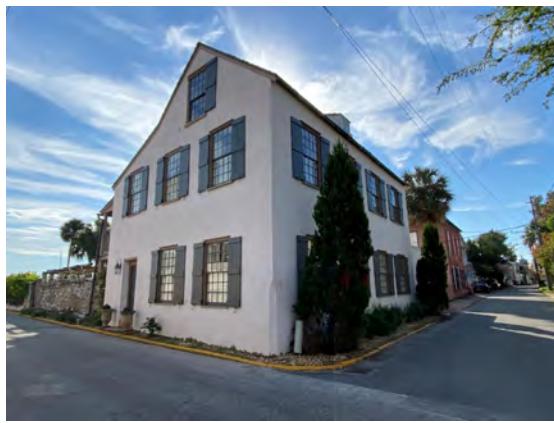
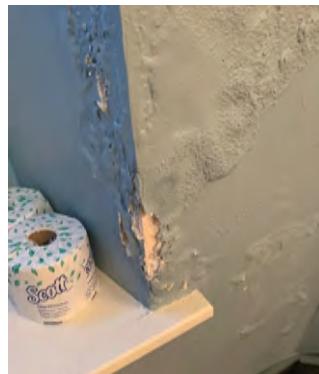
Address:	7 Bridge Street
Name:	Long Sanchez House
Ownership:	Private
Construction Date:	1793
Additions/alterations:	
Restoration Date:	
Exterior walls:	Stucco
First Floor Elevation (FFE):	Flush at east courtyard.
Flood Risk Level:	Severe. Zone AE BFE 8'
Window Sill Height (abv FFE):	15 ½" in courtyard, 26" (min) at street
Case Study (y/n):	Yes
Site Walls (y/n):	Yes

This resource “fronts” on Marine Street, Bridge Street, and Avenida Menendez; a fact that makes it highly susceptible to storm damage and flooding. Inundated in both recent named storm events, this resource has a high risk of damage from flooding and rising water table issues. All exterior walls are coquina masonry with stucco on the exterior and painted plaster on the interior. The site is walled with a very low concrete wall abutting Avenida Menendez and a taller mixed material garden wall on both sides. The short wall is too low to form an effective barrier to storm events and the taller wall is in very poor condition and is incapable of resisting hydrostatic pressure from a significant flood event.

Two options for this resource are site floodproofing the property at the garden wall or dry floodproofing the building using floodgates. For site floodproofing - The garden wall is currently structurally inadequate, improvements could be made to its condition and two gates equipped with permanent brackets that allow for installation of floodgates at the openings. For dry floodproofing the building - removable pressure fit floodgates could be installed and the two doors. Damage related to rising damp should be addressed as outlined in the main report.

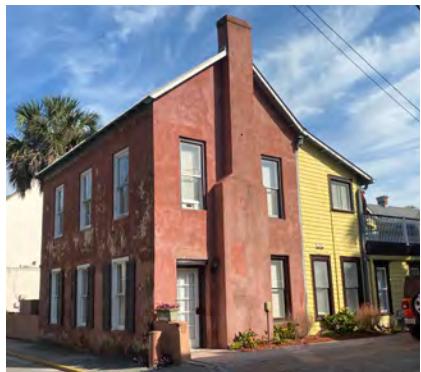
Address:	47 Marine Street
Name:	Marin House
Ownership:	Private
Construction Date:	1791
Additions/alterations:	
Restoration Date:	
Exterior walls:	Stucco
First Floor Elevation (FFE):	
Flood Risk Level:	Severe. Zone "AE" BFE 8'
Window Sill Height (abv FFE):	28" from curb, 34" from street
Case Study (y/n):	No
Site Walls (y/n):	No

This waterfront resource fronts on Marine Street and Avenida Menendez and is adjacent to the Long Sanchez house. Three of the perimeter walls are painted stucco in poor condition on the exterior and there are modern materials such as drywall on the interior. The site is not walled and is open to adjacent properties; and the east-building wall is open to a large frame addition that has many openings. The main entry door is at grade and many other openings in the addition are susceptible to flooding. Inundated in both recent named storm events, this resource is likely to be subject to recurring flooding.

There is no practical method to protect this resource from inundation. Given the modern materials on the interior and the frame sections, wet floodproofing is not recommended. The only remediation scenario is site floodproofing with an adequately high and strong wall around the entire site, which may not be practical.

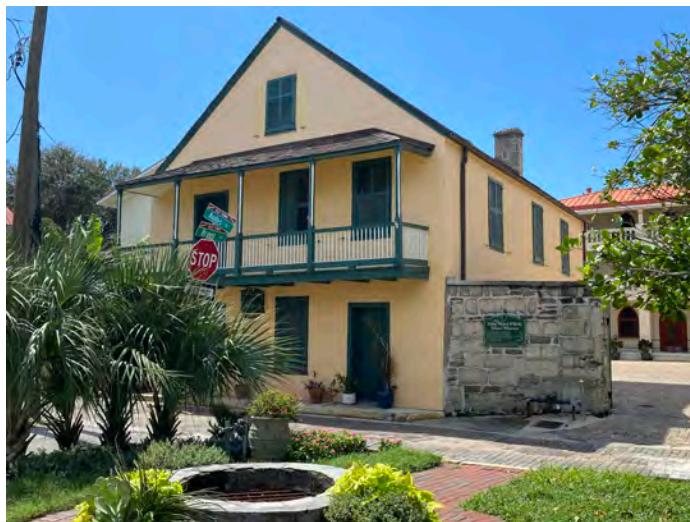
Address:	32 Aviles Street
Name:	O'Reilly House
Ownership:	Sisters of St. Joseph
Construction Date:	1702
Additions/alterations:	1910
Restoration Date:	1940s
Exterior walls:	Stucco
First Floor Elevation (FFE):	
Flood Risk Level:	Moderate. Zone "AE" BFE 7'
Window Sill Height (abv FFE):	19 1/2" minimum
Case Study (y/n):	Yes
Site Walls (y/n):	Yes

Perimeter walls are painted stucco on the exterior in excellent condition and painted plaster on the interior. The interior of the walls are a combination of dressed and rubble coquina with some tabby. There are four doors into the building, two from Aviles Street and two within the courtyard. The site is walled, but the wall encompasses the majority of the block and has numerous large openings.

This resource is a good candidate for dry floodproofing of the building. The building can be floodproofed with removable pressure fit floodgates set in between the door jambs and without the use of permanently installed brackets. Site flood proofing is not recommended because of the large openings in the site walls.

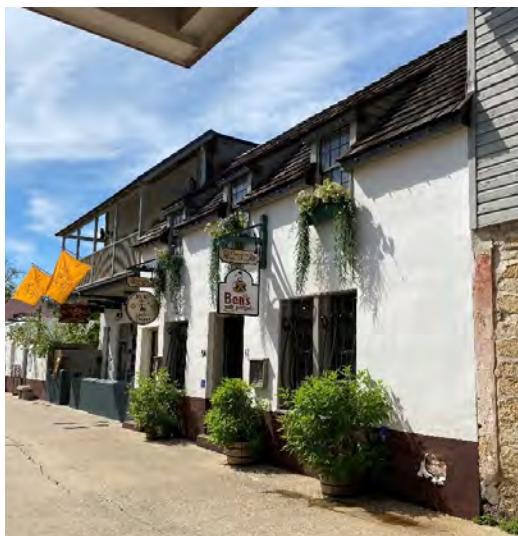
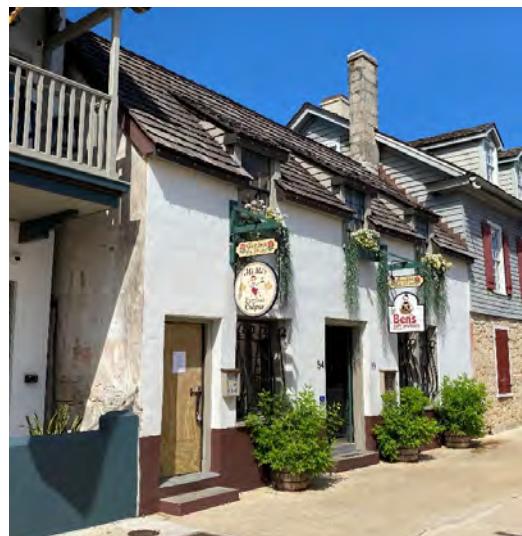
Address: 54 St. George Street
 Name: **Paradres-Dodge House**
 Ownership: University of Florida
 Construction Date: 1813
 Additions/alterations: 1822 – 1860, c. 1890, 1948
 Restoration Date:
 Exterior walls: Stucco, coquina
 First Floor Elevation (FFE):
 Flood Risk Level: Low. Zone "AE" BFE 7'
 Window Sill Height (abv FFE): 21"
 Case Study (y/n): Yes
 Site Walls (y/n): Yes

All exterior walls are coquina masonry with stucco exterior and painted plaster on the interior. One interior wall is exposed coquina and a few other details are exposed. This resource has not been inundated in a named storm event, however heavy localized rain poses a periodic concern in the rear.

The first floor exterior exhibits severe rising damp and spalling issues on the east facade due at least in part to very short overhangs and vapor impermeable paint materials. Interior walls have a much smaller incidence of rising damp.

This resource can be protected with minimal site floodproofing measures by installing permanent brackets for short floodgates at the site wall and removable pressure fit floodgates at the three doorways.

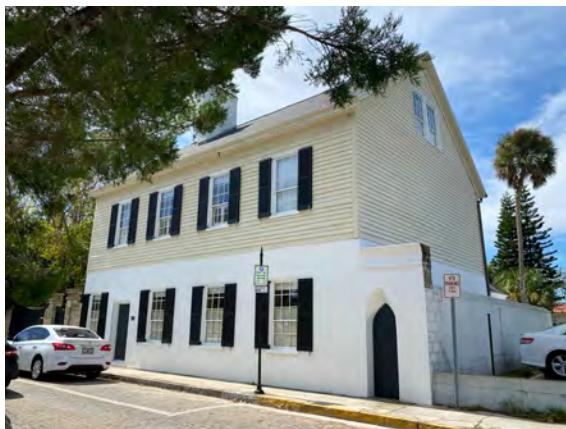
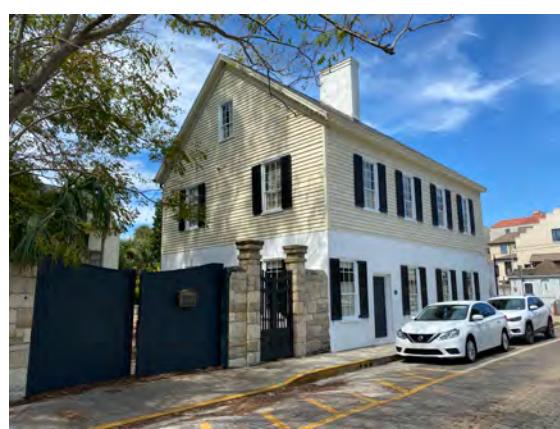
Address:	224 St. George Street
Name:	Parades-Ortega-McMillan House
Ownership:	Private
Construction Date:	1763
Additions/alterations:	1820s, 1884, 1899, 1970
Restoration Date:	1964
Exterior walls:	Stucco, coquina, wood siding
First Floor Elevation (FFE):	
Flood Risk Level:	Moderate. Zone "X" BFE 7'
Window Sill Height (abv FFE):	28"
Case Study (y/n):	No
Site Walls (y/n):	Yes

Perimeter walls are painted stucco on the exterior; the interior was not accessible. The site is walled and is completely closed to the neighboring properties. The coquina site wall section is not historic and is buttressed with steel. The one main entry to St. George has been sealed shut. The owner installed a yard drain that is piped through the curb. This property was not inundated in a named storm event.

This resource is a very good candidate for site waterproofing. Temporary floodgates can be installed at both narrow site wall openings and the vehicle gates can be made watertight. The site wall appears capable of supporting significant hydrostatic forces. A check valve should be installed on the yard drain and a sump and pump to remove water that enters around the protection measures would be helpful. The building can be floodproofed with removable pressure fit floodgates set in between the door jambs and without the use of permanently installed brackets.

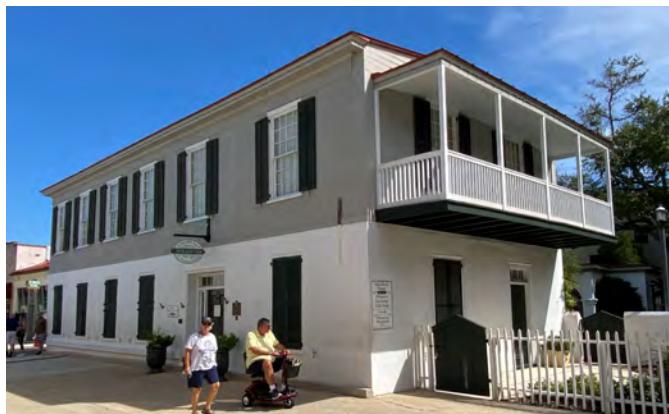
Address:	143 St George Street
Name:	Pena Peck House
Ownership:	City of St. Augustine
Construction Date:	1750
Additions/alterations:	1930s, 1960s
Restoration Date:	1969
Exterior walls:	Stucco, wood siding
First Floor Elevation (FFE):	
Flood Risk Level:	High. Zone AE BFE 7'
Window Sill Height (abv FFE):	24" on two major streets
Case Study (y/n):	No
Site Walls (y/n):	Partial

Perimeter walls are painted stucco on the exterior in excellent condition and painted plaster on the interior. Door openings are up 5" from St. George Street and 11" up from Treasury Street.

The site is partially walled and appears structurally sound enough to resist some hydrostatic forces.

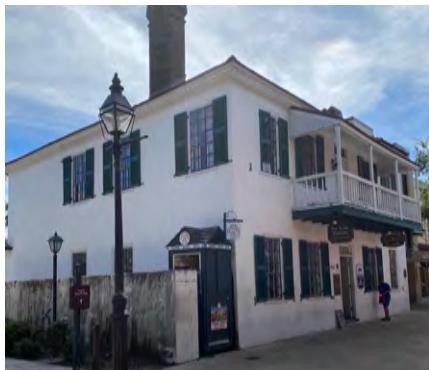
Address:	105 St. George Street
Name:	Poujoud-Burt House
Ownership:	Private
Construction Date:	1816
Additions/alterations:	1968
Restoration Date:	
Exterior walls:	Stucco
First Floor Elevation (FFE):	
Flood Risk Level:	Low. Zone "X" BFE 7'
Window Sill Height (abv FFE):	36"
Case Study (y/n):	No
Site Walls (y/n):	Yes

Perimeter walls are painted stucco in excellent condition on the exterior and painted plaster on the interior. The site is walled and not open to adjacent properties. There are closed-off vents that appear to have ventilated joist space below the floor. This resource was not inundated in the two recent named storm events.

This resource is a good candidate for dry floodproofing. Protection by temporary measures around the perimeter of the site and removable pressure fit floodgates at the two doorways should be considered. Door dams should be removable and not require permanent brackets. Floodgates in openings in the site wall can protect the rear of the building. Investigation should be undertaken to determine if the vent closures are watertight and, if not, sealing these openings should be a priority.

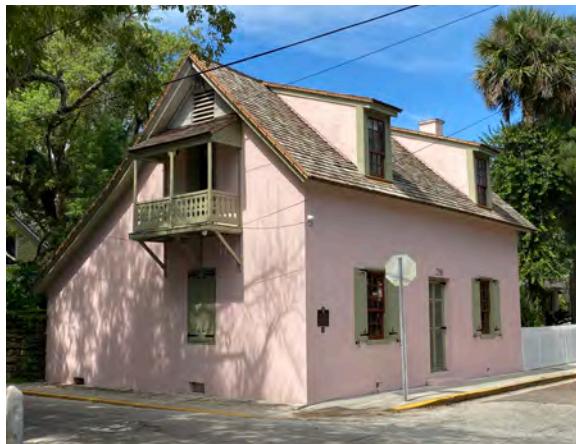
Address:	250 St. George Street
Name:	Prince Murat House
Ownership:	Private
Construction Date:	1815
Additions/alterations:	c. 1880, c. 1940
Restoration Date:	
Exterior walls:	Stucco
First Floor Elevation (FFE):	
Flood Risk Level:	Moderate. Zone "AE" BFE 7'
Window Sill Height (abv FFE):	30"
Case Study (y/n):	No
Site Walls (y/n):	No

This resource is a valuable example of Second Spanish Period colonial architecture and the "St. Augustine plan" with the original fabric intact. Perimeter walls are painted stucco in excellent condition on the exterior and painted drywall on furring strips on the interior. The site is not entirely walled and is open to adjacent properties. The one main entry door is 10" above the sidewalk as is the one to the rear. There are closed-off vents that appear to have ventilated joist space below the floor.

The first floor should be carefully protected against future water damage using the least intrusive methods possible. Protection by temporary measures including removable pressure fit floodgates at the two doorways should be considered at a minimum. Floodgates should be removable and not require permanent brackets. Investigation should be undertaken to determine if the vent closures are watertight and, if not, they should be sealed.

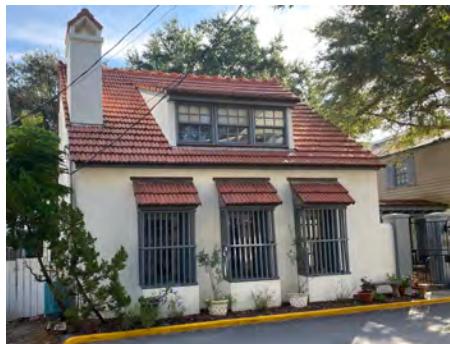
Address:	53 Marine Street
Name:	Puello House
Ownership:	Private
Construction Date:	1812
Additions/alterations:	1987
Restoration Date:	
Exterior walls:	Stucco
First Floor Elevation (FFE):	
Flood Risk Level:	Severe. Zone "AE" BFE 8'
Window Sill Height (abv FFE):	26" from curb, 30" from street
Case Study (y/n):	No
Site Walls (y/n):	Minimal

This resource fronts on Marine Street and Avenida Menendez with direct exposure to the water. Walls are painted stucco in good condition on the exterior and indeterminate materials on the interior. The site is walled with a low (24") wall and is open to adjacent properties. The one main entry door is at grade and many other openings are low. The flooding history for the property is unknown but its elevation suggests inundation in recent named storm events. This resource is extremely likely to be subject to recurring flooding.

This resource is a good candidate for dry floodproofing of the building. Site flood proofing could be employed however the site wall would need to be raised, strengthened, and floodgates provided at the openings. The building alone can be floodproofed with the doors closed with removable floodgates set in between the door jambs with or without the use of permanently installed brackets. The low window sill elevation may need to be addressed with removable floodgates on permanent brackets that allow for installation of floodgates on the outside of the *reja* (window grille).

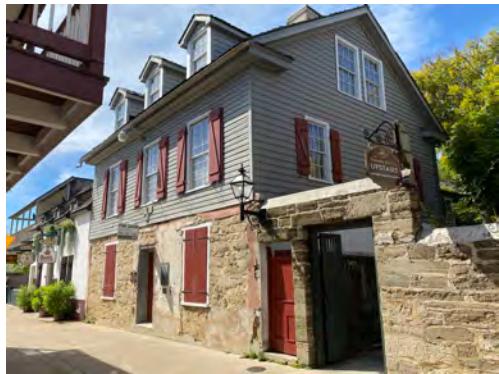
Address:	52 St. George Street
Name:	Rodriquez Avero Sanchez House
Ownership:	Private
Construction Date:	1763
Additions/alterations:	1791-1802, 1833-1869, 1960s, 1966
Restoration Date:	1962
Exterior walls:	Stucco, coquina
First Floor Elevation (FFE):	
Flood Risk Level:	Low. Zone "AE" BFE 7'
Window Sill Height (abv FFE):	26"
Case Study (y/n):	No
Site Walls (y/n):	No

This resource is one of three buildings included in the study that has exposed coquina on the entirety of the public facade. The north, south, and west facades are painted stucco over coquina. All exterior walls are coquina masonry. The flood history of this resource is unknown however its elevation suggests that it has not been inundated in a named storm event. The grade behind the building suggests heavy localized rain may pose a periodic concern.

This resource can be protected by temporary measures including removable pressure fit floodgates within the door openings and without permanent attachment. Protecting the exposed coquina could be undertaken through the use of sheet waterproofing to avoid staining and subsequent cleaning of the stone although any trapped moisture can damage coquina if not removed quickly after water has receded.

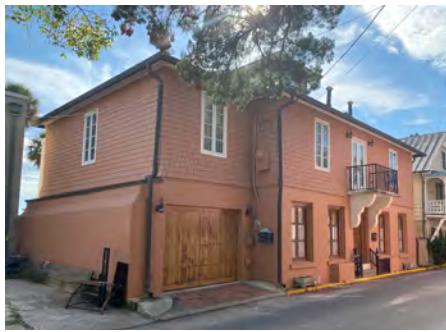
Address:	71 Marine Street
Name:	Rovira-DeWhurst House
Ownership:	Private
Construction Date:	1798
Additions/alterations:	1910-1914
Restoration Date:	
Exterior walls:	Stucco, wood shingles
First Floor Elevation (FFE):	
Flood Risk Level:	Severe. Zone "AE" BFE 8'
Window Sill Height (abv FFE):	21"
Case Study (y/n):	No
Site Walls (y/n):	Yes

This waterfront resource fronts on Marine Street and Avenida Menendez. Walls are painted stucco in excellent condition on the exterior and indeterminate materials on the interior. The site is walled with a window through to the property on the north. Foundation or crawl space is vented but vents have 26" tall protective walls surrounding them. Flood history on this property is unavailable however it is very likely that it was inundated in both recent named storm events and is extremely likely to be subject to recurring flooding. There is a large garage door with indeterminate strength or conditions within the garage.

This resource is a good candidate for site floodproofing due to the strong and tall nature of the surrounding wall. The main entry to the west can be floodproofed with a removable floodgate set in between the door jambs with or without the use of permanently installed brackets. The garage door may withstand hydrostatic pressure and could be floodproofed or, alternatively, allow water into the garage with the flood barrier taking place within. The gate on Avenida Menendez is easily floodproofed with a removable floodgate and the large windows in neighbor's perimeter wall can be closed with a removable floodgate mounted to permanent tracks. Coordination with the neighbor to close a small gap and flood proof the windows is required.

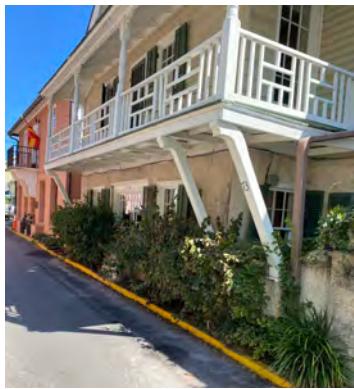
Address:	172 Avenida Menendez
Name:	Rovira -Hernandez House
Ownership:	Private
Construction Date:	1803
Additions/alterations:	c. 1888
Restoration Date:	
Exterior walls:	Stucco, coquina
First Floor Elevation (FFE):	
Flood Risk Level:	Severe. Zone "AE" BFE 8'
Window Sill Height (abv FFE):	30.5" from Marine Street
Case Study (y/n):	No
Site Walls (y/n):	Yes

This resource fronts on Marine Street and Avenida Menendez with direct exposure to the water. Walls are painted stucco in good condition on the exterior and varying materials on the interior. The site is walled with only two gates. Foundation or crawl space is vented but vents have protective walls surrounding them. Inundated in both recent named storm events, this resource is extremely likely to be subject to recurring flooding. The owner has installed a sump and pump to evacuate water from the site.

The owner is proactive and has implemented strategies for dry and site floodproofing. The owner has already has improved site wall integrity and opening protection measures. The gates in the site wall are easily floodproofed with removable dams. The foundation or crawl space is vented but have protective walls surrounding them

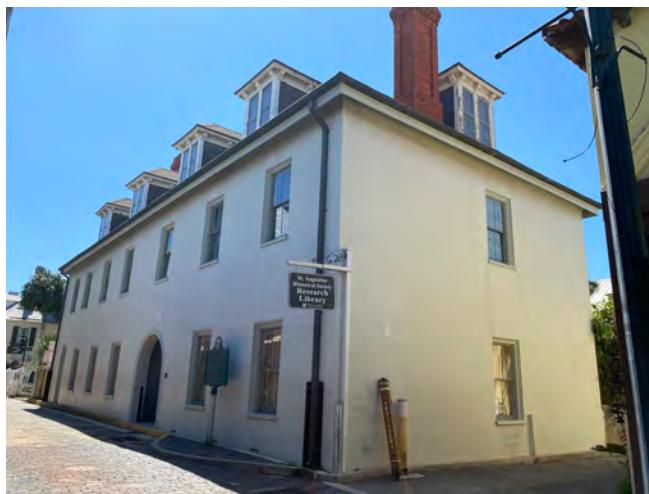
Address:	12 Aviles Street
Name:	Segui House
Ownership:	Public Library
Construction Date:	1790
Additions/alterations:	1888-1895
Restoration Date:	
Exterior walls:	Stucco
First Floor Elevation (FFE):	
Flood Risk Level:	Low. Zone "X" BFE 7'
Window Sill Height (abv FFE):	26"
Case Study (y/n):	No
Site Walls (y/n):	No

Perimeter walls are painted stucco on the exterior in excellent condition and painted plaster on the interior. There are six doors into the building from within the compound and door openings are up at least 6" from St. Aviles Street. The rear of the site is walled with the garden accessed through a large gate and archway through the building. There is an obvious low spot in the garden at the entry arch and no visible yard drainage.

This resource is a good candidate for dry floodproofing. Two alternatives for flood protection are site floodproofing of the property at the surrounding wall or floodproofing the building. Although the garden wall has significant openings, these openings can be protected with removable door floodgates and permanent brackets would not significantly impact existing historic fabric. A generator could be installed with a sump pump to remove water accumulating in the yard. Alternatively, the building alone can be floodproofed with the doors closed with removable floodgates.
