FLOOD MITIGATION DESIGN GUIDANCE FOR HISTORIC COQUINA BUILDINGS

CITY OF ST. AUGUSTINE, FLORIDA

September 2021

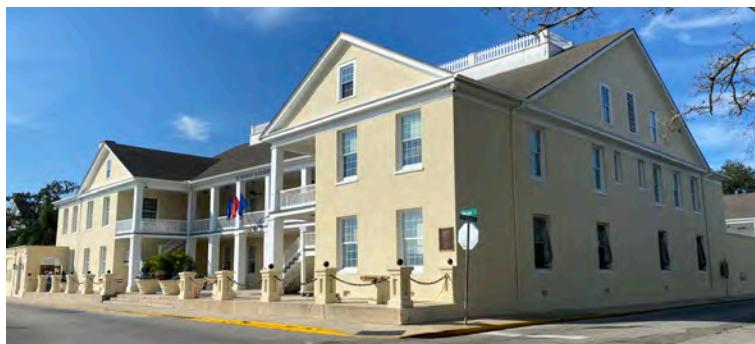
Address:	82 Marine Street
Name:	St. Francis Barracks
Ownership:	State of Florida
Construction Date:	1767
Additions/alterations:	
Restoration Date:	
Exterior walls:	Stucco
First Floor Elevation (FFE):	
Flood Risk Level:	Severe. Zone "AE" BFE 8'
Window Sill Height (abv FFE):	24"
Case Study (y/n):	No
Site Walls (y/n):	Yes

This resource fronts on Avenida Menendez and St. Francis Street with direct exposure to the water. Walls are painted stucco in excellent condition on the exterior although decades of coating with vapor impermeable treatments has likely entrapped moisture within the walls. The interior walls vary in materials interior including drywall and exposed coquina. Although in a precarious location, the building is elevated on a plinth with additional elevation to the interior. The site is walled with a large vehicular gate and an adjacent building completing the enclosure. Foundation or crawl space is vented above the plinth. The crawl space was inundated in both recent named storm events. This resource is extremely likely to be subject to recurring flooding.

This resource is a good candidate for site floodproofing to the rear and easily protected on the east facade with removable floodgates set in between the door jambs with or without the use of permanently installed brackets. The large gate in the perimeter wall can be made to withstand hydrostatic forces and sealed to the adjacent walls. Foundation vents will need to be protected with removable covers.

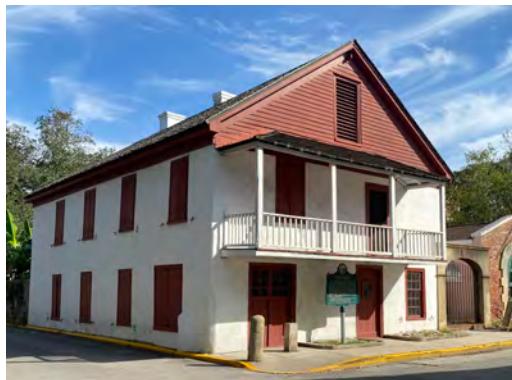
Address: 22 St. Francis Street
 Name: **Tovar “Cannonball” House**
 Ownership: St. Augustine Historical Society
 Construction Date: 1791
 Additions/alterations:
 Restoration Date:
 Exterior walls: Stucco, wood siding
 First Floor Elevation (FFE):
 Flood Risk Level: Severe. Zone “AE” BFE 8'
 Window Sill Height (abv FFE): 17"
 Case Study (y/n): Yes
 Site Walls (y/n): No

Perimeter walls are painted stucco on the exterior in fair condition and a patchwork of various plaster-type materials on the interior. Recent named storm events have significantly inundated this resource up to 24". There are three doors into the building and all are at sidewalk level, which in this instance is slightly below natural grade. There is a site wall it but includes several buildings and has numerous large openings. The floor elevation is one of the lowest in the city.

The natural and unadorned state of the interior of this resource suggests that it is a good candidate for wet floodproofing. For storm events, the furniture and artifacts on the first floor can be removed to the second floor and the spaces lightly washed and dried after they have been inundated.

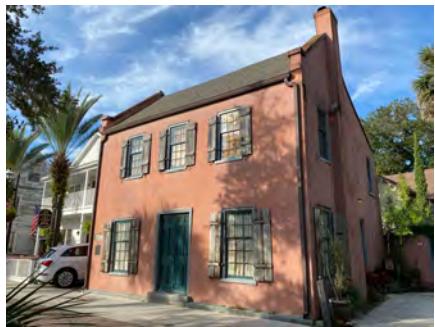
Address:	42 Spanish Street
Name:	Triay House
Ownership:	Private
Construction Date:	1806
Additions/alterations:	
Restoration Date:	1951
Exterior walls:	Stucco
First Floor Elevation (FFE):	
Flood Risk Level:	Moderate. Zone "AE" BFE 7'
Window Sill Height (abv FFE):	28" sill window / 11.5" door sill
Case Study (y/n):	No
Site Walls (y/n):	Yes

Perimeter walls are painted stucco on the exterior in fair condition and unknown material on the interior. There are three doors into the building with sills approximately 11 ½" from the Spanish Street. The front door has been sealed shut but is not watertight or structurally sound. The site is walled with only a few openings and appears sound.

This resource is a good candidate for dry floodproofing of the building and/or site floodproofing. The building alone can be floodproofed with the sealing of the Spanish Street door improved and the other doors closed with removable floodgates with permanent or temporary brackets. Similar floodgates would be necessary at site wall openings if site floodproofed.

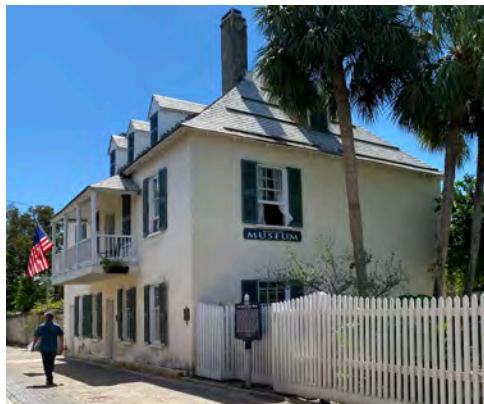
Address:	20 Aviles Street
Name:	Ximenez Fatio House
Ownership:	Society of Colonial Dames
Construction Date:	1797
Additions/alterations:	
Restoration Date:	1979
Exterior walls:	Stucco, coquina, wood siding
First Floor Elevation (FFE):	
Flood Risk Level:	Low. Zone "X" BFE 7'
Window Sill Height (abv FFE):	
Case Study (y/n):	Yes
Site Walls (y/n):	Yes

The first floor exterior walls are coquina masonry with painted stucco on the exterior and painted plaster on the interior. Floors are wood in areas and concrete in a few places. There are many exterior doors on the first floor. This resource has not been inundated in a recent named storm event however heavy localized rain poses a periodic concern. There is a French drain along the courtyard facade and a sump and pump in the former well location to evacuate rain accumulation in the courtyard.

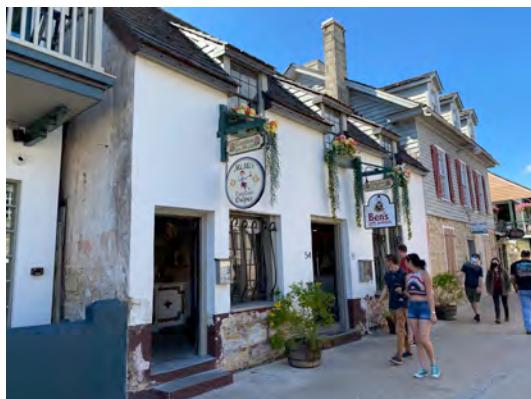
54 St George Street, St Augustine FL
Example of rising damp approx. 30 inches
above grade

- Historic stucco, plaster, paints, and coatings such as lime wash were vapor permeable and, as a result, the water vapor escapes and takes with it soluble salts and other minerals. Escaping moisture leaves a small amount of condensation on wall surfaces that provide a medium for mildew growth and may evaporate some of the coatings. To hide the discoloration from mildew, a tinted coating or 'zocalo' is applied to the bottom 30" or so of historic buildings. The 'zocalo' is a historic treatment that not only disguised dirt and mud splatters from unpaved roads but also hid the discoloration of rising damp on coquina structures. See example photos before and after a 'zocalo' treatment below.

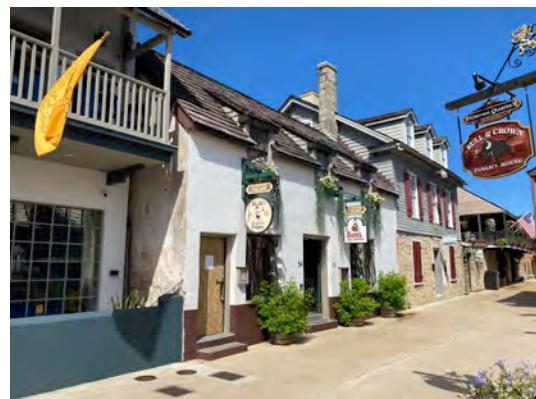
Rising Damp - After 'zocalo' treatment

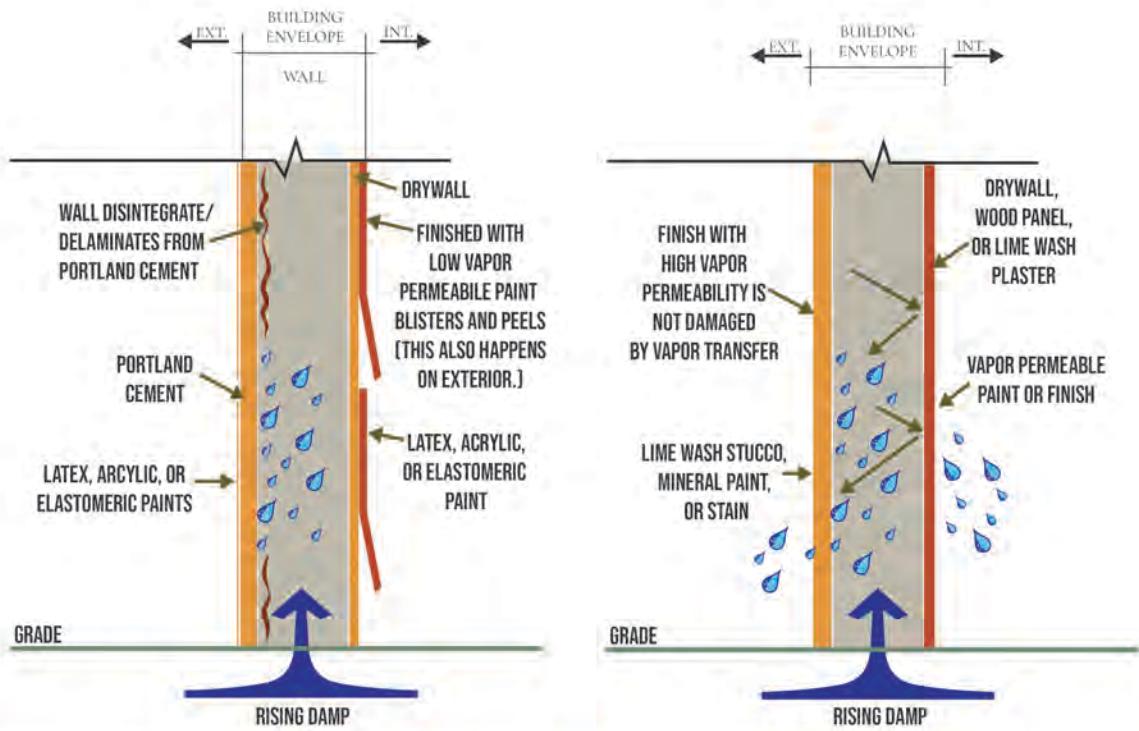
TRAPPED MOISTURE

Detail Section Example of trapping moisture in a wall using vapor impermeable finishes and paints versus allowing the walls to breath using vapor permeable finishes and paints

Modern vapor-impermeable materials including high-strength portland cement based mortar and stucco, single coat plasters, and latex and oil based paints are commonly applied to coquina structures. The effect of applying these coatings traps moisture and its associated salts within the wall. This subsequently results in pressure from capillary action, which can cause the failure of the vapor impervious coating or, if the coating remains in place, salts are deposited in the moist area behind the coating while the moisture rises ever higher seeking a place to escape. The continued rise of moisture can result in peeling paint, delaminating and failing plaster, damp and rotting wood window sills, and structural failure of stucco coverings. Salts in the moisture are concentrated and deposited on the surface of the coquina eventually breaking down the calcium carbonate that binds the stone together. This problem is being exacerbated by steadily rising water tables.

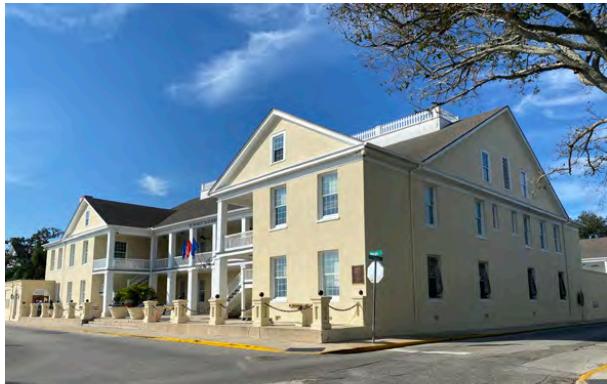
82 Marine Street, St Augustine FL
Vapor impermeable finish on the exterior

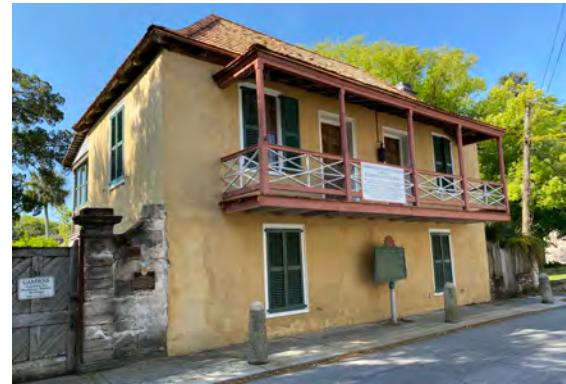
31 St Francis Street, St Augustine FL
Vapor permeable finish on the exterior

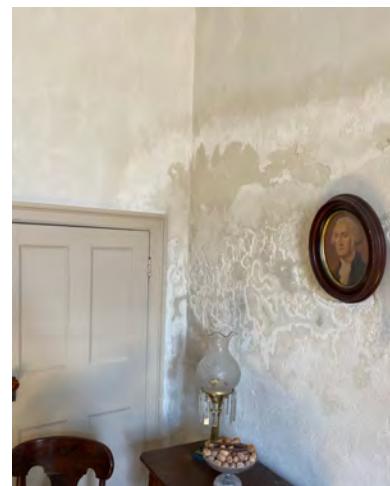
2) Plaster over Coquina - The historic interior finish application is a hydraulic lime render plaster over the natural coquina. This finish is applied in many structures such as the Ximenez Fatio (interior photo to the right) and Llambias house. The lime-based plaster protects the natural coquina and allows it to "breath". Rising damp evidence (salts collecting) may be visible on the lower portion of the walls and this can be repaired over time with additional coats of the lime-based plaster. While plaster over coquina is the historic application the wall finish can appear textured and mottled. This is the wall "breathing" and in it's natural state. It is important to note that vapor permeable plaster will need to be lightly cleaned after water inundation.

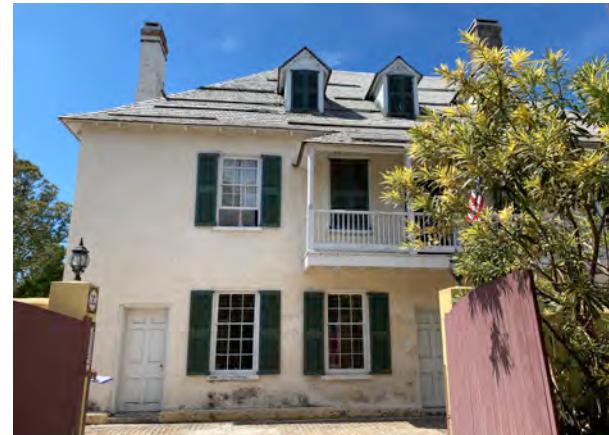
20 Aviles Street, St Augustine FL
Hydraulic limewash finish on exterior

This traditional coating provides a breathable, decorative finish that soaks into the underlying material to which it is applied. The material is primarily composed of slaked lime (calcium hydroxide) usually with a low proportion of an organic binder. The calcium hydroxide sets slowly by combining with carbon dioxide to form calcium carbonate, the principal component of limestone and marble. As a coating for lime-based render and stucco, and limestone in particular, limewash is in many ways comparable in nature to that of the underlying material, with similar porosity, alkalinity (pH value) and coefficient of thermal expansion.

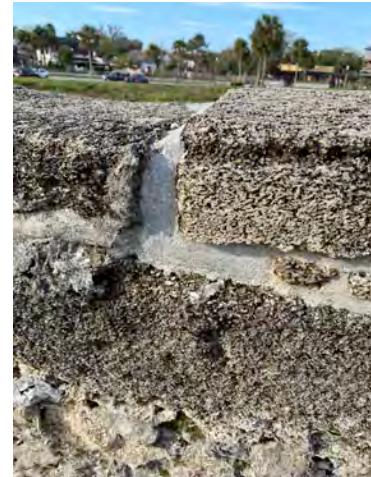
For exposed coquina, weathering or surface erosion is due principally to exposure to the elements. Contributing factors include: wind driven particles, water (e.g., scupper wash and splash-back), acid rain, and evaporation of moisture containing ionized salts. Many garden walls, gateways, and, for more recent (post-1820) structures, exposed coquina masonry. Other causes of loss of stone surface include: application of an inappropriate surface consolidating treatment, surface repair coating (e.g., portland cement stucco), and repointing with cement-based mortar that is harder than the stone (see example of photo to right). Water impermeable mortar traps water in the coquina face and it erodes the coquina eventually leaving a ledge of mortar that traps even more water and worsens the condition.
